PDHonline Course S177 (2 PDH)

Petrographic Analysis of Concrete Deterioration

Instructor: Matthew Stuart, PE, SE

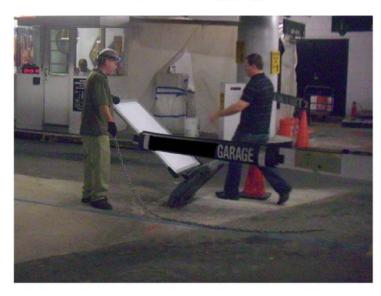
6

So back to my list of the top 5 on-site survey techniques: Chain dragging is an inexpensive but very effective method used to locate subsurface delaminations, or voids, which resonate differently than the distinct sound generated by sound concrete. The best results are obtained from slapping the chain against the surface as opposed to simply dragging it across the surface.

This method of evaluating hidden deterioration helps to:

- 1. Establish accurate quantities for estimating the initial repair costs during the investigation phase, and...
- 2. Establish the boundaries of the extent of demolition of the deteriorated concrete during the actual repair phase.

GPR (or Ground Penetrating Radar) has also been shown to accurately identify subsurface delaminations by detecting hidden voids in the slab.

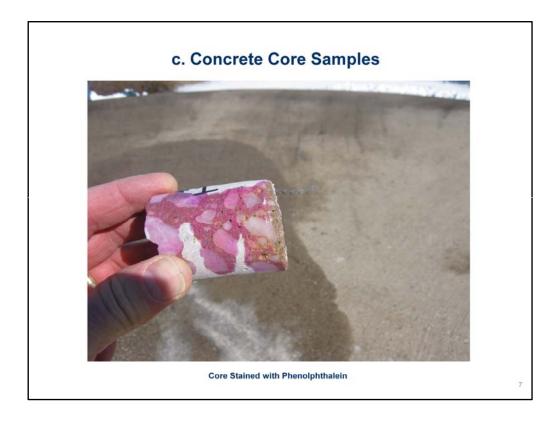
Concrete core samples for petrographic analysis should be obtained from areas that exhibit deterioration. It is also recommended that at least one core sample be obtained from what appears to be an undamaged, undeteriorated area of the structure so that a comparison can be made between the damaged and undamaged areas of the concrete. This comparison can be invaluable when it comes to establishing the root cause of the deterioration.

The diameter of a core sample required for petrographic analysis varies to some degree between different labs, but in general cores from 2 inches to 4 inches in diameter are acceptable, even though the ASTM specification for petrographic analysis recommends 6-inch diameter cores.

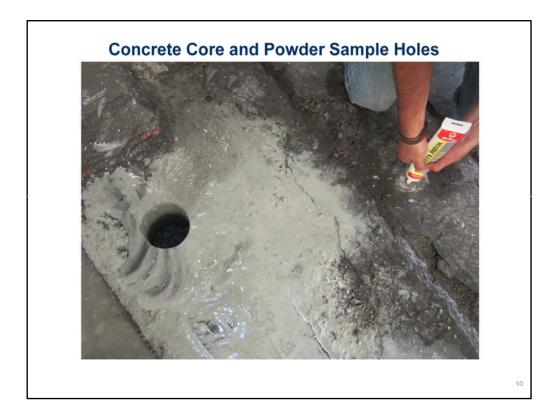
Here is a photo of a concrete core hole, which will be filled in with a high-strength, fast-setting epoxy grout concrete so that the area can continue to be used safely after the sample is obtained. On the right hand side of the same photo a drilled powder sample hole is being filled back up with a durable sealant to fill the small hole for similar reasons.

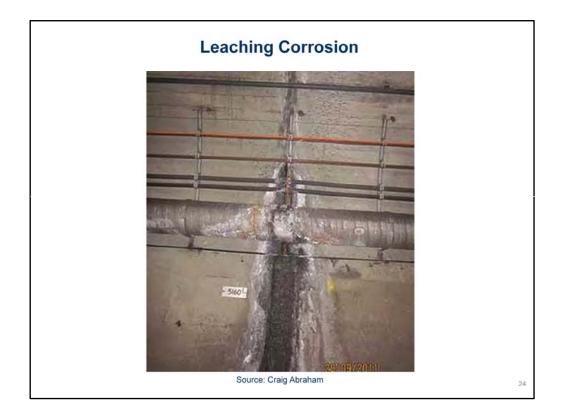
Leaching Corrosion is a type of attack that effects concrete in contact with fresh water and results in the slow elimination of the bond between the cement and aggregate.

I have seen this type of deterioration destroy concrete man-holes that were not adequately waterproofed on the exterior.

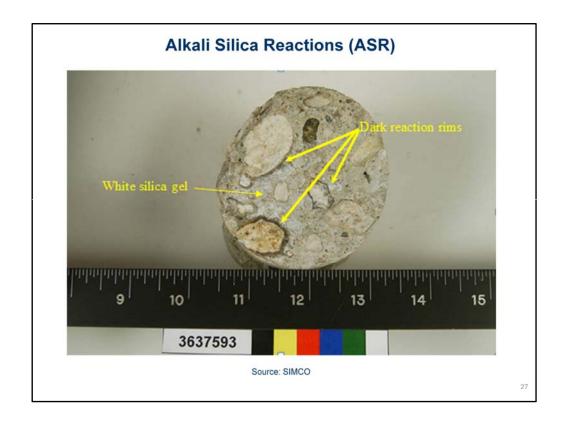
Alkali Silica Reactions, or ASR, occur as a result of a chemical reaction between some types of aggregates which contain reactive silica and the alkalinity of the concrete in the presence of moisture.

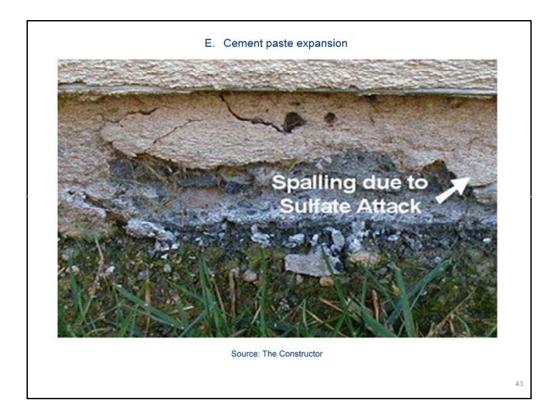
E. Cement Paste Expansion

Sometimes external sulfate attack can also cause the cement paste to expand which results in the formation of gaps around the aggregates. This type of deterioration depends on many factors including the water/cement ratio and the type of cement, exposure time, temperature, the concentration of sulfates and the chemistry of the water.

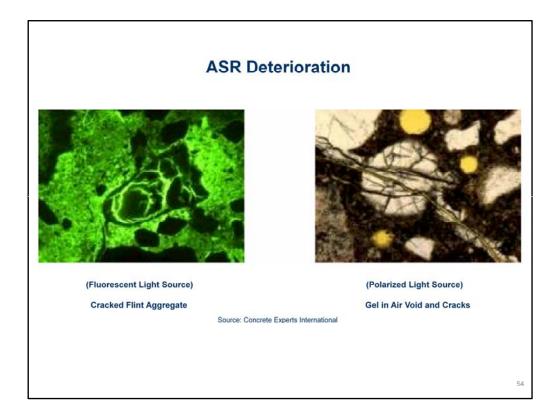
Some of the effects of ASR are illustrated in this slide, including a cracked flint aggregate on the left and gel in air voids and cracks on the right.

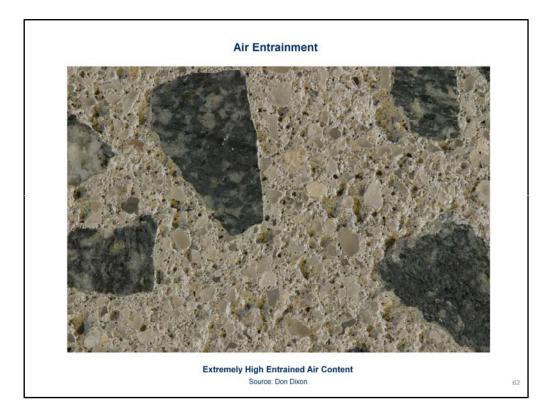
Deterioration of concrete from freeze thaw actions may occur when the concrete is saturated, or approximately 90% of its pores are filled with water. When water freezes to ice it occupies approximately 10% more volume than that of water. If there is no space for the expansion to occur in the concrete, freezing may cause internal stresses in the concrete. Damage to concrete from freezing and thawing will start with the first freeze thaw cycle and continue throughout each winter season resulting in repeated deterioration of the concrete surface. Concrete with a high water content and a high water/cement ratio is less frost resistant than concrete with a lower water content.

To protect concrete from freeze thaw damage air-entrainment admixtures should be used in the concrete mixture. This type of admixture will create a large number of closely spaced, small air bubbles in the hardened concrete. The air bubbles provide relief to the internal pressure within the concrete caused by the formation of ice by providing many small voids for the freezing water to expand into.

A minimum of 4% to 5% air by volume is needed in a well distributed pattern with a distance between each void of not less than 0.25 mm in the concrete in order for airentrainment to be effective in preventing freeze thaw damage. Typically I specify 6% air entrainment in concrete mixes intended for exterior exposure.
