**PDHonline Course A105 (5 PDH)**

# **Preservation Standards and Guidelines for Historic Buildings**

# Standards for Preservation & Guidelines for Preserving Historic Buildings

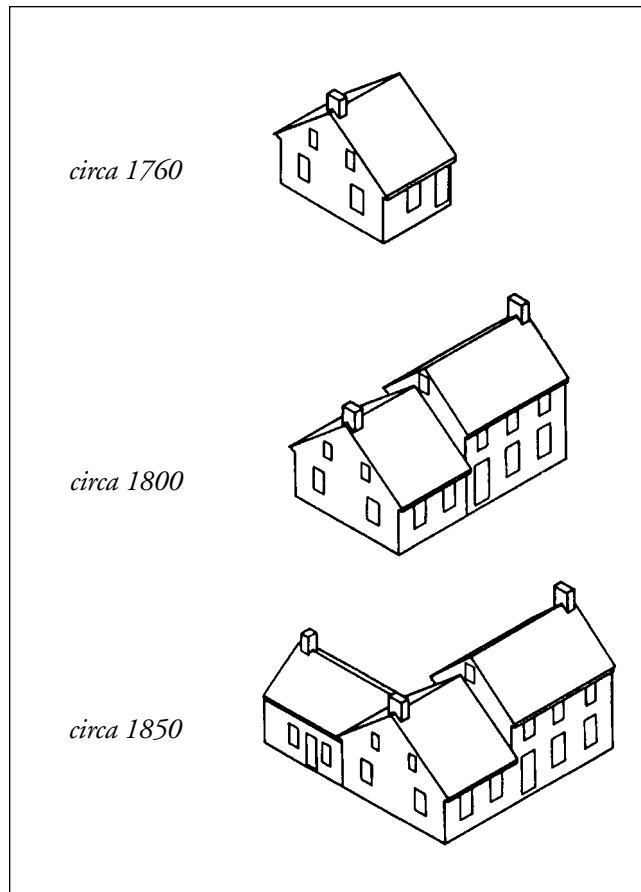
*This three-part drawing shows the evolution of a farm house over time. Such change is part of the history of the place and is respected within the treatment, Preservation. Drawing: Center for Historic Architecture and Engineering, University of Delaware (adapted from Preservation Brief 35: Understanding Old Buildings).*

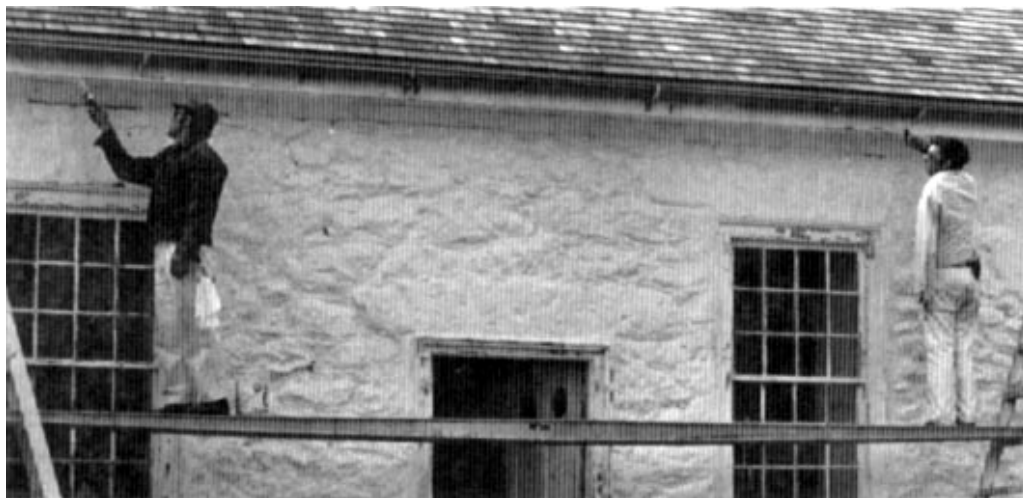
*Adequate protection and maintenance of a historic building is an ongoing commitment. Here, two workers are priming and repainting exterior stone and wood trim. If surface treatments are neglected, more extensive repair and replacement will be required. Each loss further undermines a building's historic integrity.*

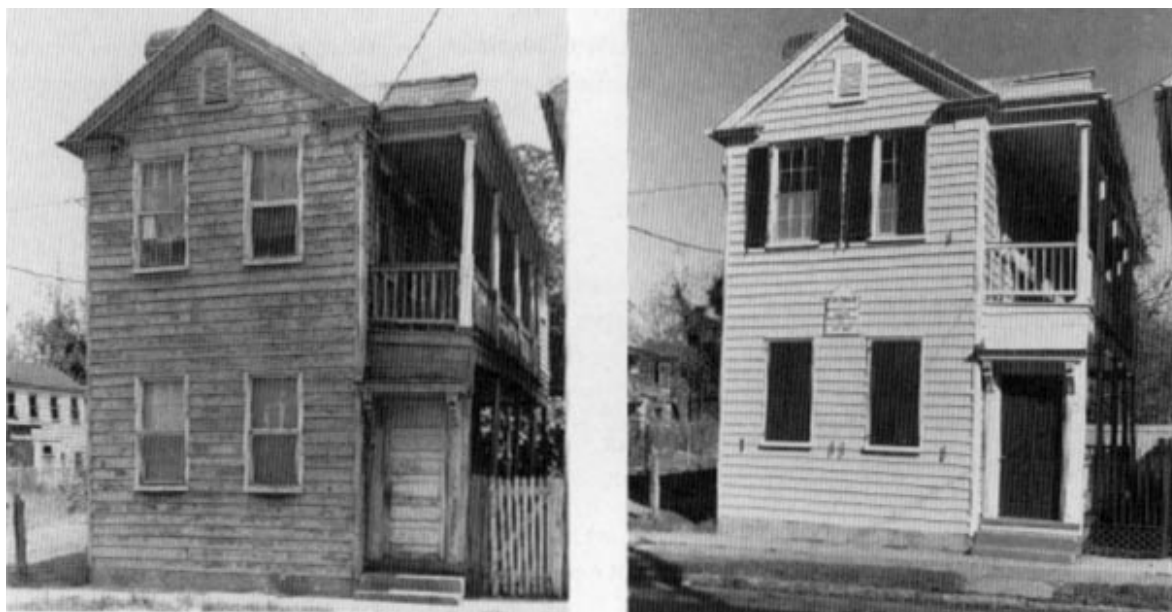
*Maximizing retention of historic materials and features is the primary goal of Preservation as demonstrated here in these “before” and “after” photographs. Aside from some minor repairs and limited replacement of deteriorated material, work on this house consisted primarily of repainting the wood exterior. Photos: Historic Charleston Foundation.*

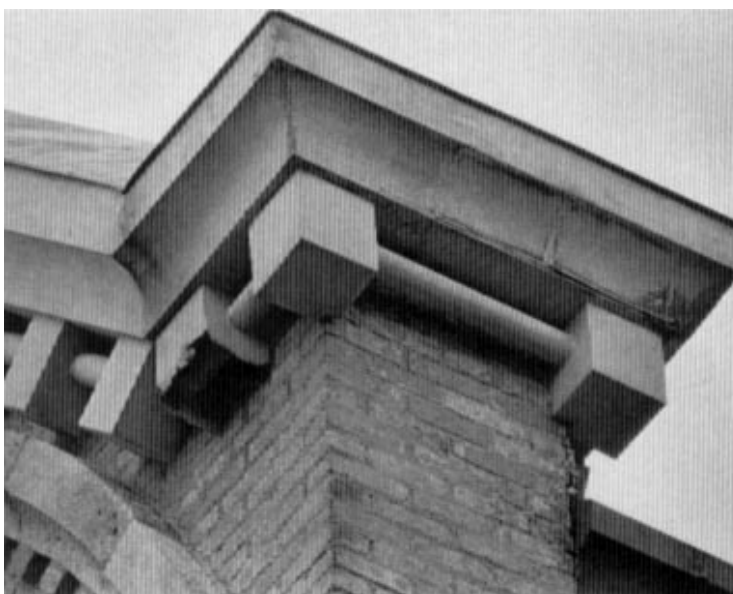
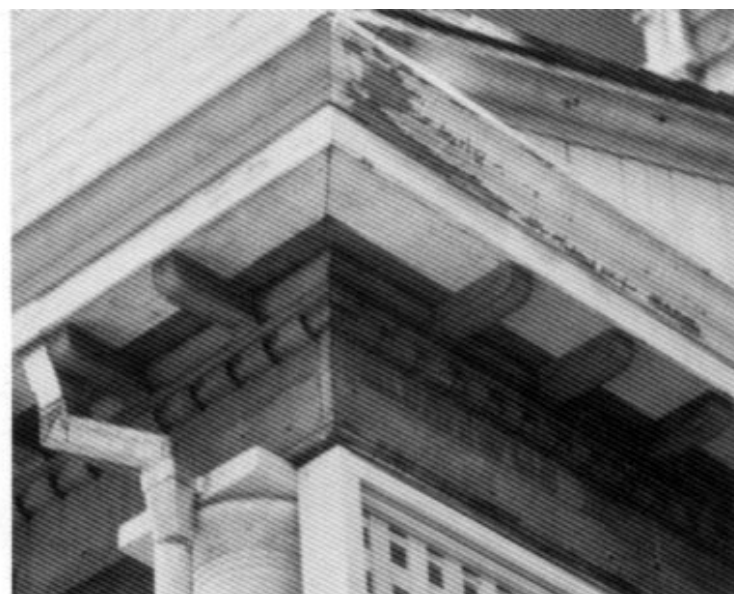
*Two examples of “limited replacement in kind” point out an appropriate scope of work within the treatment, Preservation. (a) One metal modillion that has sustained damage from a faulty gutter will need to be replaced; and (b) targeted repairs to deteriorated wood cornice elements (fascia board and modillions) meant that most of the historic materials were retained in the work.*

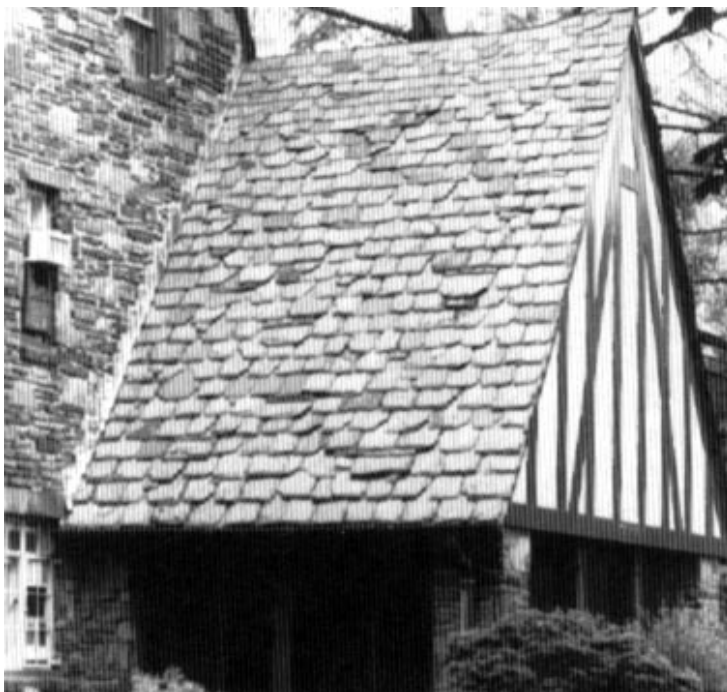
*It is particularly important to preserve materials that contribute to a building's historic character, such as this highly visible slate roof. In the event that repair and limited replacement are necessary, all new slate would need to match the old exactly. Photo: Jeffrey S. Levine.*

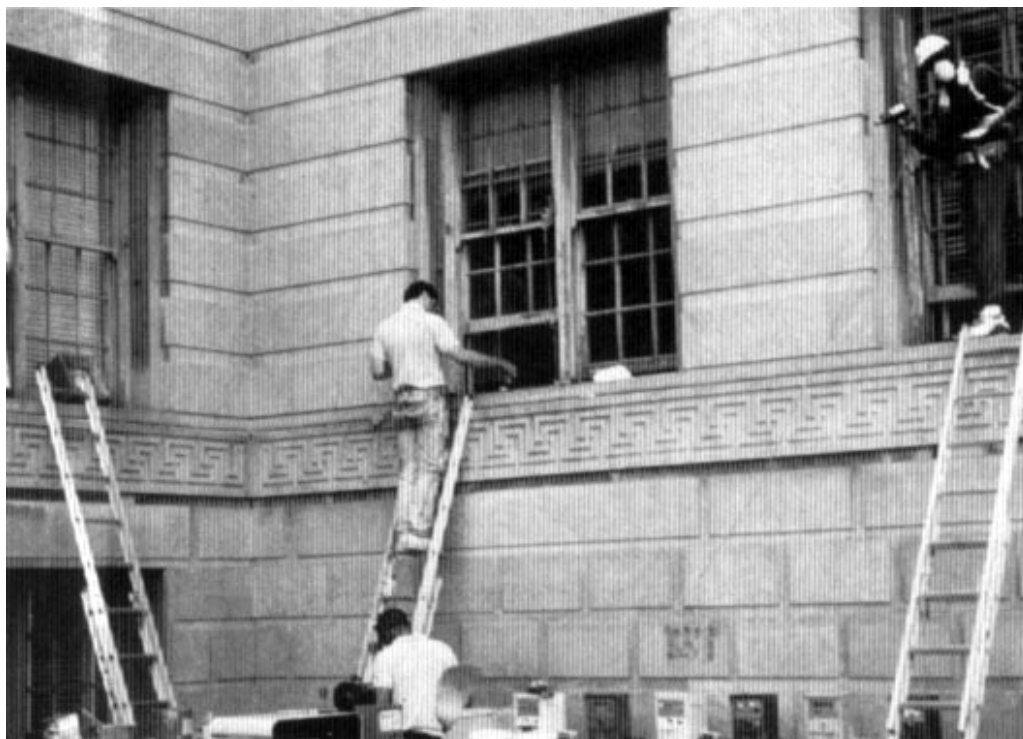
*Preserving a building's historic windows generally involves scraping, sanding, and re-painting. While some repair work will most likely be undertaken within the scope of work on this institutional building, replacement of the window units is usually not an appropriate Preservation treatment. Photo: Chuck Fisher.*

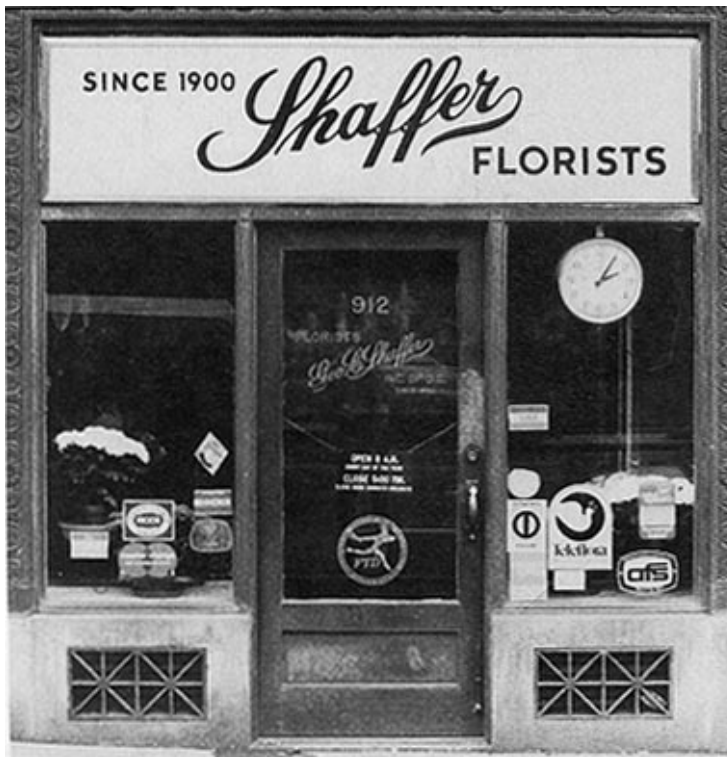
*The original form and features of this 1920s storefront have been retained through Preservation. Photo: David W. Look, AIA.*

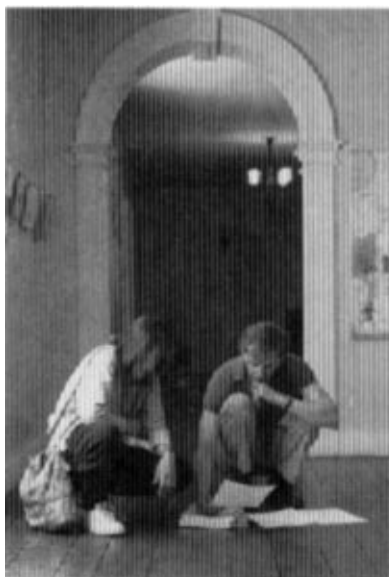
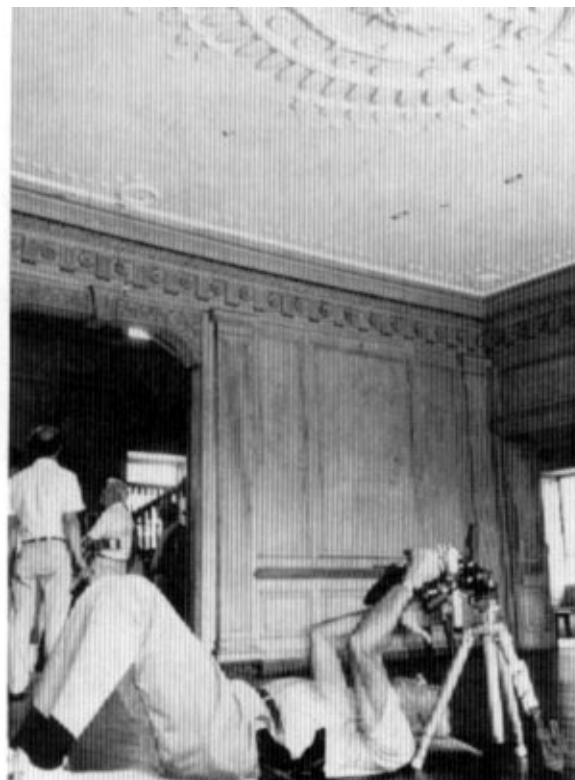
*Careful documentation of a building's physical condition is the critical first step in determining an appropriate level of intervention. (a) This may include relating the historical research to existing materials and features; or (b) documenting a particular problem such as this cracked ceiling. Photo (a): Jean E. Travers; Photo (b): Lee H. Nelson, FAIA.*

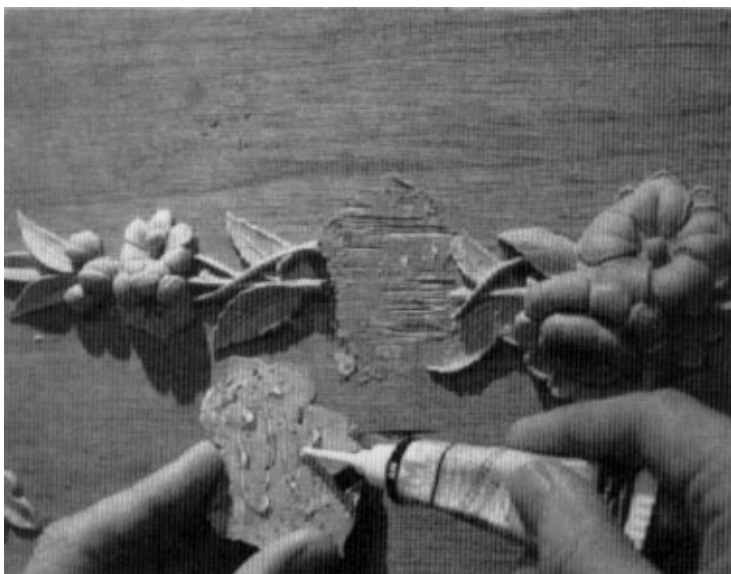
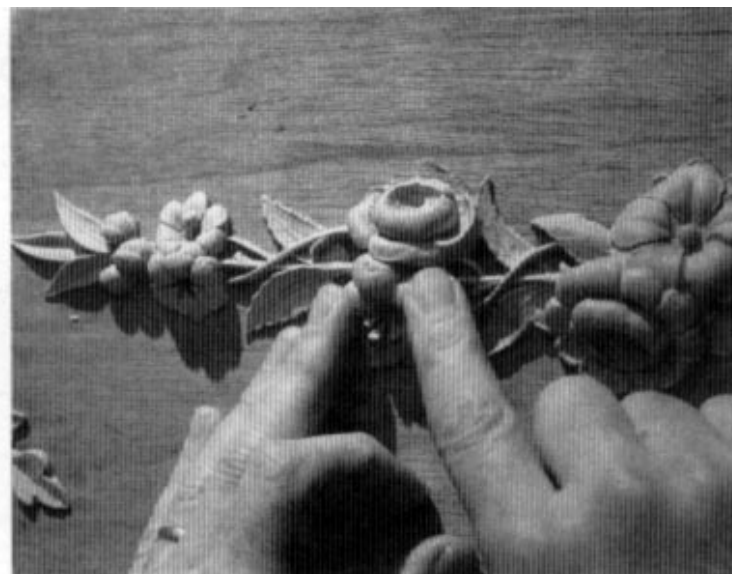
*In Preservation, an appropriate level of intervention is established prior to work in order to maximize retention of historic materials.*

*(a) A conservator is applying adhesive to 19th century composition ornament that has delaminated from its wood substrate.*

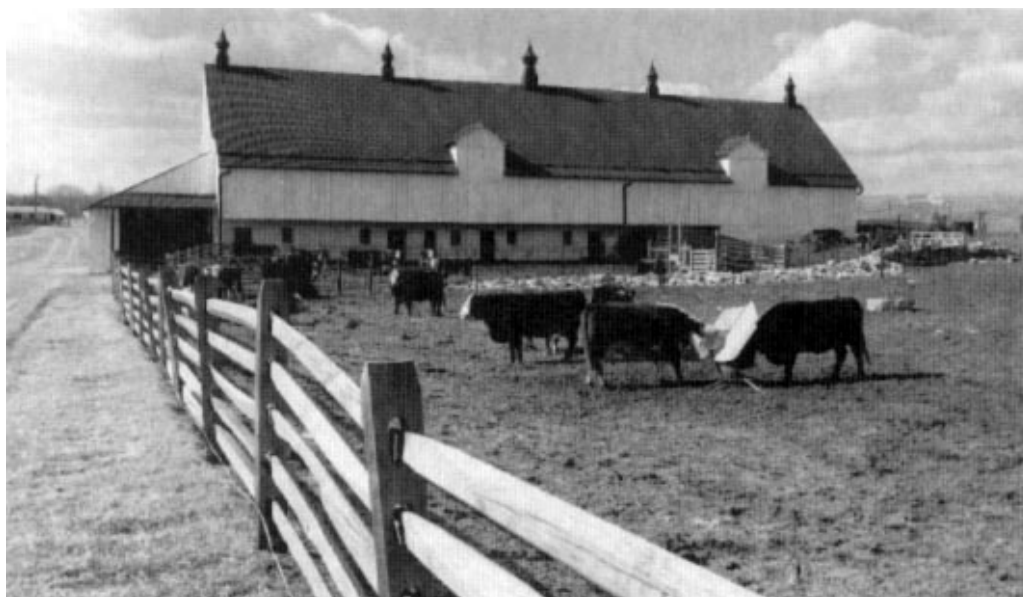
*The goal of Preservation is to retain the historic form, materials, and features of the building and its site as they have changed—or evolved—over time. This bank barn was built in the 1820s, then enlarged in 1898 and again in 1914. Today, it continues its role as a working farm structure as a result of sensitive preservation work. This included foundation re-grading; a new gutter system; structural strengthening; and replacement of a severely deteriorated metal roof. Photo: Jack E. Boucher, HABS.*
