# **Excavation Hazard Recognition- OSHA Standards**

# Aurora OSHA Construction News

## Trenching Still A Concern

Volume 3, Issue 2  
Fall 2002

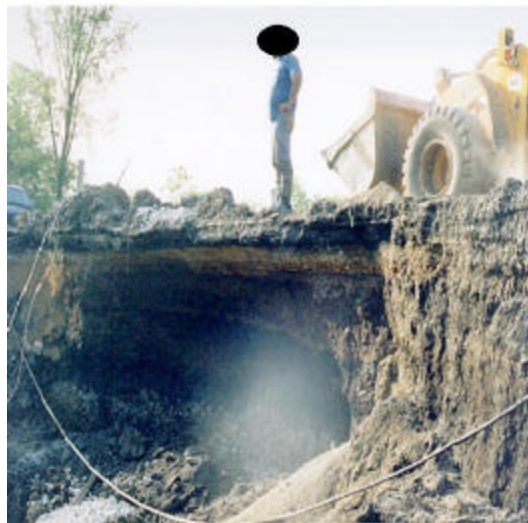
Yes—this is a violation. The excavation is undercutting the street and the front end loader only adds to the problem.
