EM 1110-2-2002

30 June 1995

Engineering and Design
EVALUATION AND REPAIR OF CONCRETE STRUCTURES

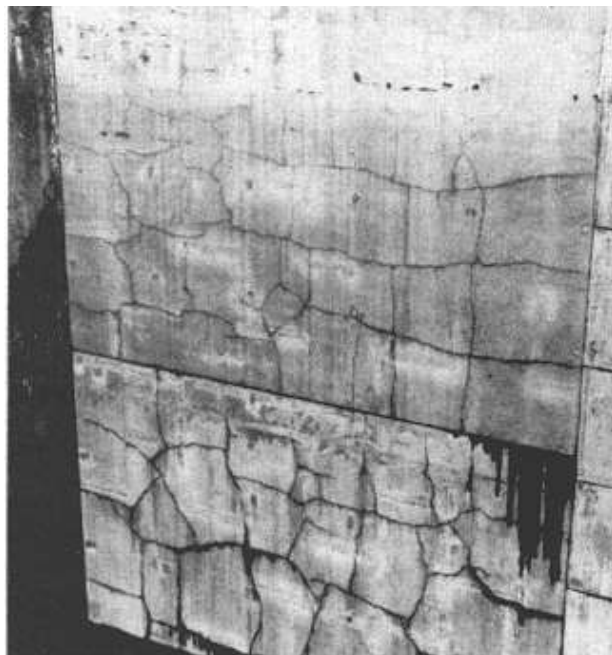
Figure 2-5. Pattern cracking caused by restrained volume changes

(a) Surface appearance of cracks. The surface appearance of cracks can give the first indication of the cause of cracking. Pattern cracks (Figures 2-5 through 2-7) are rather short cracks, usually uniformly distributed and interconnected, that run in all directions. Pattern cracking indicates restraint of contraction of the surface layer by the backing or inner concrete or possibly an

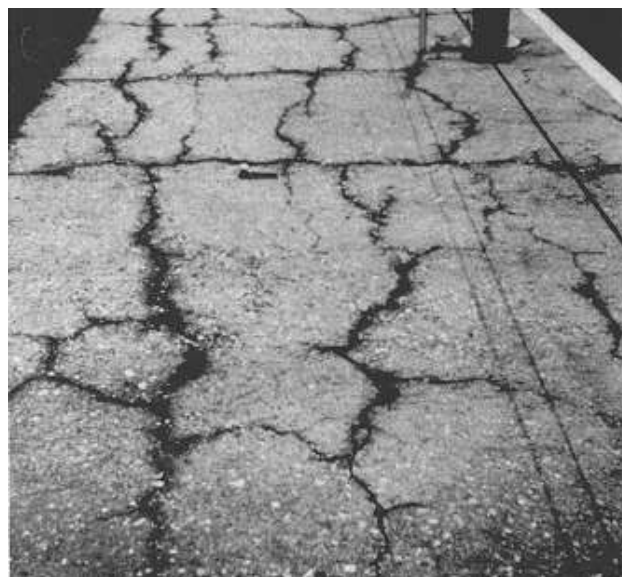
Figure 2-6. Pattern cracking resulting from alkali-silica reaction

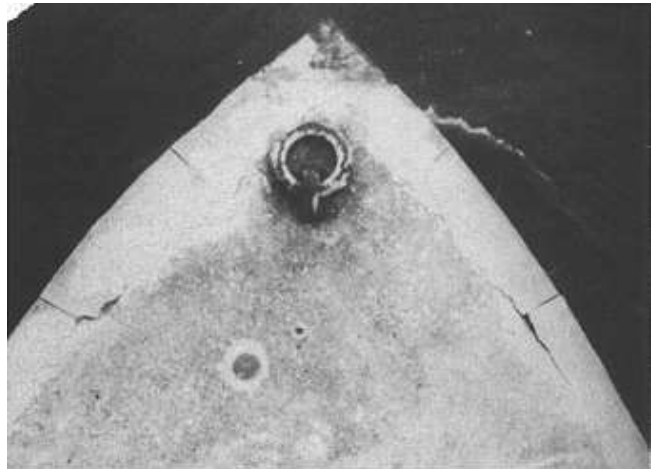
Figure 2-9. Isolated cracks as a result of restraint in the direction perpendicular to the crack

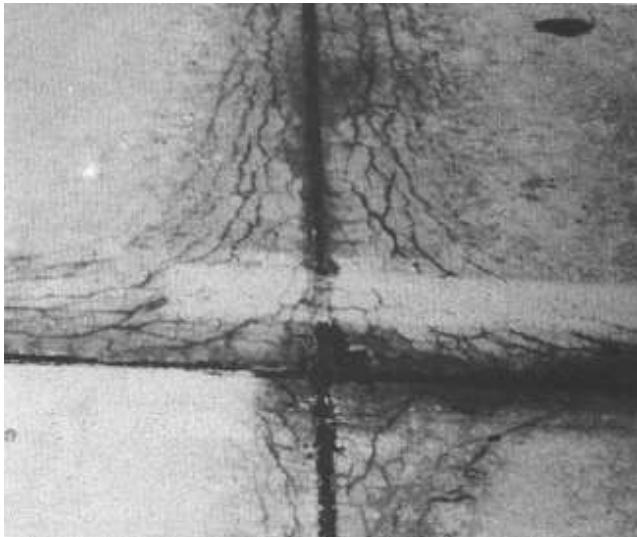
Figure 2-8. D-cracking in a concrete pavement

increase of volume in the interior of the concrete. Other terms used to describe pattern cracks are map cracks, crazing, and checking (see Glossary, Appendix B, for definitions). Another type of pattern crack is D-cracking. Figure 2-8 shows typical D-cracking in a concrete pavement. D-cracking usually starts in the lower part of a concrete slab adjacent to joints, where moisture accumulates, and progresses away from the corners of the slab. Individual cracks (Figures 2-9 through 2-11) run in definite directions and may be multiple cracks in parallel at definite intervals. Individual cracks indicate tension in the direction perpendicular to the cracking. Individual cracks are also frequently referred to as isolated cracks. Several terms may be used to describe the direction that an individual or isolated crack runs. These terms include diagonal, longitudinal, transverse, vertical, and horizontal.

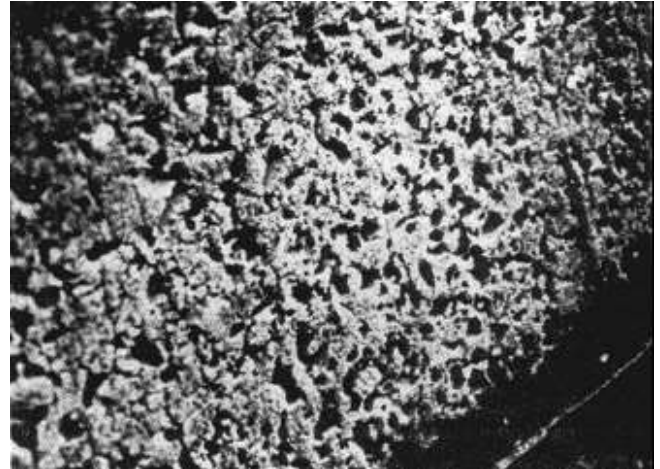
Figure 2-12. Disintegration of concrete caused by exposure to aggressive water

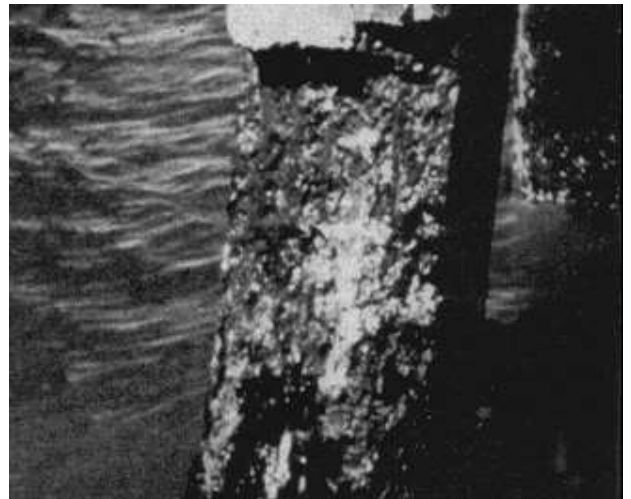
Figure 2-13. Disintegration of concrete caused by exposure to acidic water

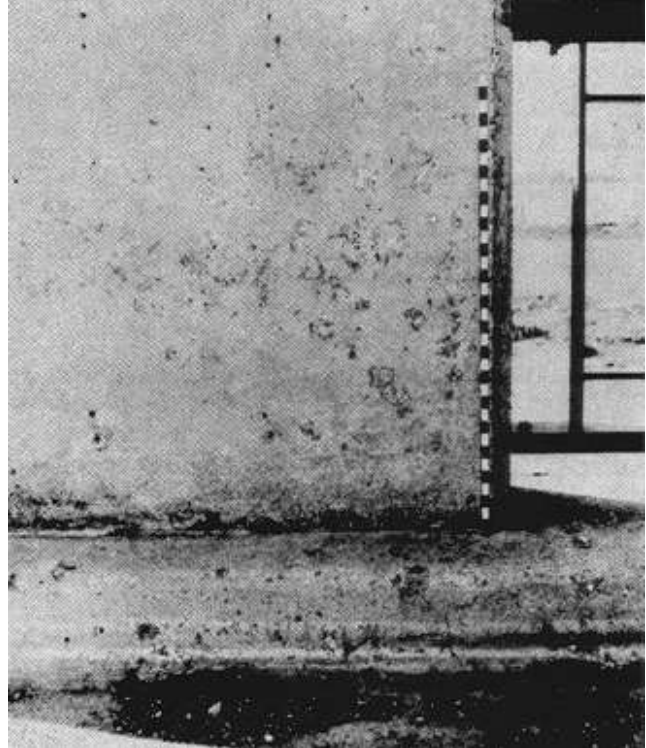
Figure 2-16. Light scaling

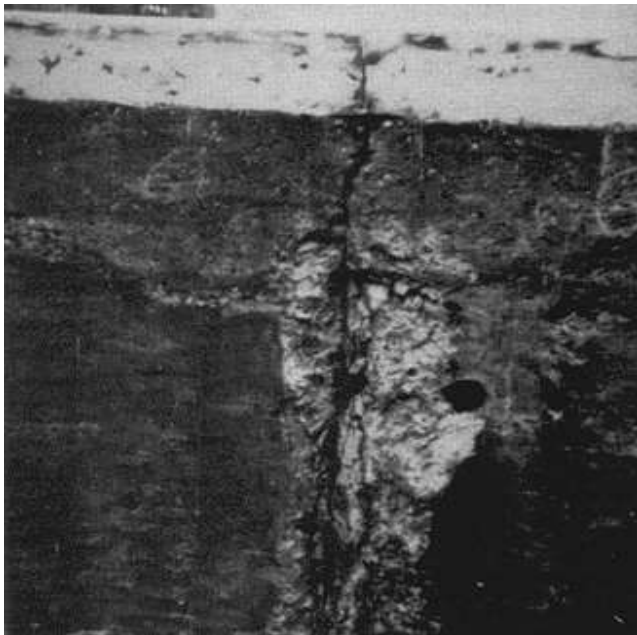
Figure 2-15. Disintegration at a monolith joint as a result of repeated cycles of freezing and thawing and barge impact

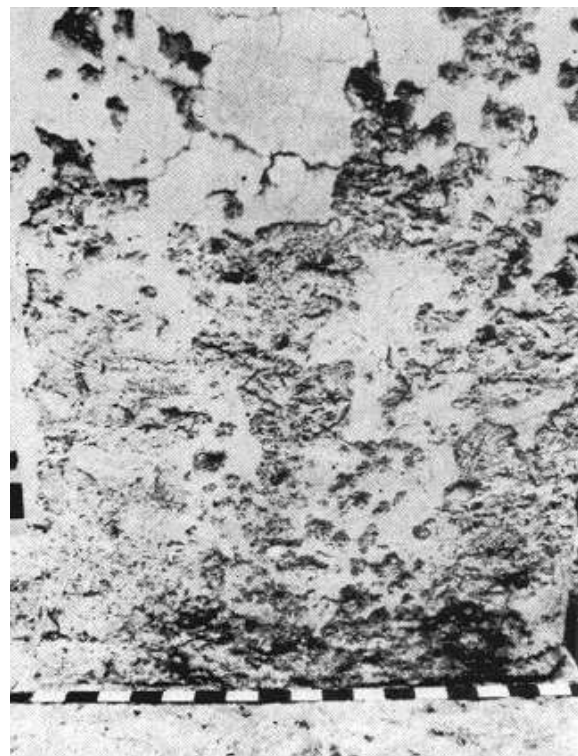
Figure 2-17. Medium scaling

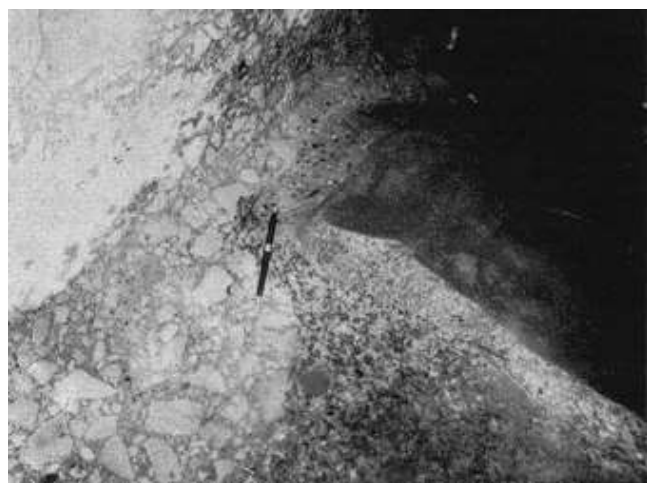
Figure 2-20. Smooth, worn, abraded concrete surface caused by abrasion of waterborne debris

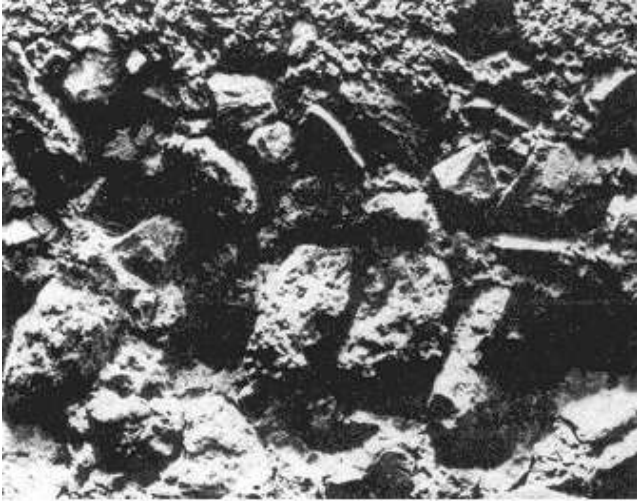
Figure 2-21. Rough, pitted concrete surface caused by cavitation

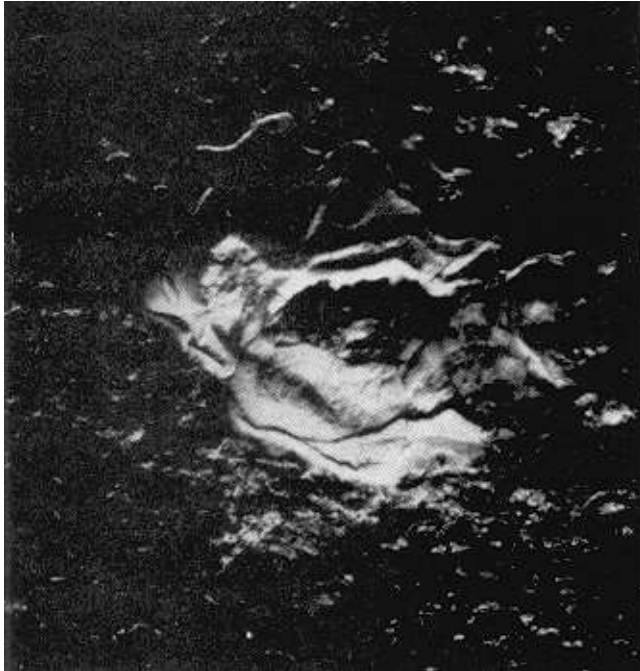
Figure 2-25. Exudation

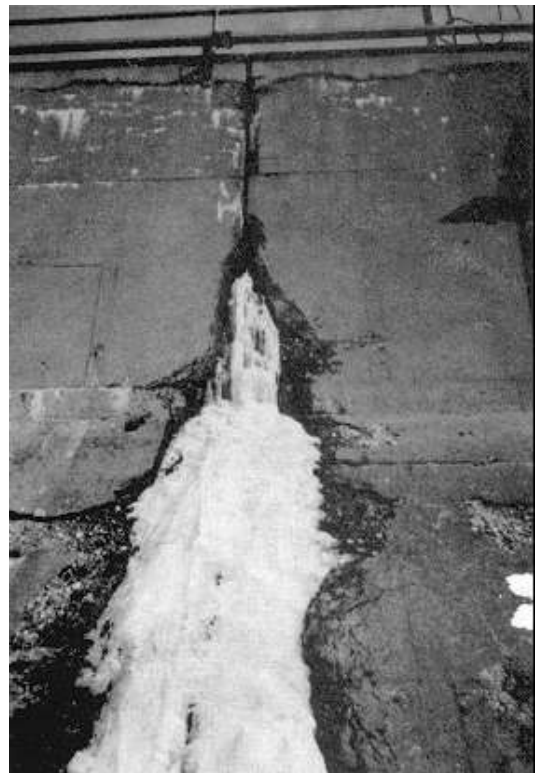
Figure 2-28. Water seepage through joint

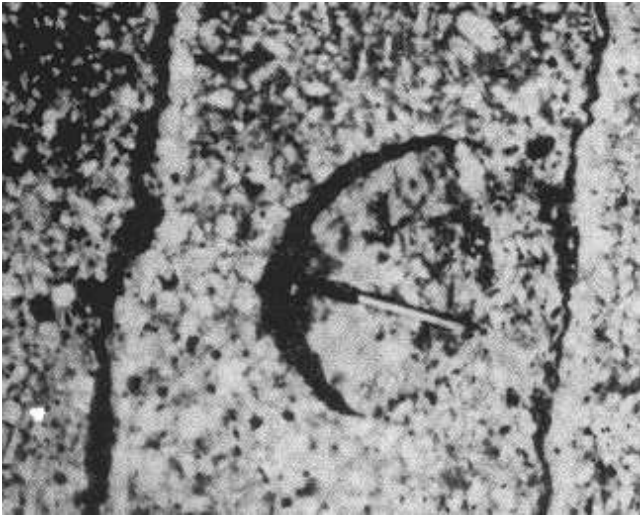
Figure 2-29. Small spall

(a) Small spall. Not greater than 20 mm (0.8 in.) in depth nor greater than 150 mm (6 in.) in any dimension (Figure 2-29).

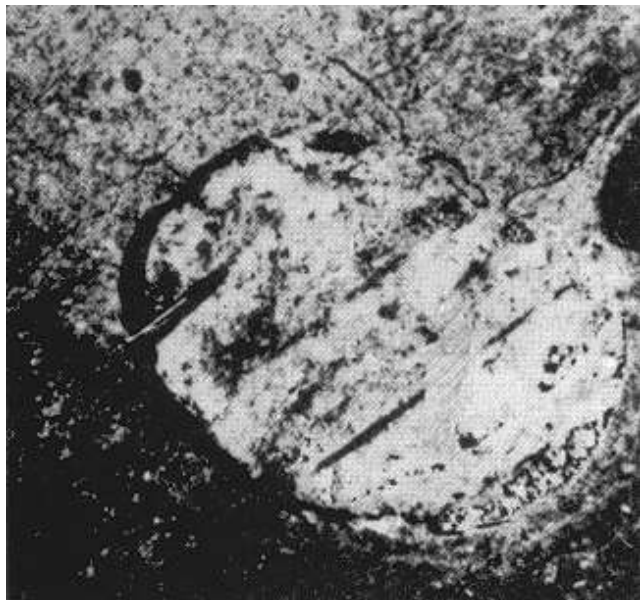
Figure 2-30. Large spall

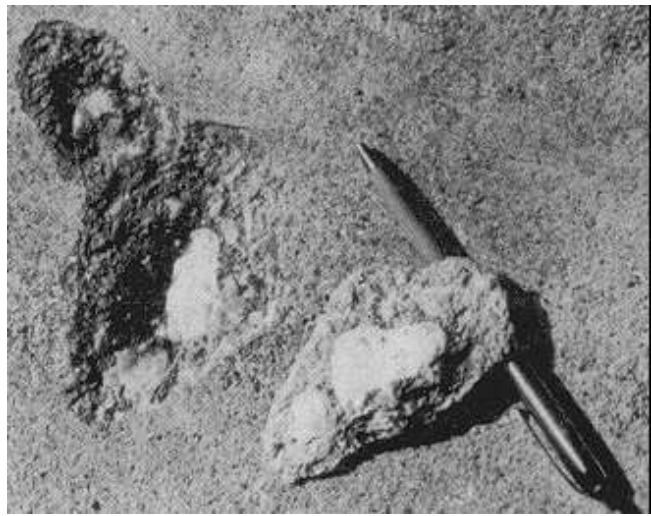
Figure 2-31. Popout

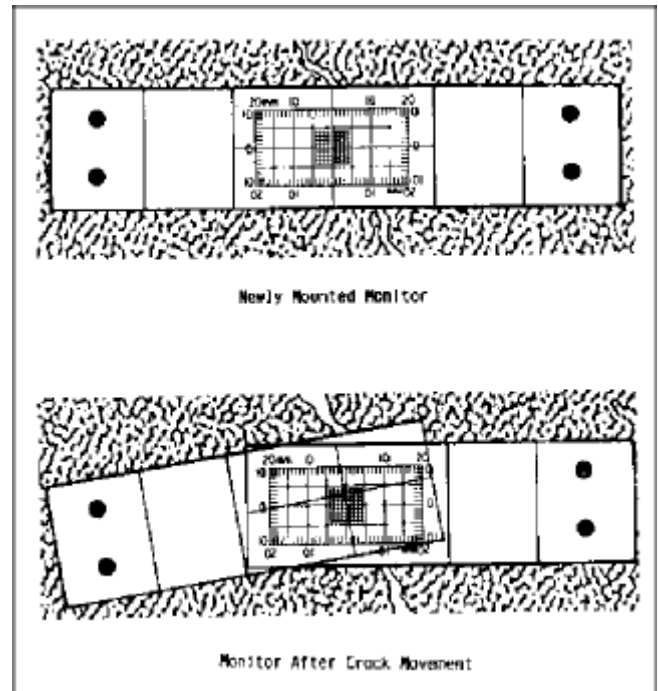
Figure 2-33. Crack monitor

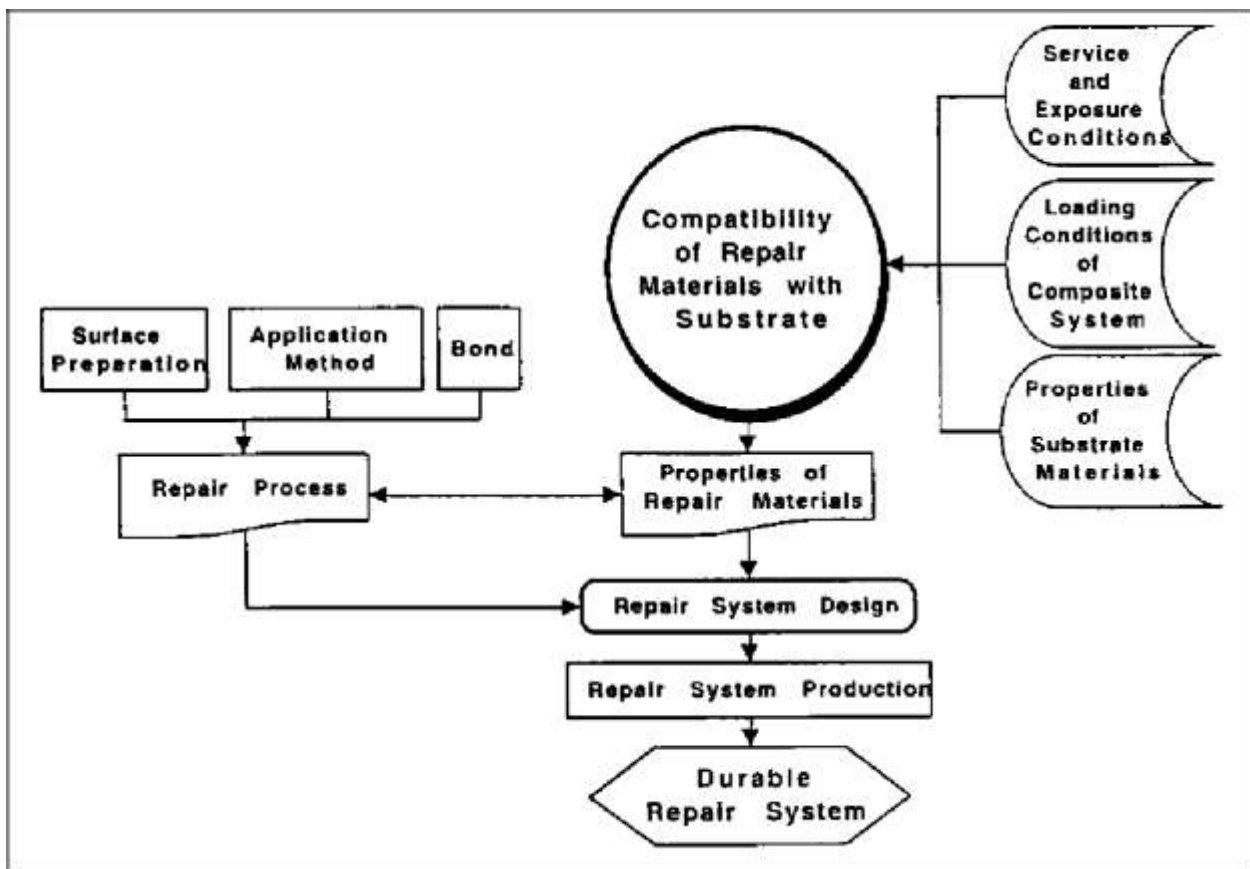
Figure 4-1. Factors affecting the durability of concrete repair systems (Emmons and Vaysburd 1995)

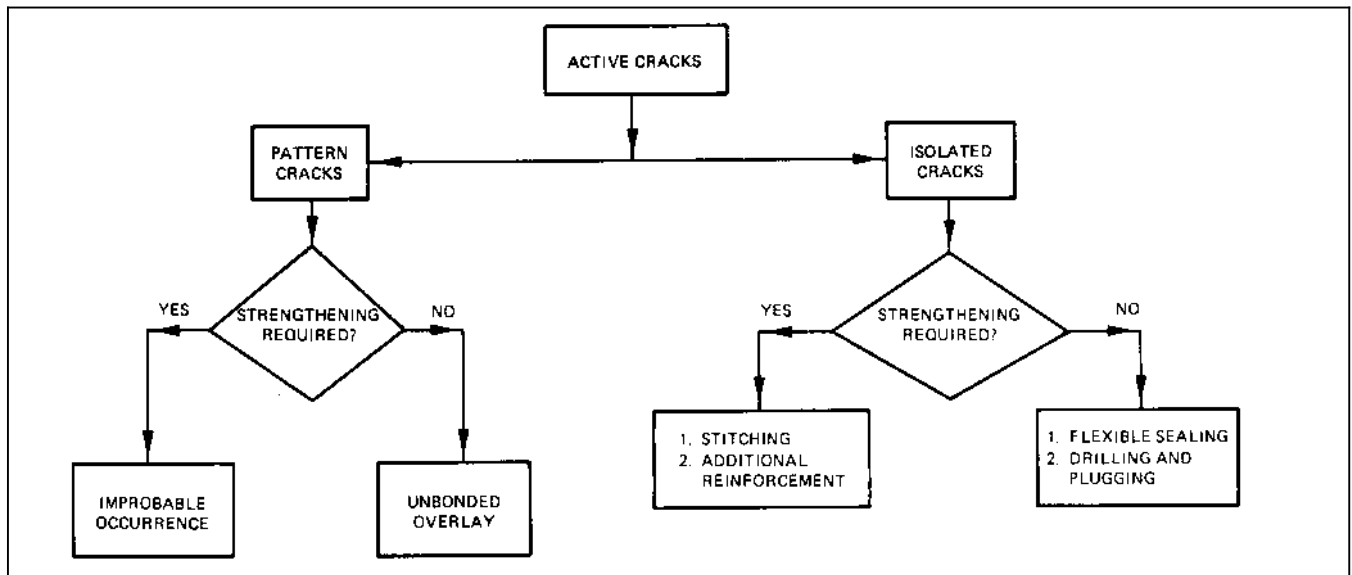
Figure 4-3. Selection of repair method for active cracks (after Johnson 1965)

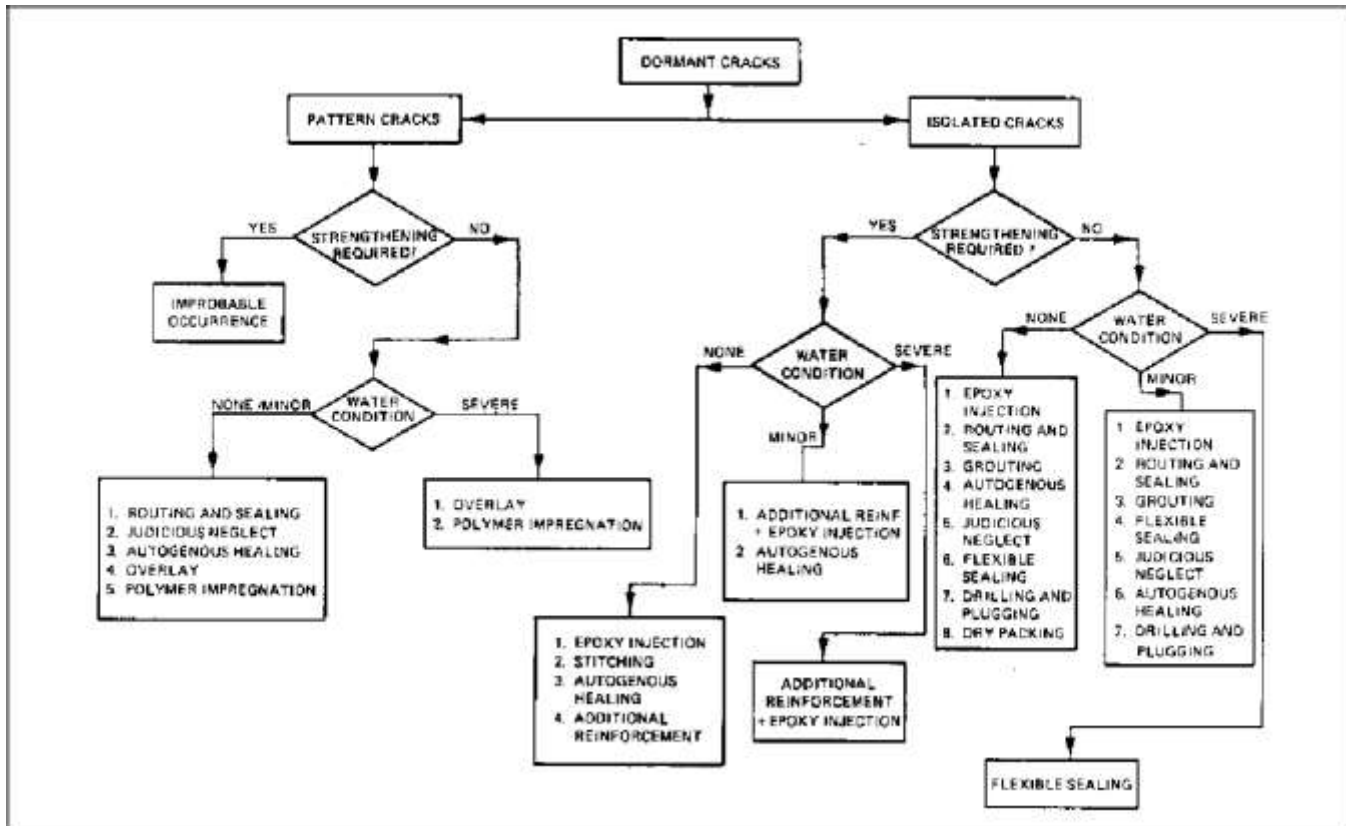
Figure 4-4. Selection of repair method for dormant cracks (after Johnson 1965)

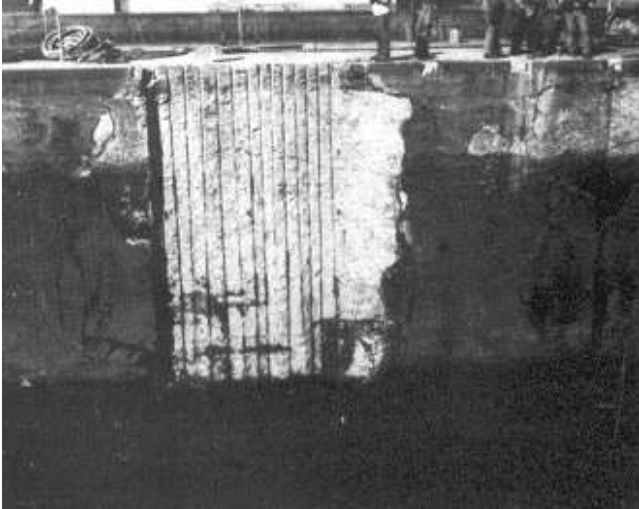
Figure 5-1. Surface removal of deteriorated concrete by explosive blasting

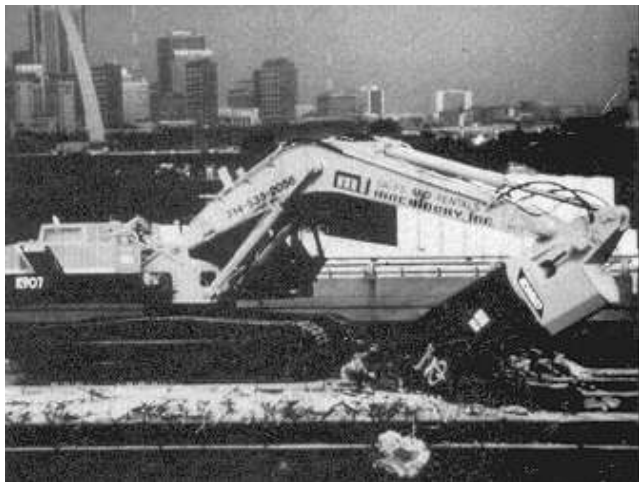
Figure 5-2. Boom-mounted concrete crusher

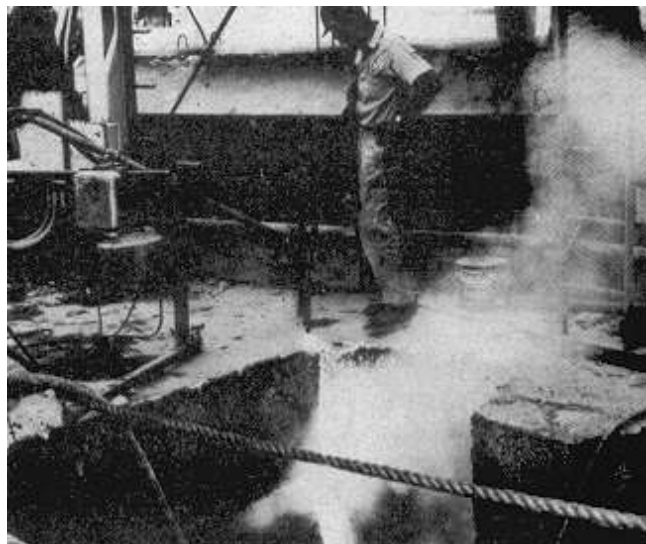
Figure 5-5. Powder torch

(5) *Thermal cutting.* Thermal-cutting methods are applicable for making cutouts through heavily reinforced decks, beams, walls, and other reinforced members where site conditions allow efficient flow of molten concrete from cuts. Flame tools (Figure 5-5) are typically employed for cutting depths of 600 mm (24 in.) or less, and lances (Figure 5-6), for greater depths. Thermal cutting tools are of limited commercial availability and are costly to use. The concrete that remains has a layer of thermal damage with more extensive damage occurring around steel reinforcement. Personnel must be protected from heat and hot flying rock produced by the cutting operation. Additional safety precautions are required because of the hazards associated with the storage, handling, and use of compressed and flammable gases. The

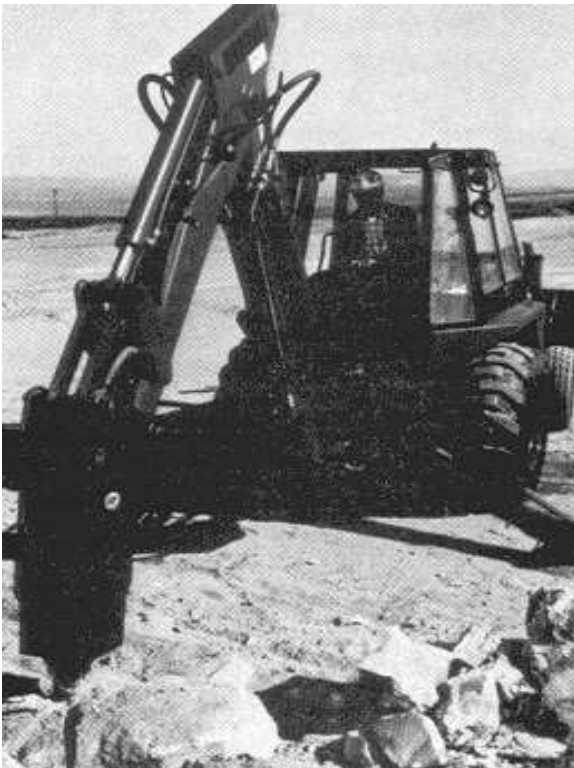
Figure 5-7. Boom-mounted breaker

(1) Boom-mounted breakers. Boom-mounted impact breakers are applicable for both full- and partial-depth removals where production rates required are greater than can be economically achieved by the use of hand-held breakers. The boom-mounted breakers are somewhat similar to the hand-held breakers except that they are considerably more massive. The tool is normally attached to the hydraulically operated arm of a backhoe or excavator (Figure 5-7) and can be operated by compressed air or hydraulic pressure. The reach of the hydraulic arm enables the tool to be used on walls at a considerable distance above or below the level of the machine. Boom-mounted breakers are a highly productive means of removing concrete. However, the blow energy delivered to the concrete should be limited to protect the structure being repaired and surrounding structures from damage resulting from the high cyclic energy generated. Saw cuts

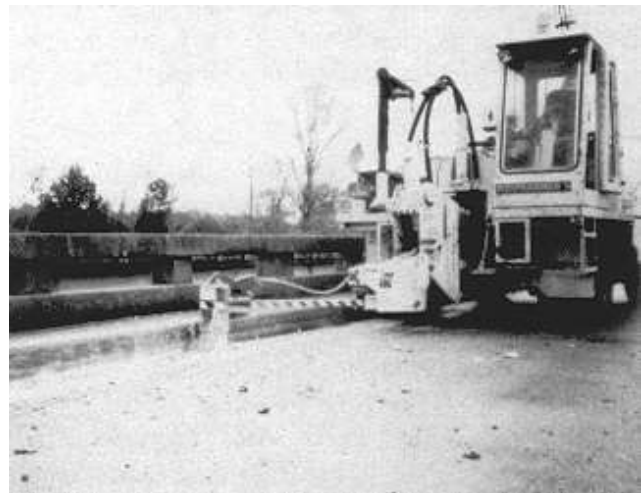
Figure 5-8. Spring-action hammer (mechanical sledgehammer)

(2) Spring-action hammers. Spring-action hammers (sometimes referred to as mechanical sledgehammers) are boom-mounted tools that are applicable for breaking concrete pavements, decks, walls, and other thin members where production rates required are greater than can be economically achieved with the use of hand-held breakers. Hammers are more applicable for total demolition of a concrete member than for removal to rehabilitate or repair. The arm of the hammer is hydraulically powered, and the impact head is spring powered. The spring is compressed by the downward movement of the arm of the backhoe or excavator and its energy released just prior to impact. There are truck units available that make it easier to move between projects. The operation of the hammer and advancement of the truck during removal are controlled from a cab at the rear of truck (Figure 5-8). The blow energy delivered to the concrete should be limited to protect the structure being repaired and surrounding structures from damage caused by the high cyclic energy generated. Saw cuts should be employed at removal boundaries to reduce the occurrence of feathered edges. The concrete that remains may be damaged (microcracking) along with the exposed reinforcing steel.

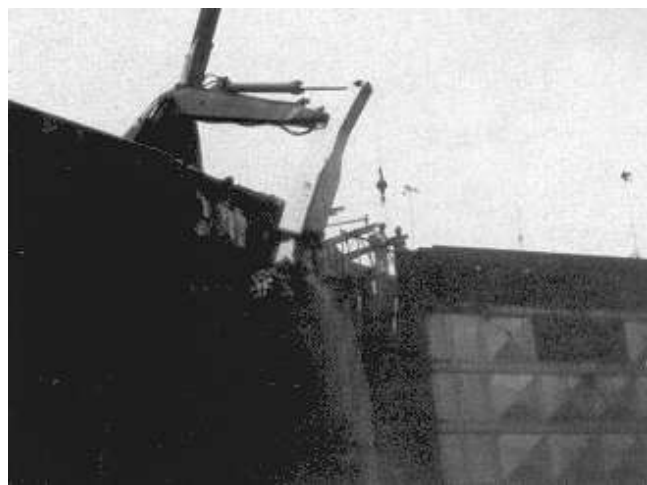
Figure 5-11. Rotary-head milling

(2) Rotary-head milling. Method is applicable for removing deteriorated concrete from mass structures (Figure 5-11) and for removing deteriorated concrete cover from reinforced members such as pavements and decks where its contact with the reinforcement is unlikely. Removal is limited to concrete outside structural steel reinforcement. Significant loss of productivity occurs in sound concrete. For concrete having a compressive strength of 55 MPa (8,000 psi) or greater, rotary-head milling is not applicable. Concrete that remains may be

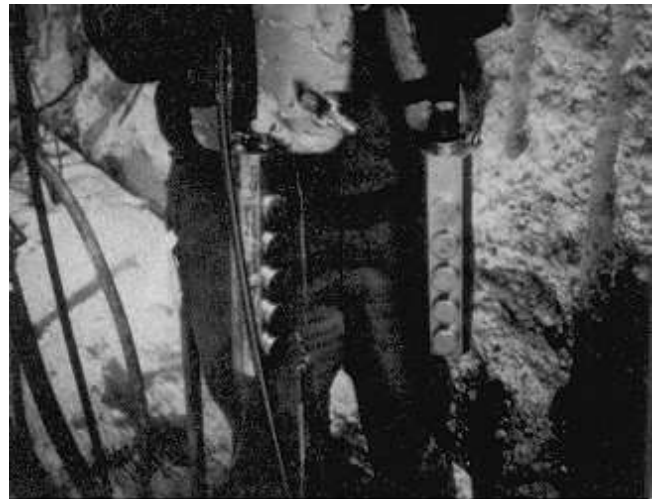
Figure 5-13. Piston-jack splitter

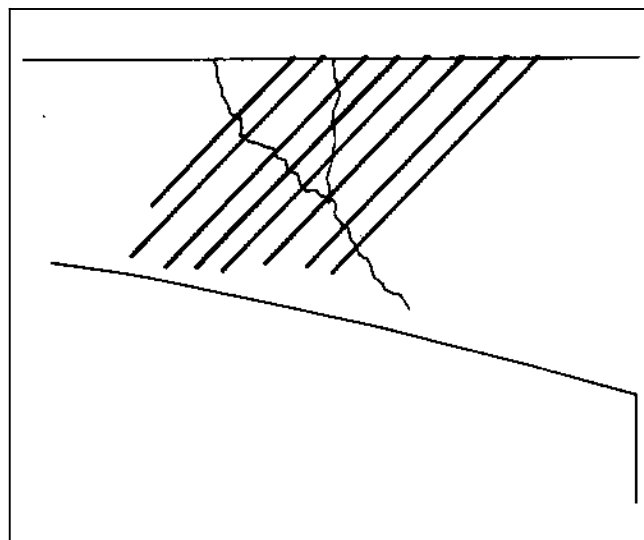
Figure 6-1. Crack repair using conventional reinforcement with drillholes 90 deg to the crack plane

(a) This technique consists of sealing the crack, drilling holes 19 mm (3/4 in.) in diam at 90 deg to the crack plane (Figure 6-1), cleaning the hole of dust, filling the hole and crack plane with an adhesive (typically epoxy) pumped under low pressure 344 to 552 KPa (50 to 80 psi), and placing a reinforcing bar into the drilled hole. Typically, No. 4 or 5 bars are used, extending at least 0.5 m (1.6 ft) on each side of the crack. The adhesive

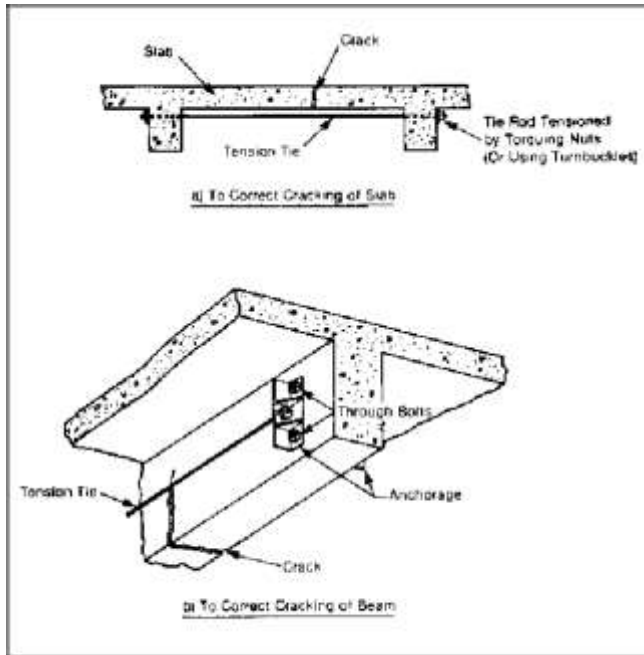
Figure 6-2. Crack repair with use of external prestressing strands or bars to apply a compressive force

(2) Prestressing steel. This technique uses prestressing strands or bars to apply a compressive force (Figure 6-2). Adequate anchorage must be provided for the prestressing steel, and care is needed so that the problem will not merely migrate to another part of the structure. The effects of the tensioning force (including eccentricity) on the stress within the structure should be carefully analyzed. For indeterminate structures posttensioned according to this procedure, the effects of secondary moments and induced reactions should be considered.

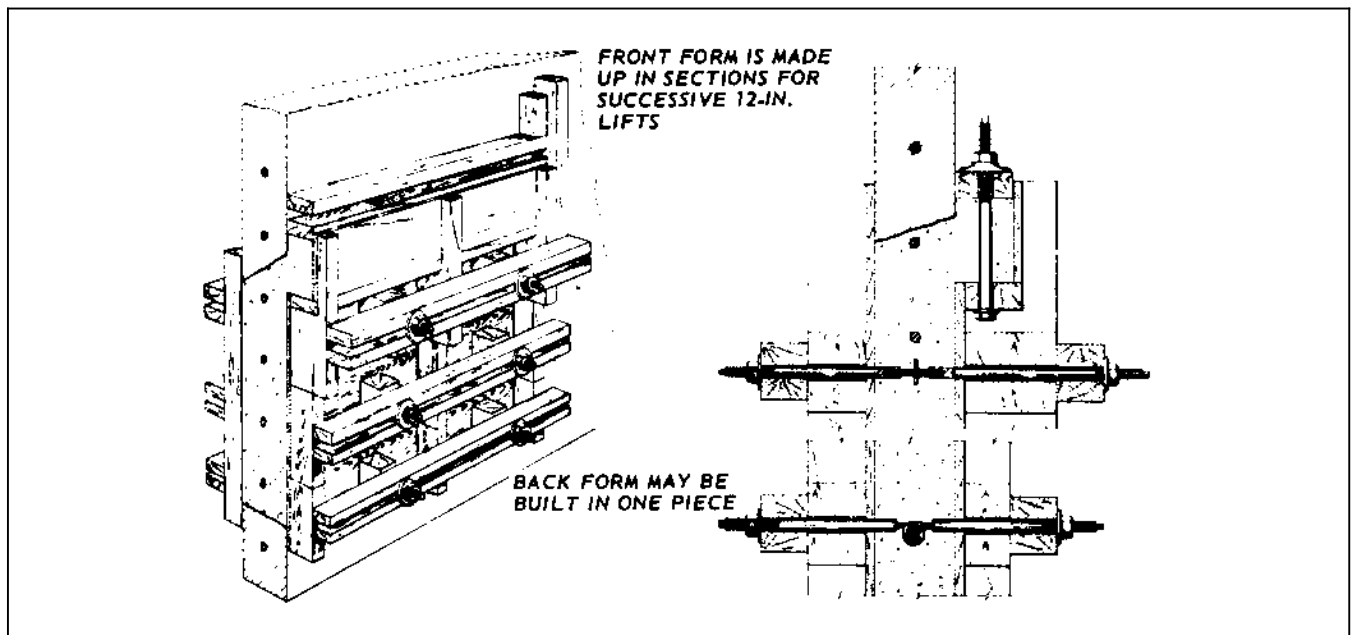
Figure 6-3. Detail of form for concrete replacement in walls after removal of all unsound concrete

(3) Forming will usually be required for massive repairs in vertical surfaces. The front form and the back form, where one is required, should be substantially constructed and mortartight. The back form may be assembled in one piece, but the front panel should be constructed as placing progresses so that the concrete can be conveniently placed in lifts. The contact surface should be dry at the time of patching. Small, thin repairs (less than 50 mm (2 in.) thick) should receive a bonding coat while thicker placements usually do not require a bonding coat (see paragraph 5-3a(2)(f)). The surface is first carefully coated with a thin layer of mortar, not exceeding 3 mm (1/8 in.) in thickness, containing sand passing the No. 16 sieve, and having the same w/c as the concrete to be used in the replacement. Hand-rubbing the mortar into the surface is effective. Epoxy resin

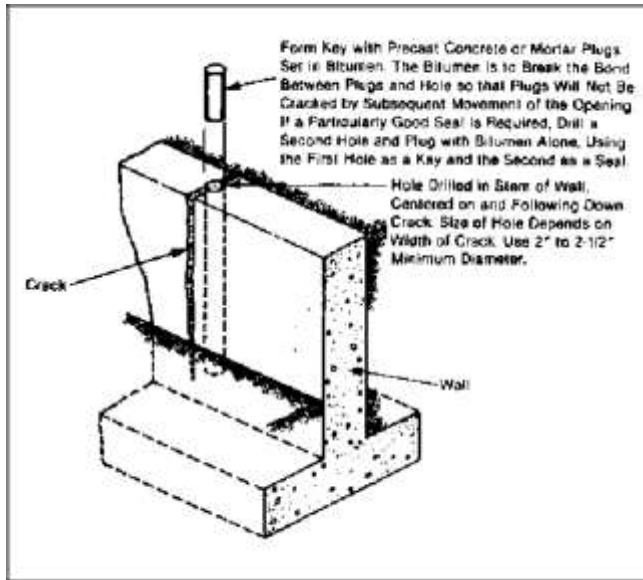
Figure 6-5. Repair of crack by drilling and plugging

a. *Description.* Drilling and plugging a crack consists of drilling down the length of the crack and grouting it to form a key (Figure 6-5).

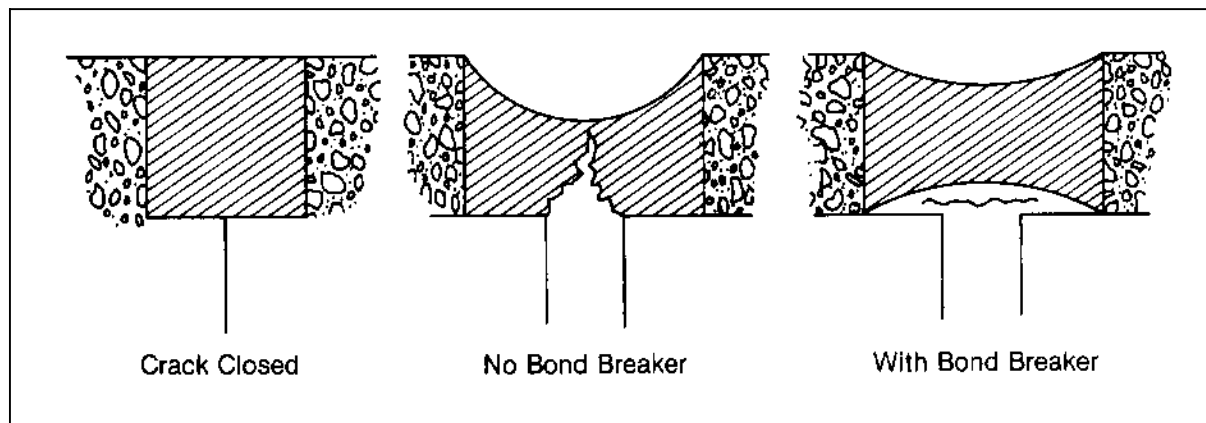
Figure 6-6. Effect of bond breaker involving a field-molded flexible sealant

(1) A bond breaker should be provided at the bottom of the slot to allow the sealant to change shape without a concentration of stress on the bottom (Figure 6-6). The bond breaker may be a polyethylene strip, pressure sensitive tape, or other material which will not bond to the sealant before or during cure.

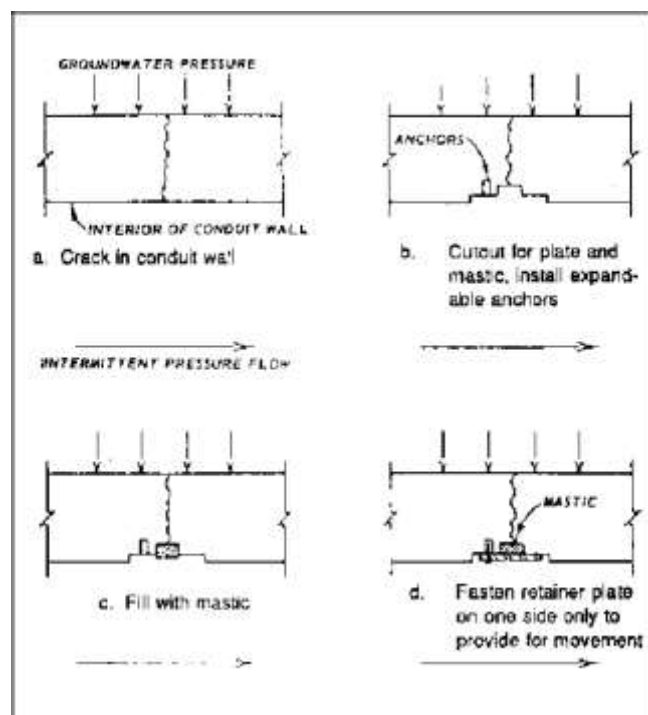
Figure 6-8. Repair of crack by use of a retainer plate to hold mastic in place against external pressure

necessary to cut the concrete surface adjacent to the crack and to place the retaining cap flush with the original flow lines (Figure 6-8).

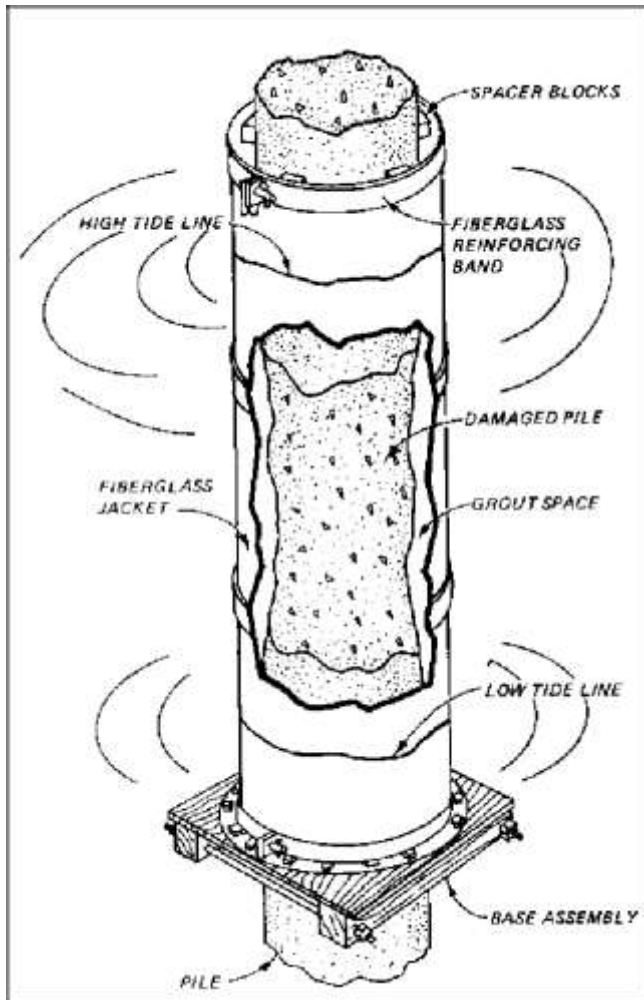
Figure 6-9. Typical preformed fiberglass jacket being used in repair of a concrete pile

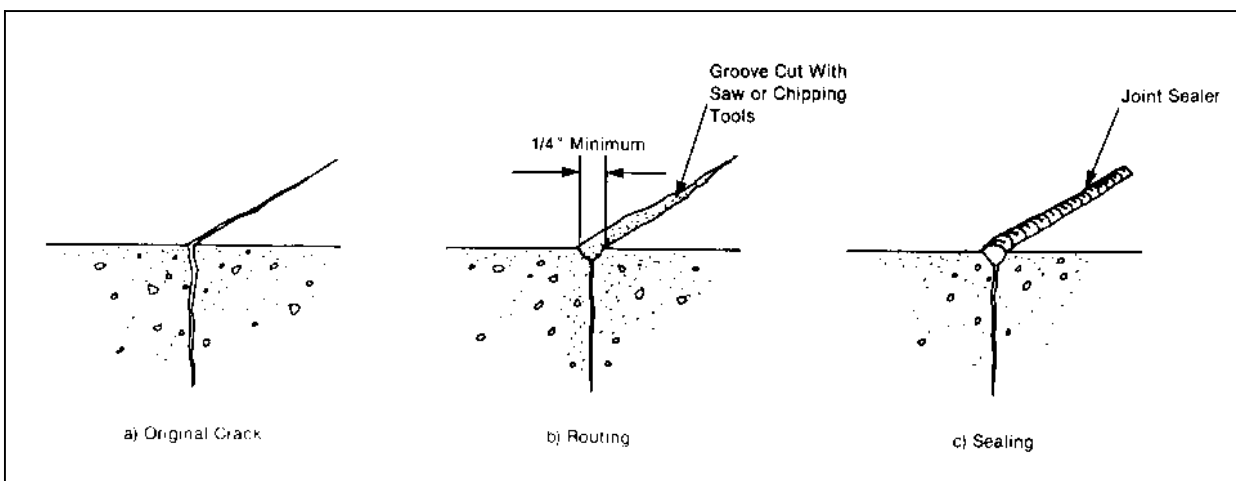
Figure 6-10. Repair of crack by routing and sealing

a. *Description.* This method involves enlarging the crack along its exposed face and filling and sealing it with a suitable material (Figure 6-10). The routing operation may be omitted but at some sacrifice in the permanence of the repair. This is the simplest and most common method for sealing dormant cracks.

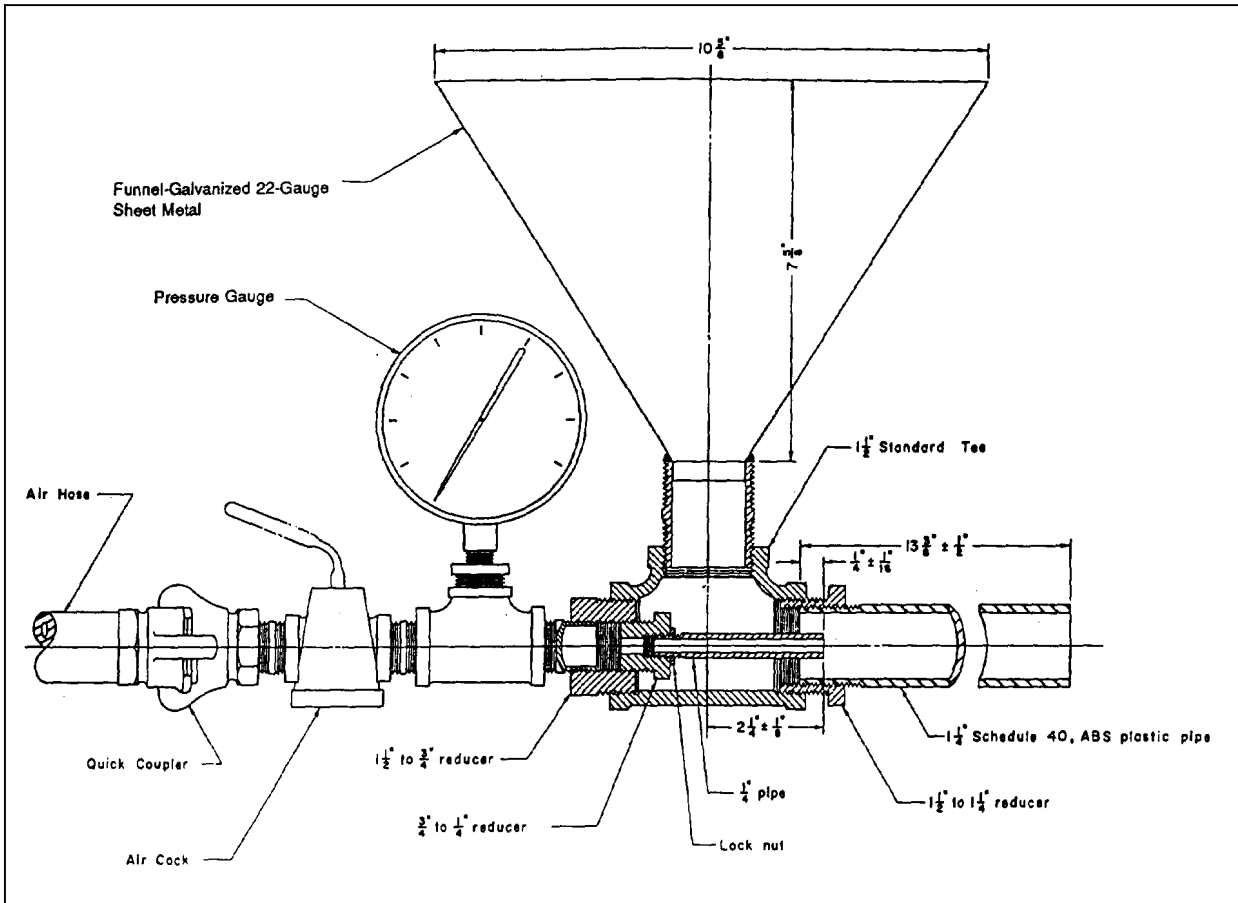
Figure 6-11. Mortar gun for concrete repair (U.S. Army Engineer Division, Missouri River 1974)

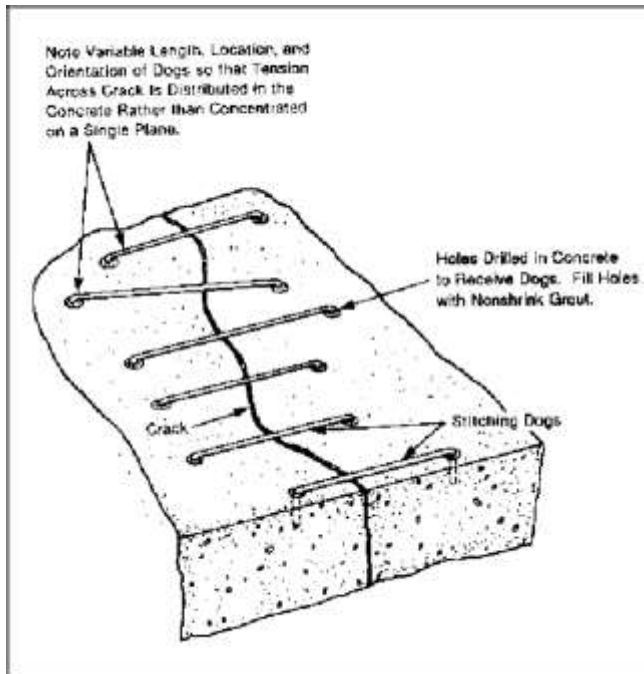
Figure 6-13. Repair of a crack by stitching

b. Applications and limitations. Stitching may be used when tensile strength must be reestablished across major cracks. Stitching a crack tends to stiffen the structure, and the stiffening may accentuate the overall structural restraint, causing the concrete to crack elsewhere. Therefore, it may be necessary to strengthen the adjacent

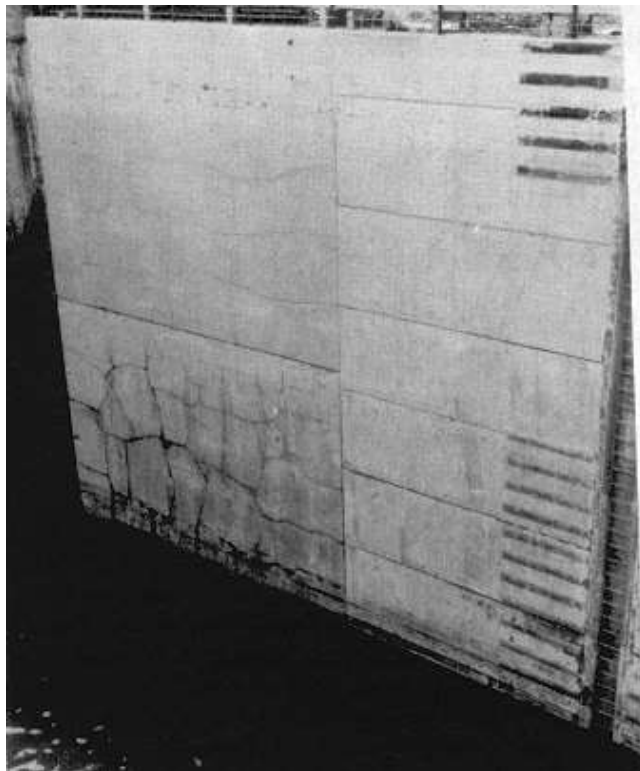
Figure 8-3. Concrete cracking in resurfaced monolith (left) compared to reconstructed monolith, Lock No. 1, Mississippi River

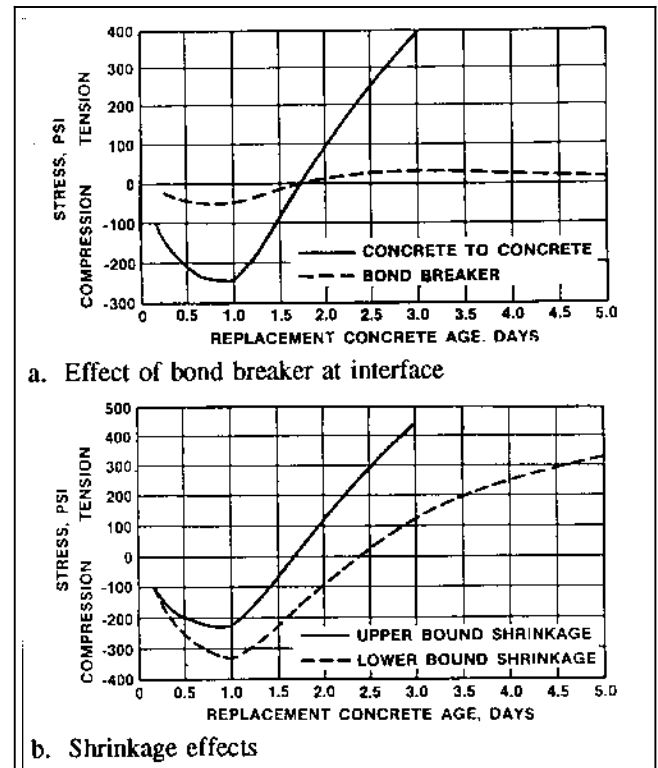
Figure 8-4. Results of a finite element analysis of a typical lock wall resurfacing

(a) A finite element analysis of a typical lock wall resurfacing (Norman, Campbell, and Garner 1988) also demonstrated the effect of restraint by the existing concrete. Under normal conditions of good bond between the two concretes, stress levels sufficient to cause cracking in the replacement concrete developed within about 3 days (Figure 8-4a). In comparison, a bond breaker at the interface resulted in almost no stress in the replacement concrete. The analysis also indicated that shrinkage was a significant factor (Figure 8-4b). Even the lower bound shrinkage resulted in tensile stresses in excess of 2.1 MPa (300 psi).

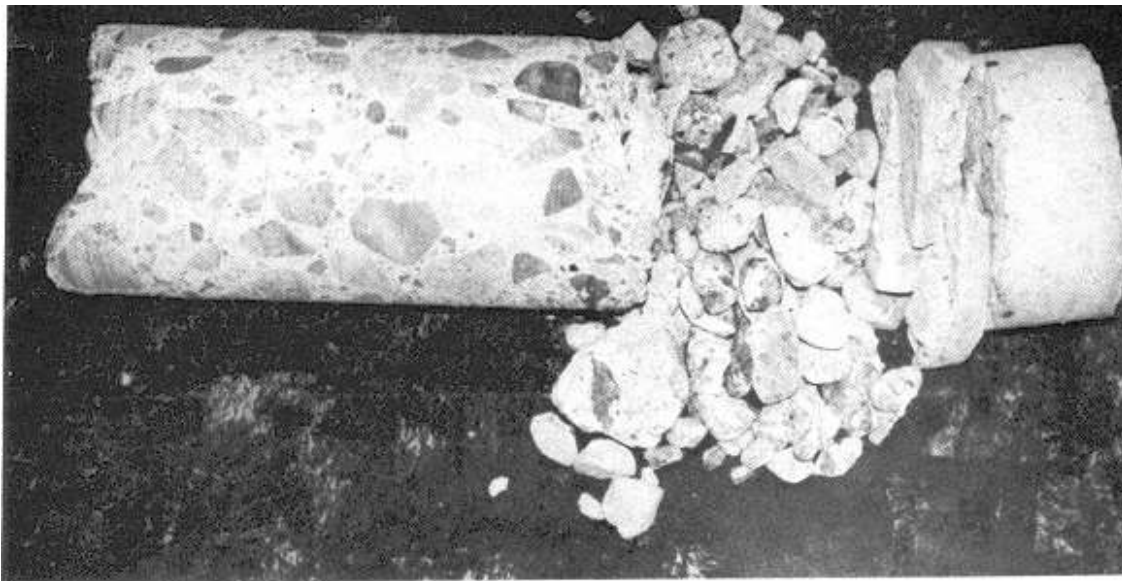
a. Concrete deterioration immediately behind shotcrete overlay

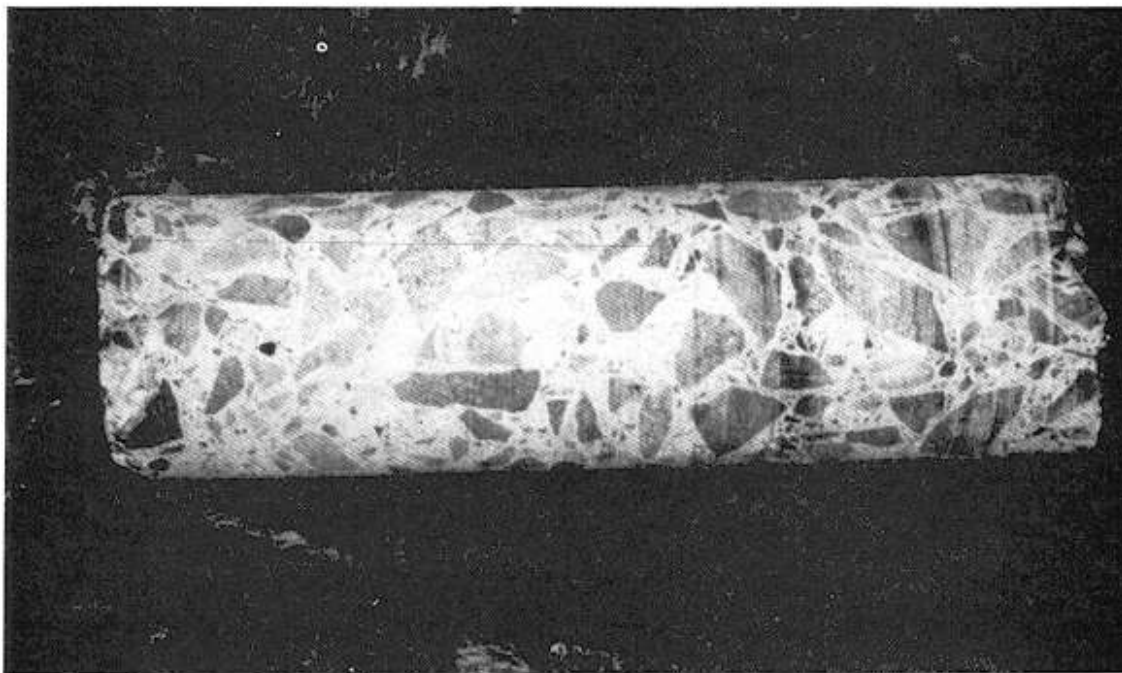
b. Concrete not refaced with shotcrete
