EM 1110-2-2002

30 June 1995

Engineering and Design
EVALUATION AND REPAIR OF CONCRETE STRUCTURES

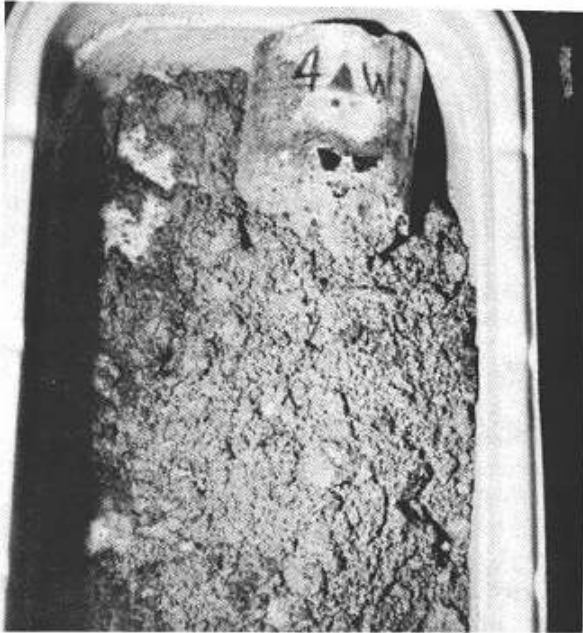
b. After freezing and thawing

Figure 8-8. Combination shotcrete and concrete core before and after 35 cycles of freezing and thawing in a saturated condition

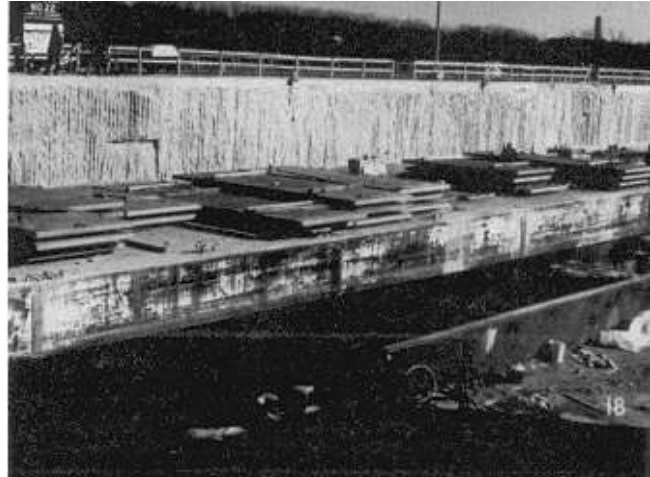
Figure 8-14. Installation of precast concrete stay-in-place forms at Lock 22, Mississippi River

(d) This application of the precast concrete stay-in-place forming system demonstrated the potential for eliminating the need to close and dewater a lock during rehabilitation. Consequently, concepts for installation of the system in an operational lock were developed as part of the REMR research program (ABAM 1989). A mobile cofferdam was selected as the preferred installation method and a final design completed for this concept. This study indicated that it is feasible to repair the walls in an operational lock with only minimal impact on costs.

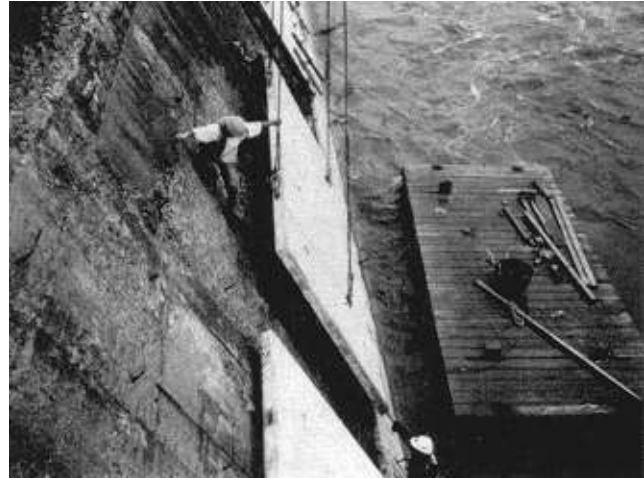
Figure 8-17. Installing precast concrete panels used to overlay the back side of the river wall at Troy Lock, Hudson River (Miles 1993)

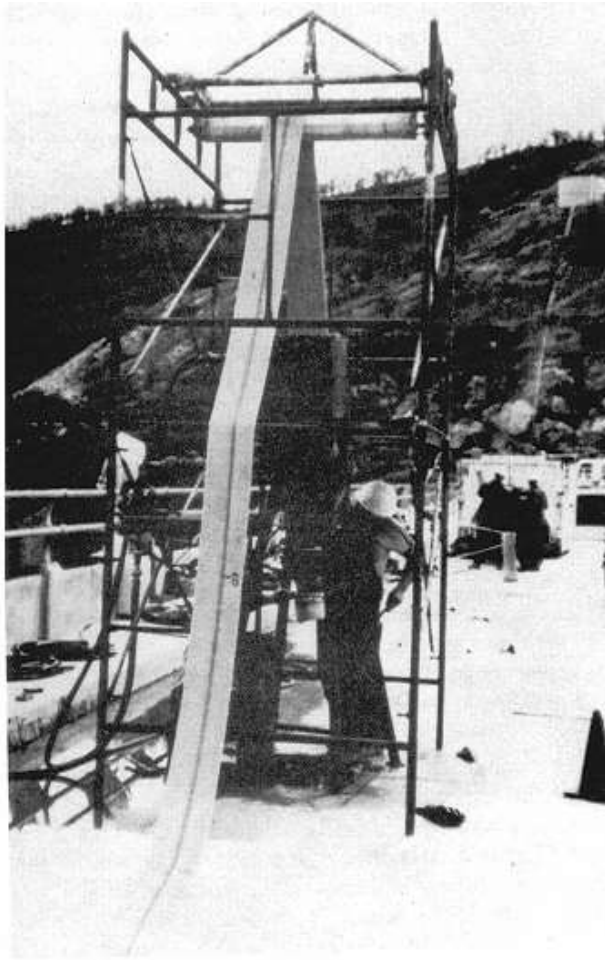
Figure 8-24. Inversion apparatus for installing tube in drill hole, Pine Flat Dam

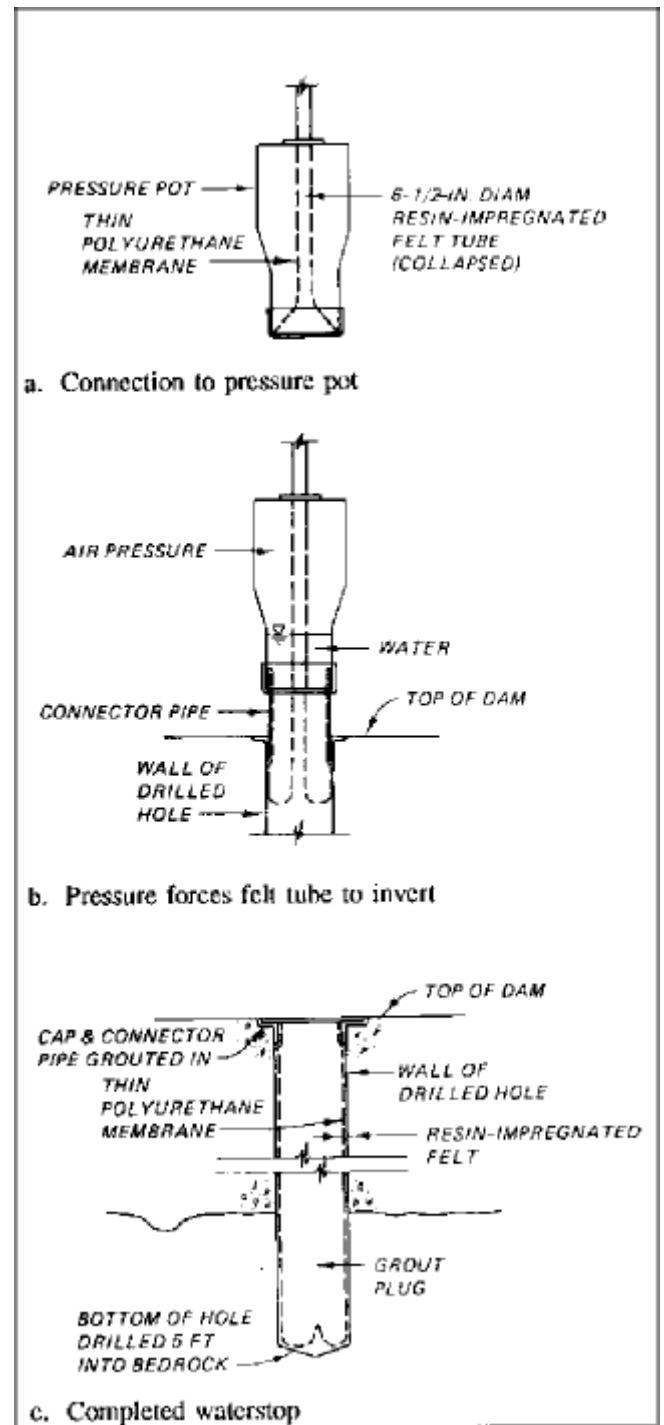
Figure 8-25. Remedial waterstop installation, Pine Flat Dam

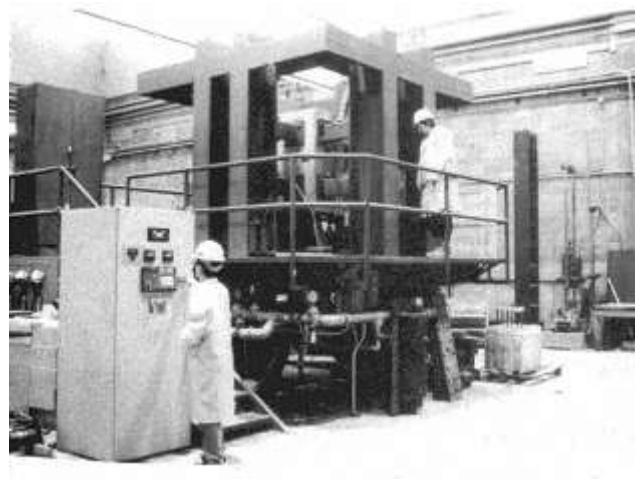
Figure 8-28. Remedial waterstop test apparatus

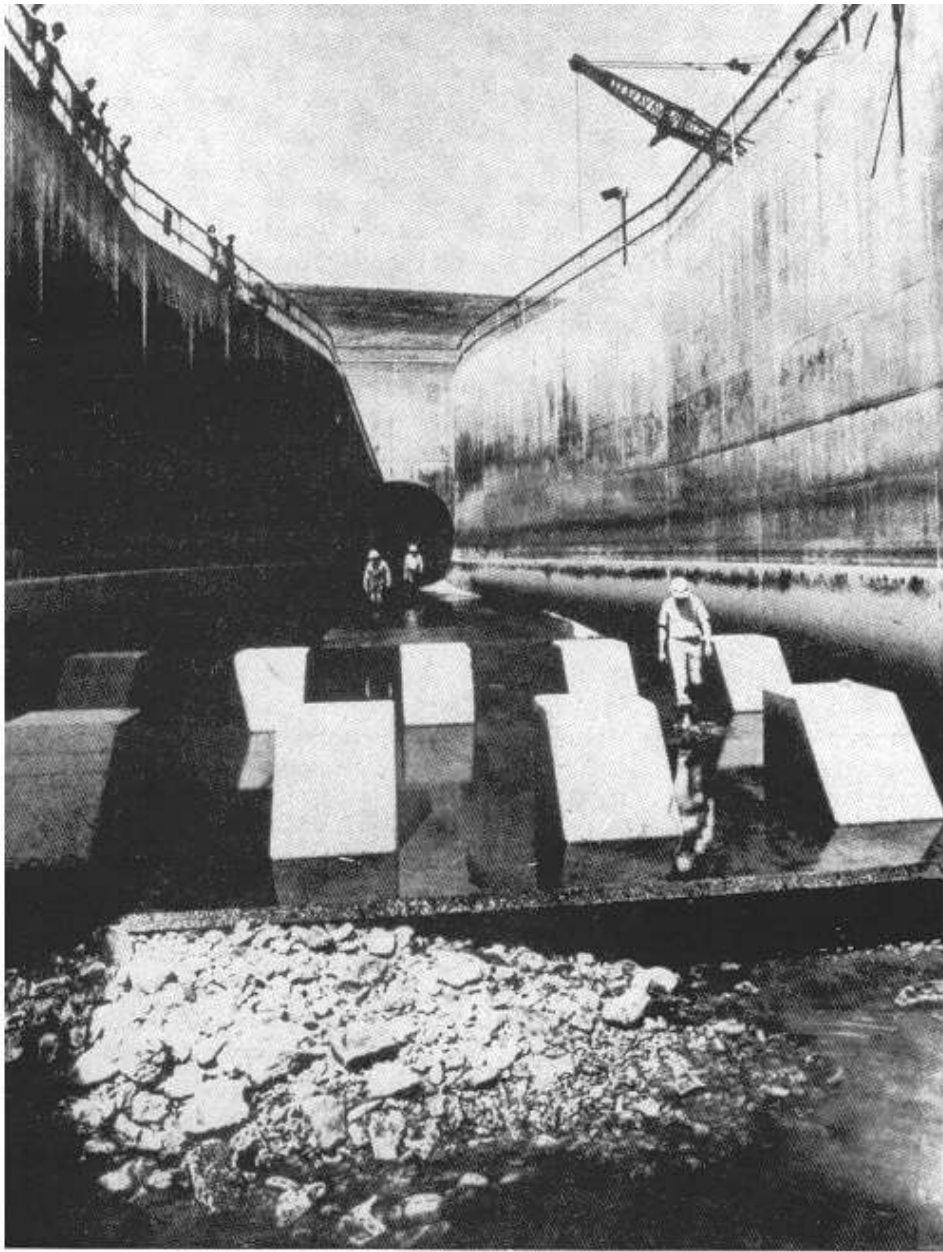
Figure 8-30. Stilling basin dewatered for inspection, Pomona Dam

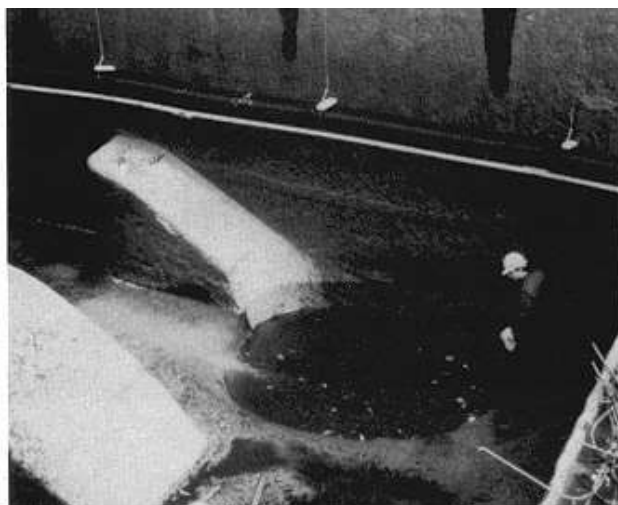
a. Scour holes behind baffles

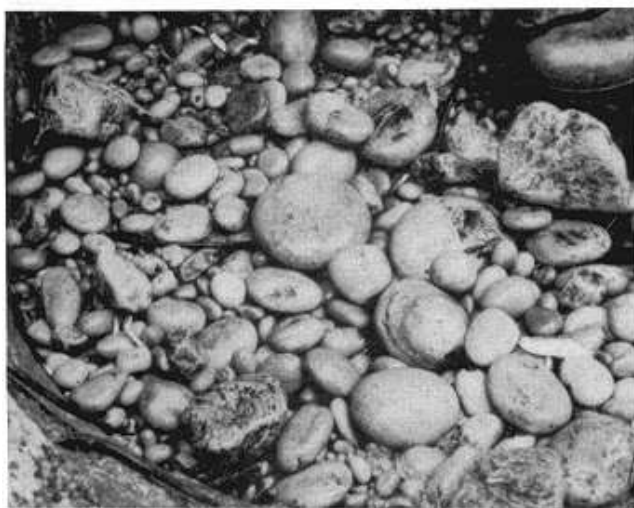
b. Debris in scour holes

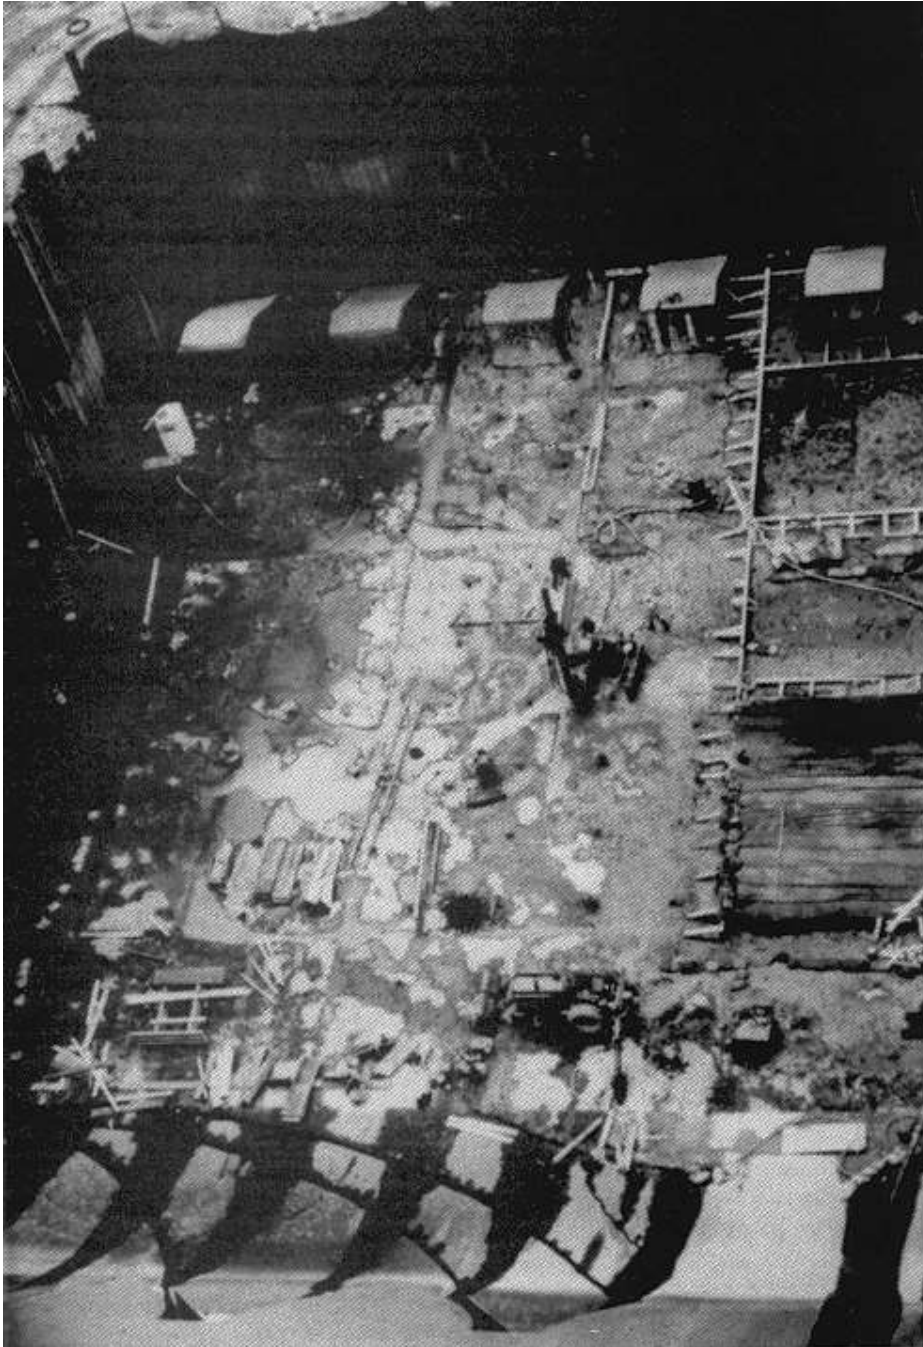
Figure 8-34. General view of repair operations, Kinzua Dam, 1974

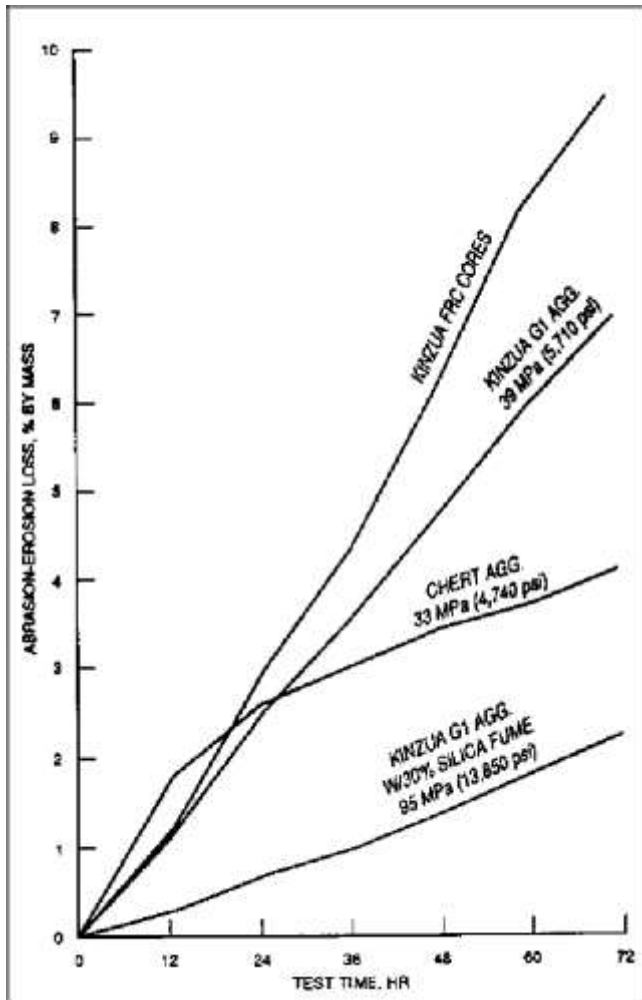
Figure 8-35. Results of selected abrasion-erosion tests, Kinzua Dam

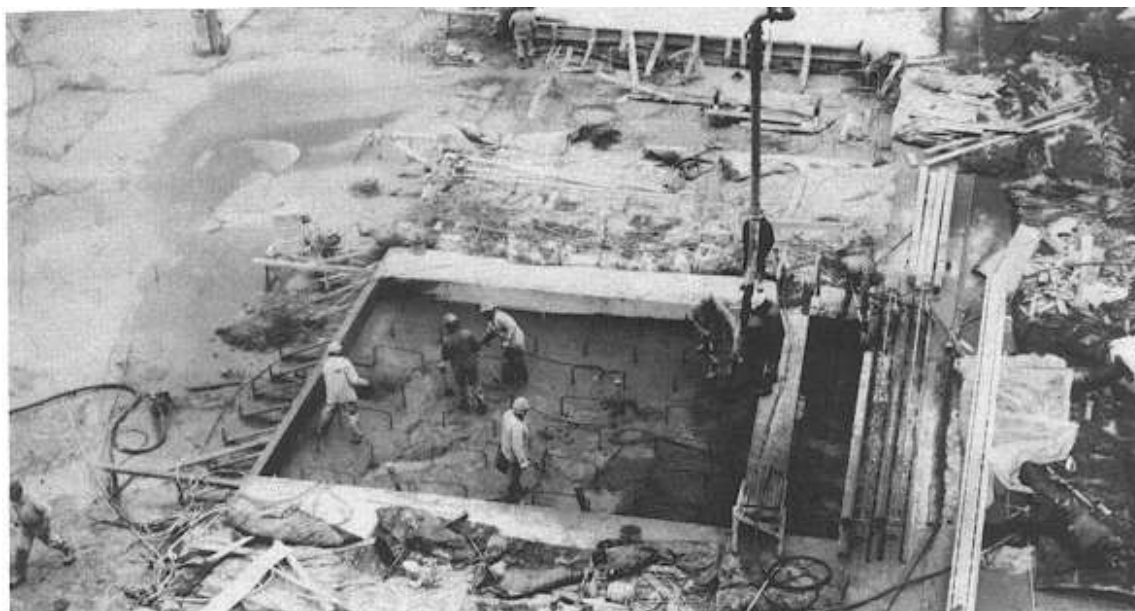
Figure 8-36. Pumping silica-fume concrete into the stilling basin from the top of the right training wall, Kinzua Dam

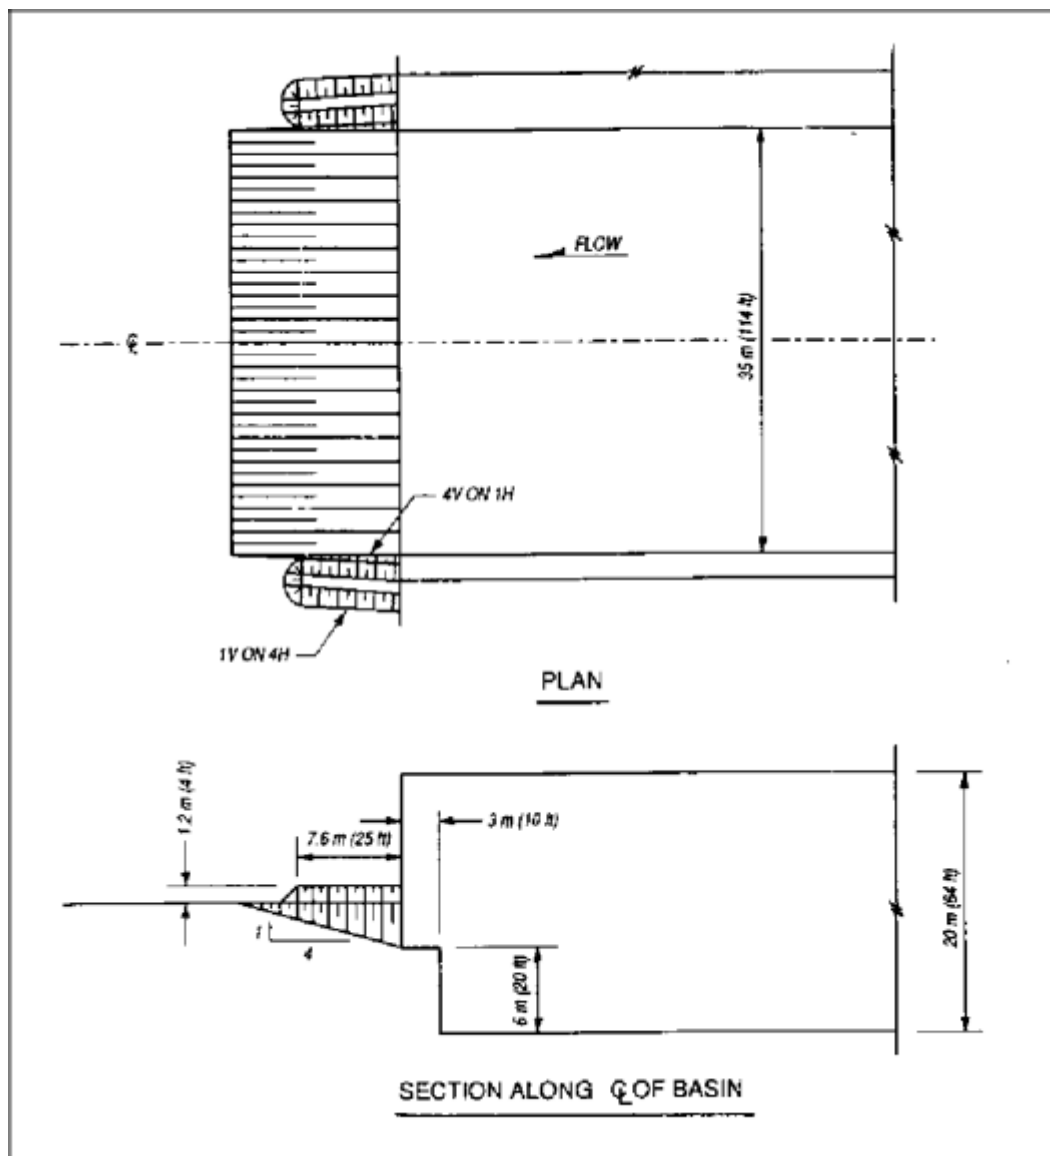
Figure 8-37. Stilling basin wall extension fills, Dworshak Dam

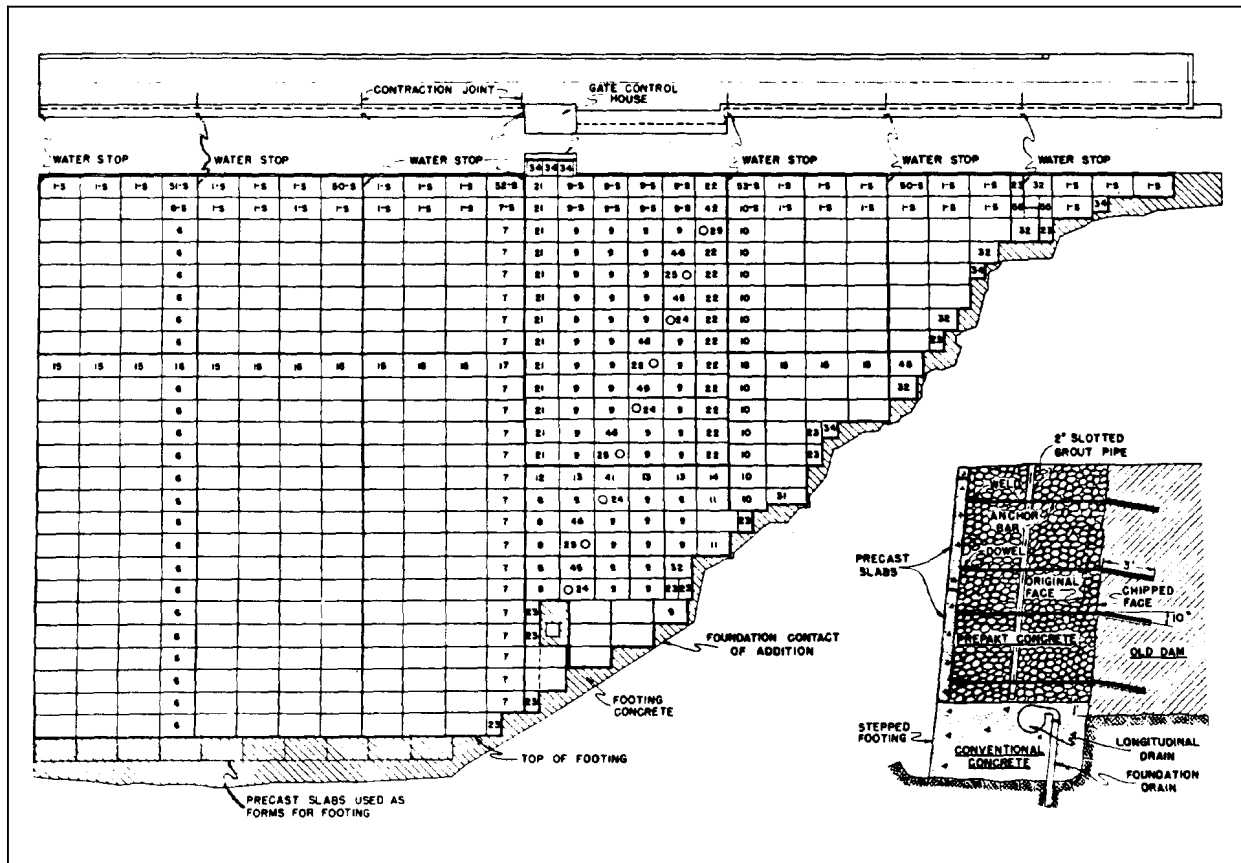
Figure 8-38. Footing and slab layout, south half of Barker Dam (from Davis, Jansen, and Neelands 1948)

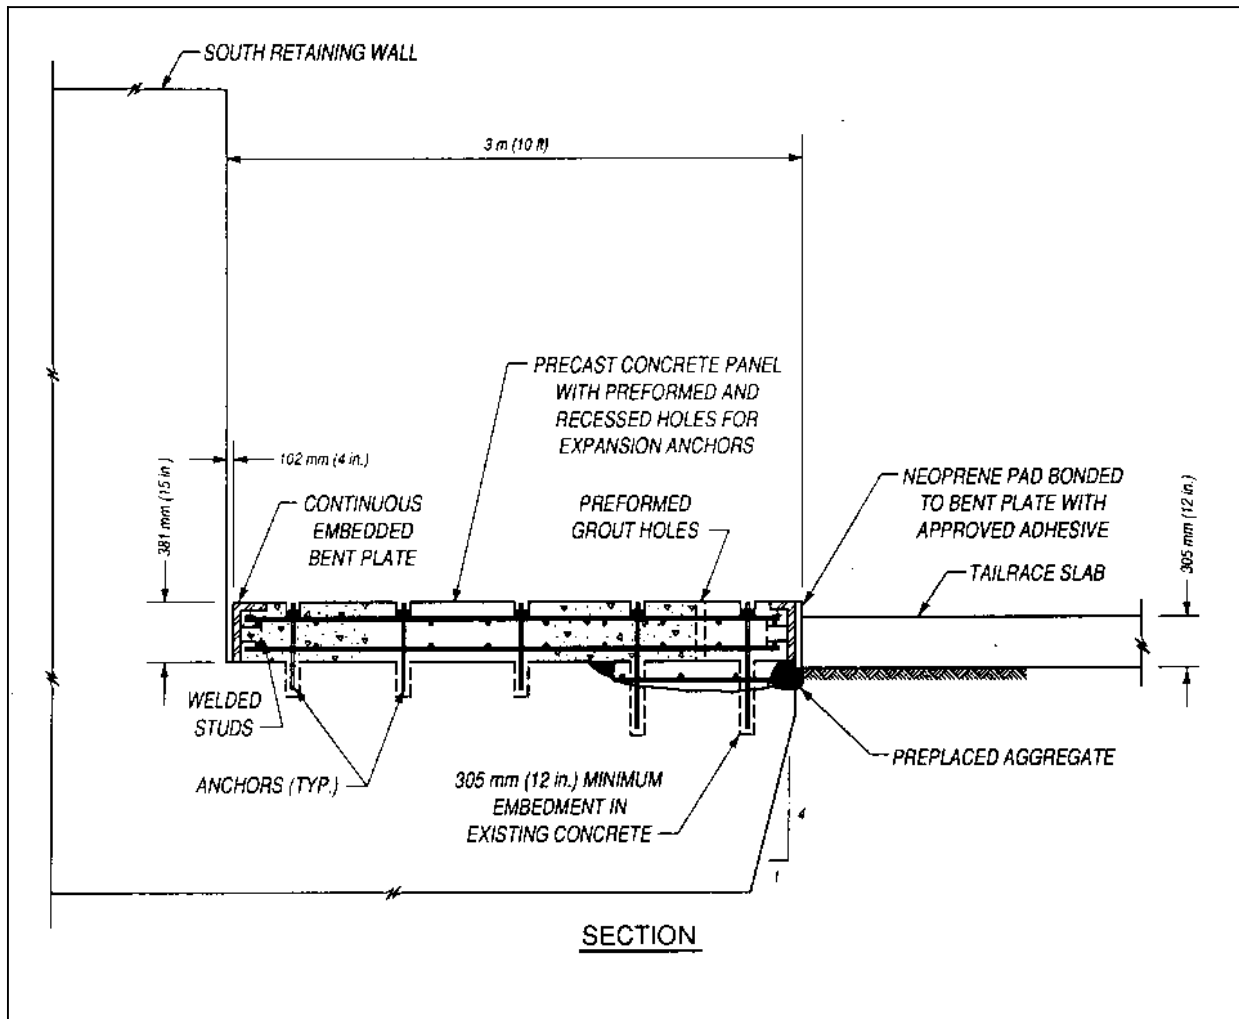
Figure 8-39. Underwater repair of concrete spalling, Gavins Point Dam

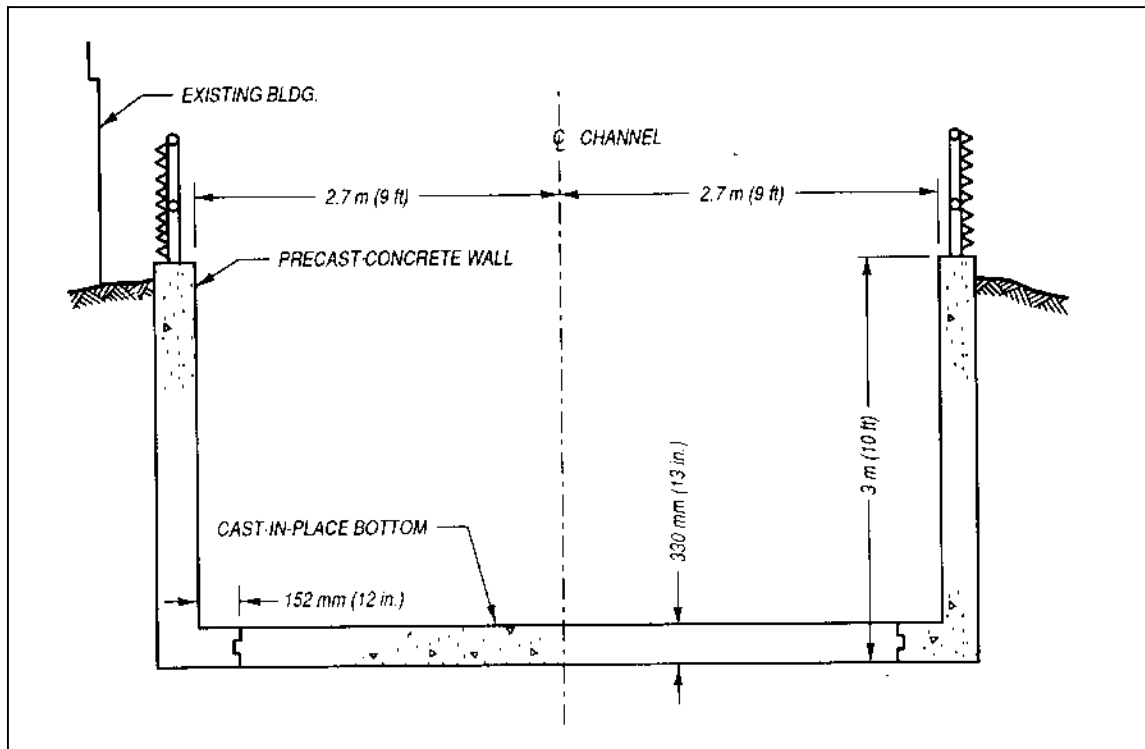
Figure 8-45. Typical channel repair section, Placer Creek (after Hacker 1986)

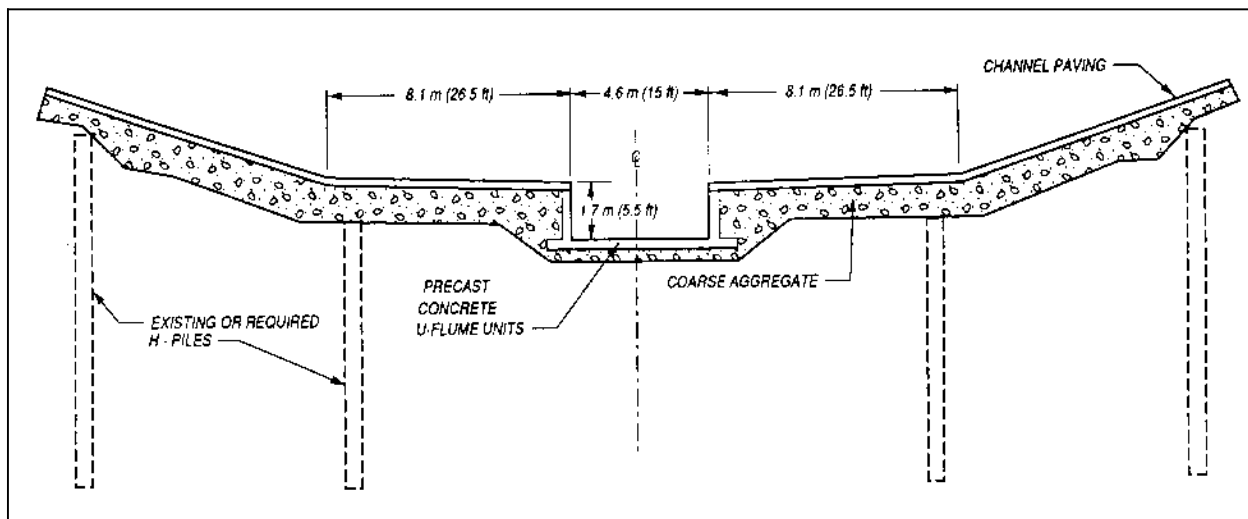
Figure 8-46. Cross section of precast low-flow channel, Blue River Channel (after Mitscher 1992)

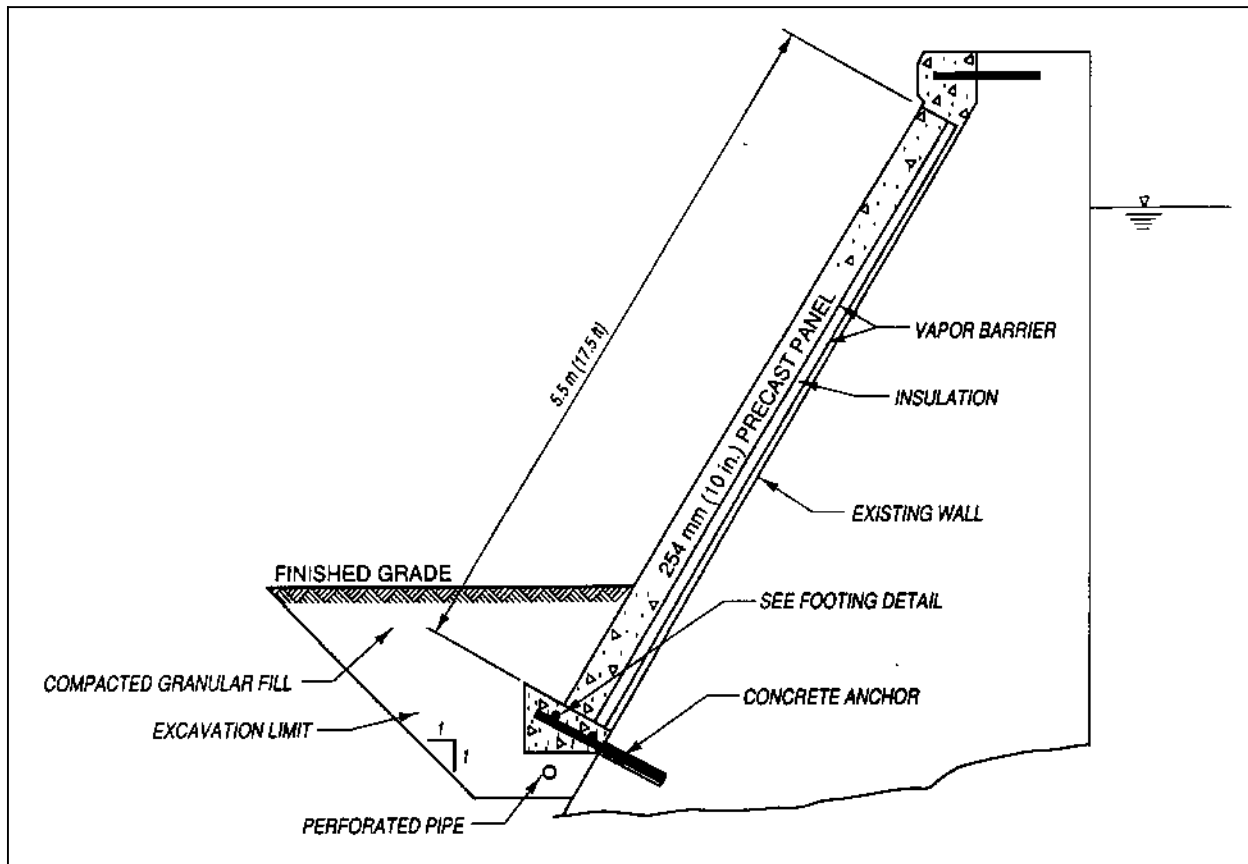
Figure 8-49. Typical repair section, Joliet Channel Wall

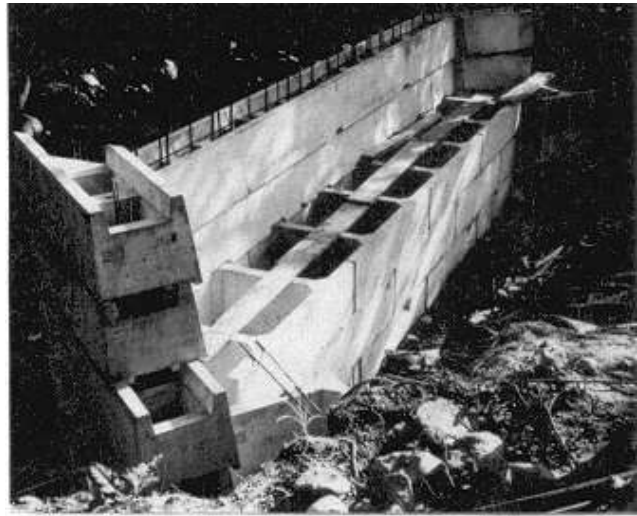
Figure 8-51. Top view of precast abutment prior to backfilling, Ulsterville Bridge

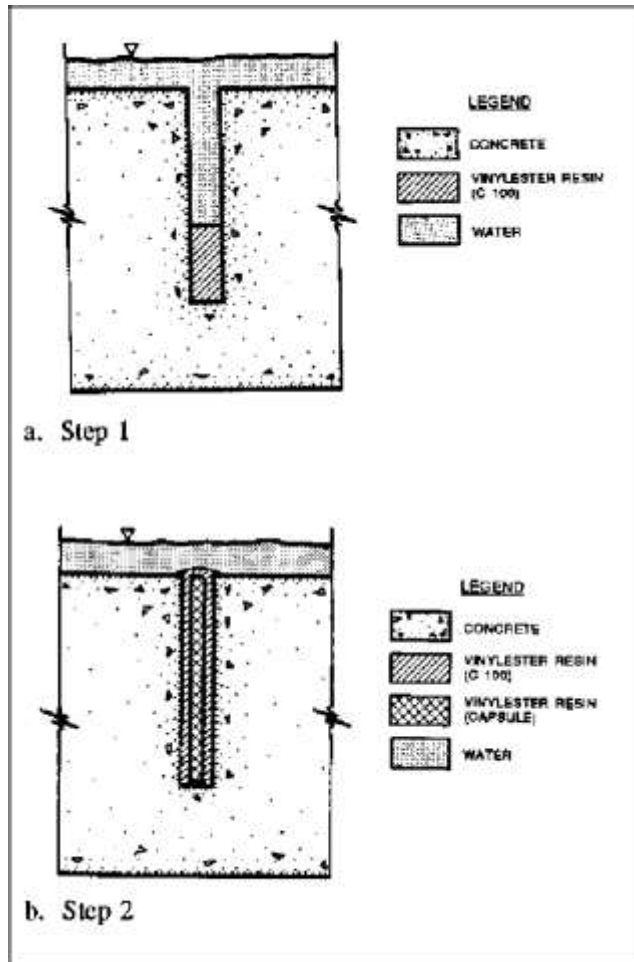
Figure 8-56. Two-step procedure for anchor installation under submerged conditions

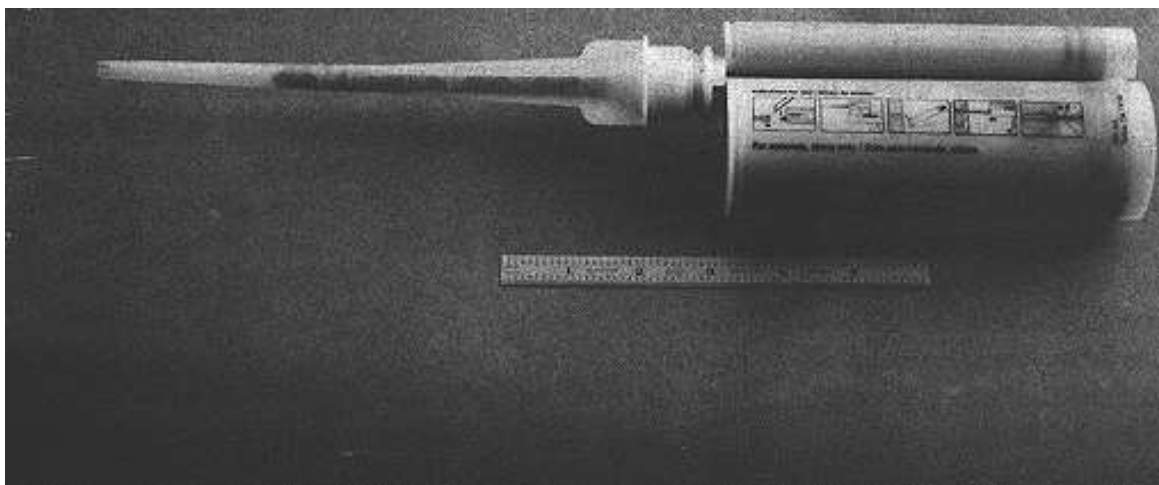
Figure 8-57. Paired disposable cartridges and static mixing tube

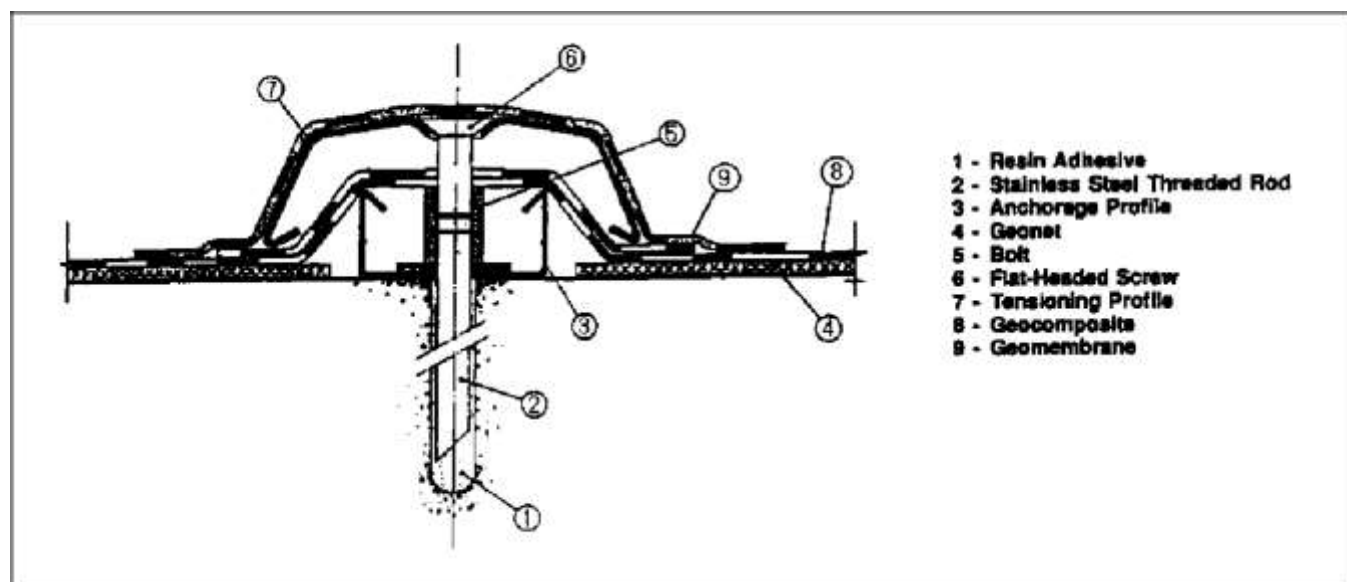
Figure 8-58. Detail of vertical anchorage and drainage profile

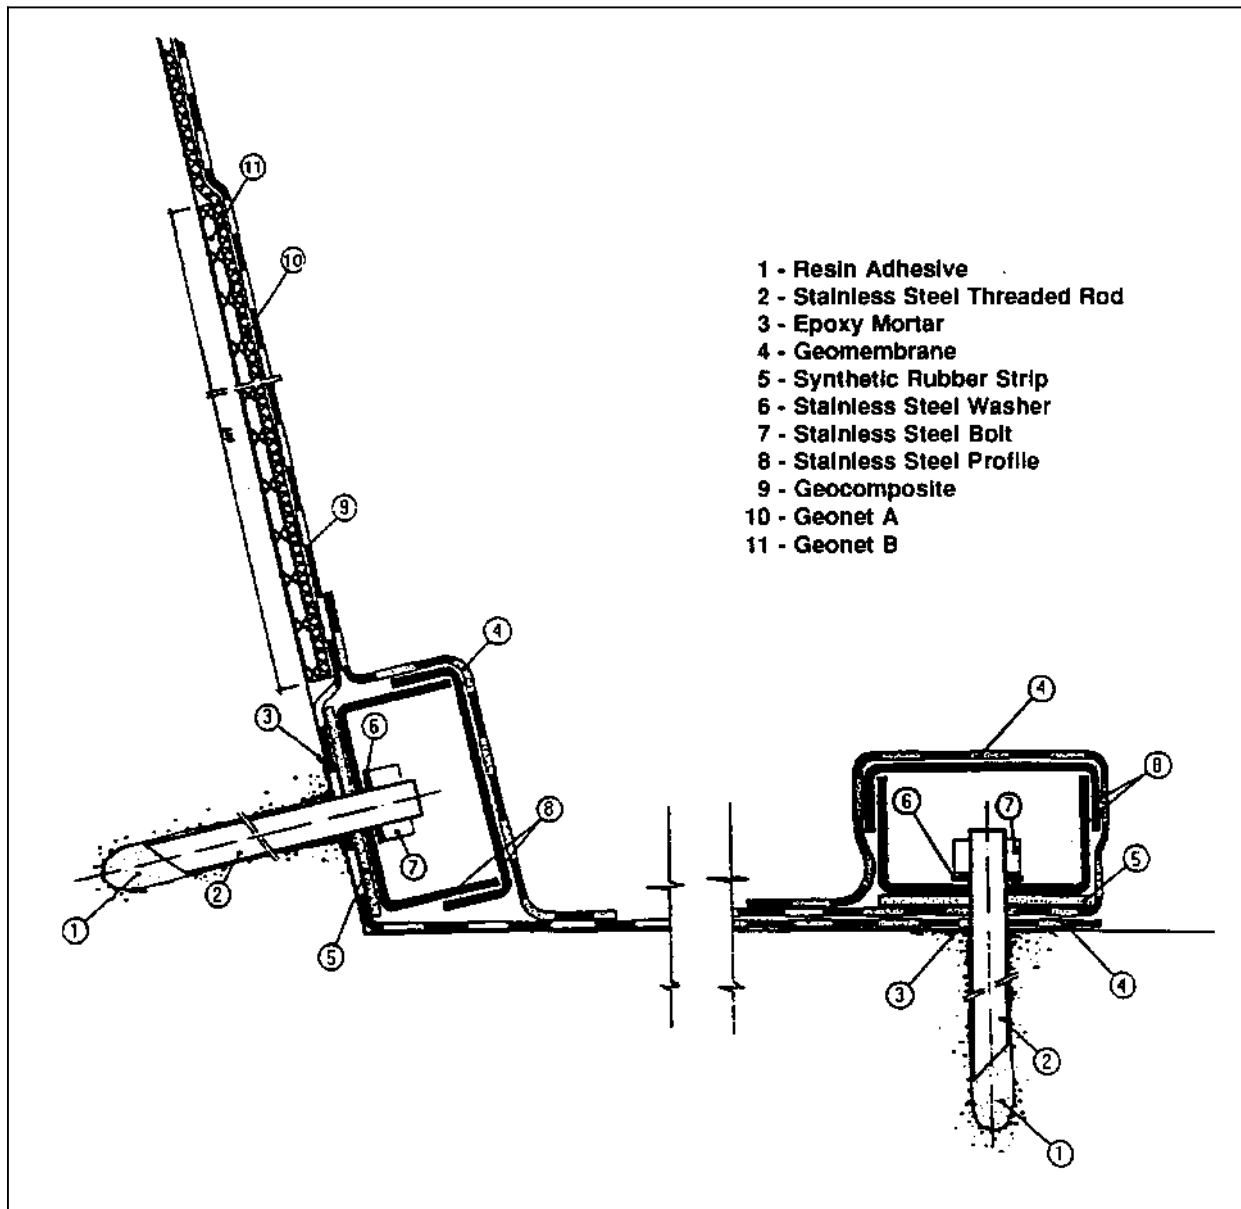
Figure 8-59. Detail of sealing profiles

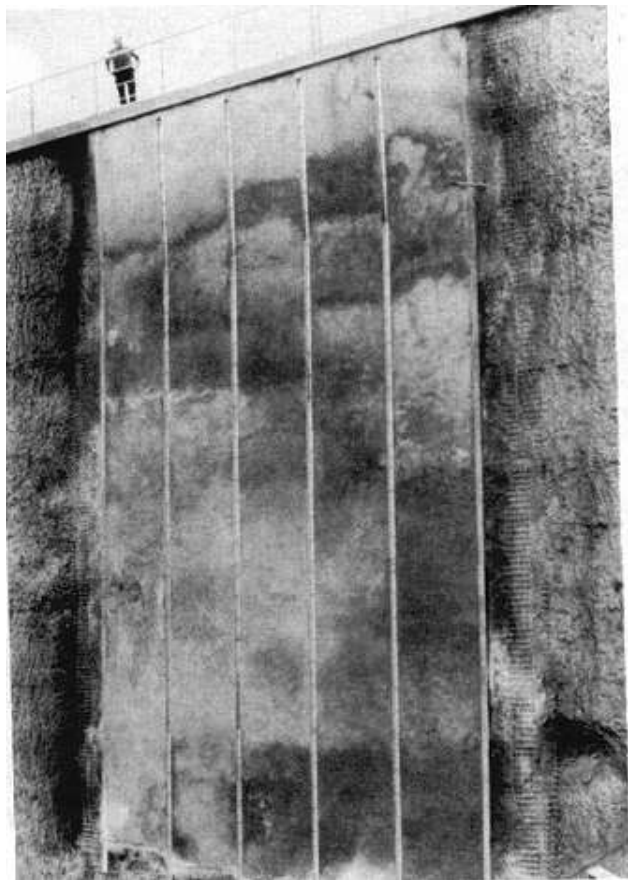
Figure 8-61. Steel profiles embedded in shotcrete, Cignana Dam

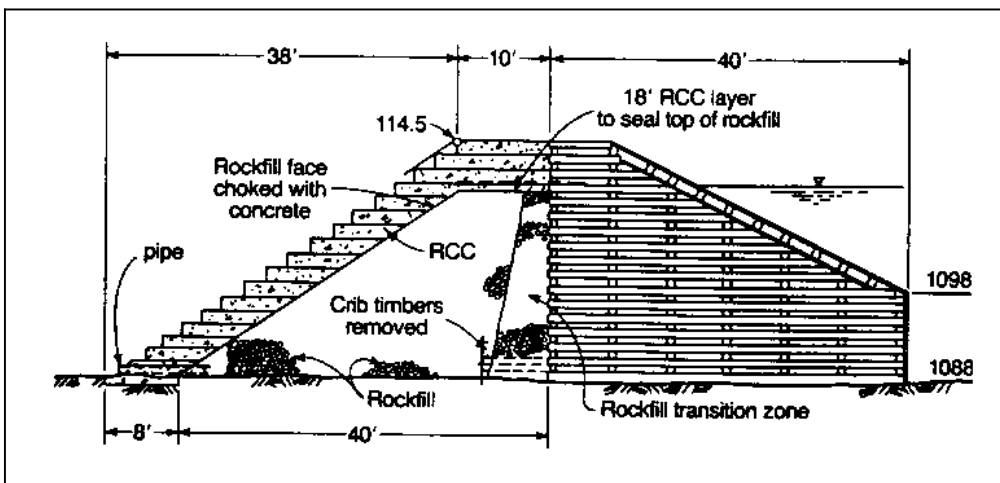
Figure 8-63. Section through modified dam, Ocoee Dam No. 2 (Hansen 1989)

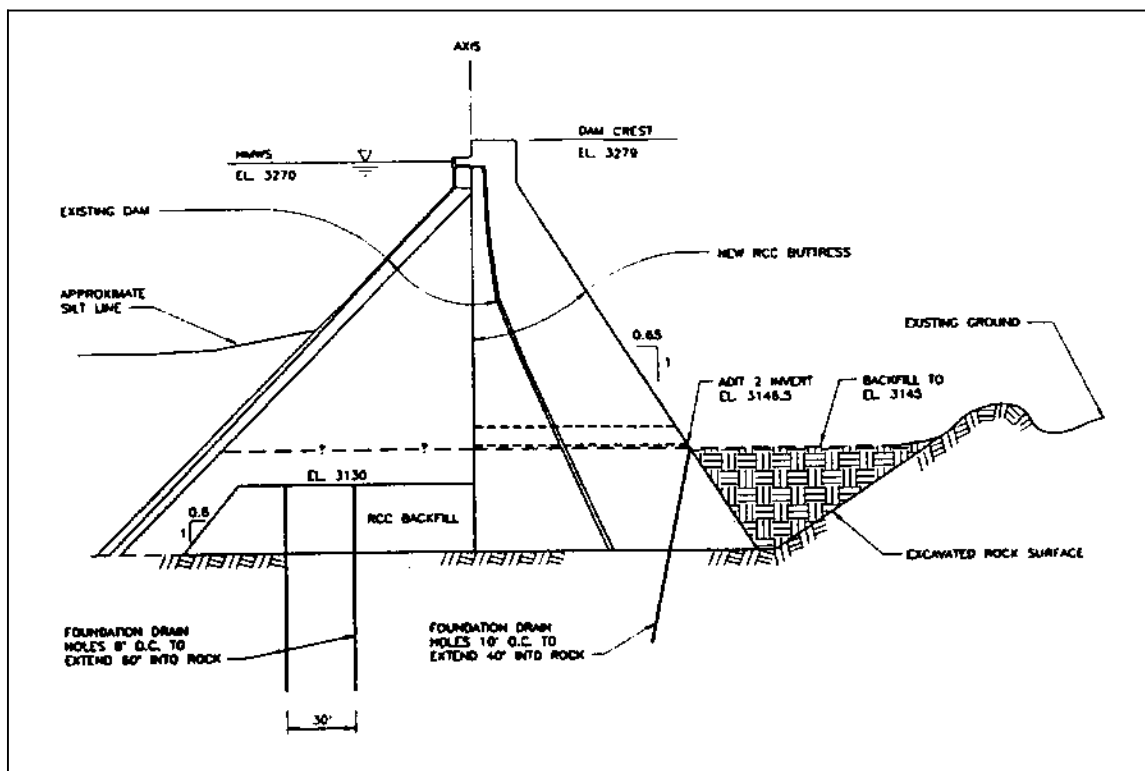
Figure 8-70. Littlerock Dam modification (Bischoff and Obermeyer 1993)
