PDHonline Course G153 (1 PDH)

Avoiding Falsework Failure

Instructor: Eugene G. Washington, P.E.

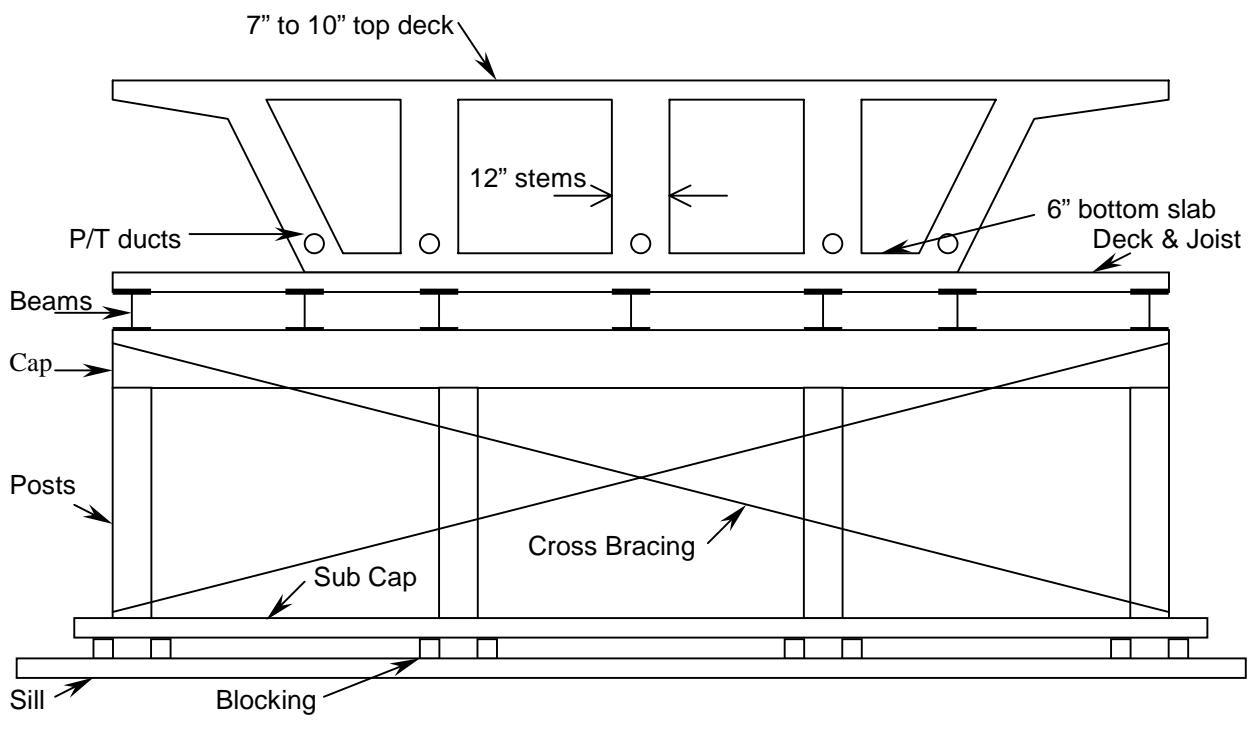
TYPICAL BRIDGE SECTION

A common freeway type bridge is the post-tensioned concrete box girder as sketched below:

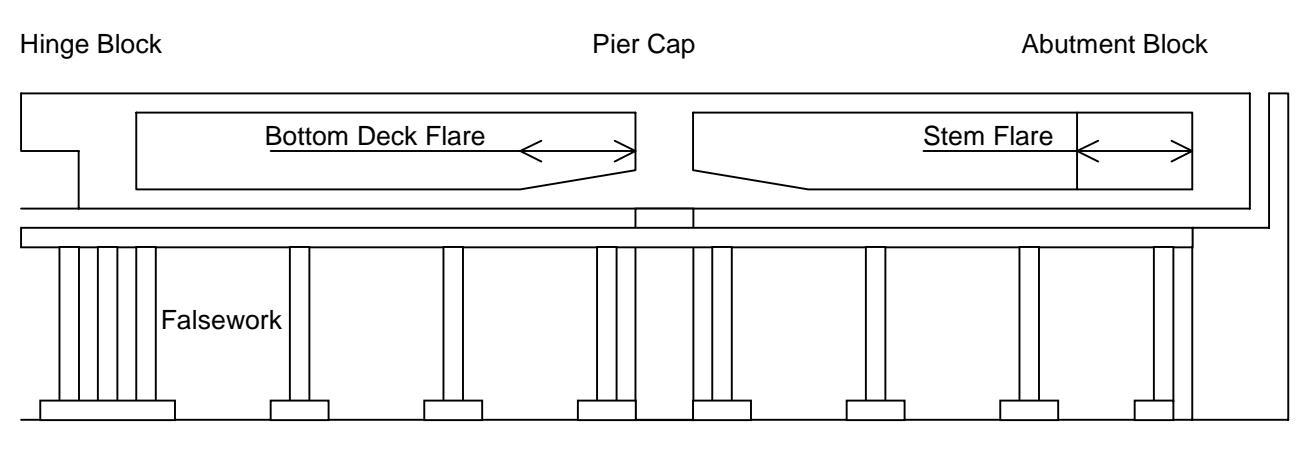
TYPICAL LONGITUDNAL SECTION

Please note that closely spaced falsework posts are shown at the hinge. The reason for this is the bridge superstructure box will camber upward when post-tensioned. The mid-span falsework will be unloaded and the bridge weight transferred to the pier, abutment and hinge support. This causes the hinge support falsework to support 30 to 50% of the total hinge span weight; depending on a number of bridge configuration elements.

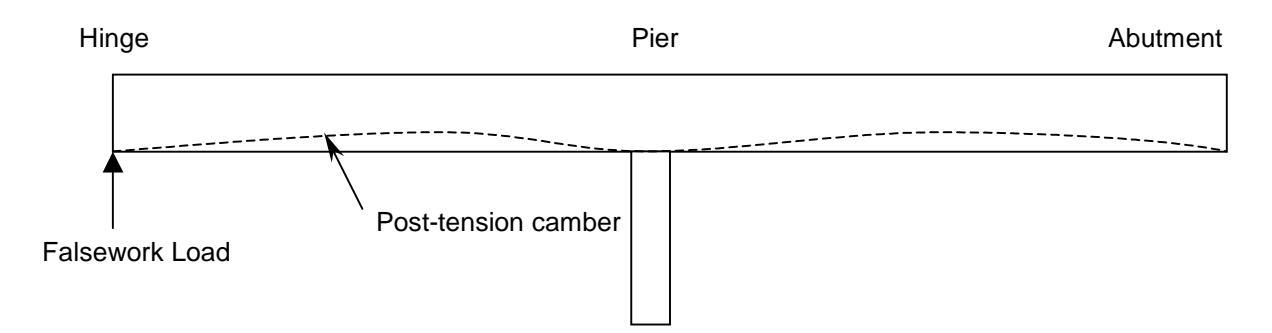
CAMBER DIAGRAM

This very large load concentrated on the hinge falsework means that crushing of the soffit joist timber must be considered. Web crippling of the beams and caps must be analyzed. This falsework must be left in place until the load can be transferred to the next segment of the bridge. The potential of long tem loading and severe weather conditions causes a careful consideration of the bearing soil condition and possible long term settlement.

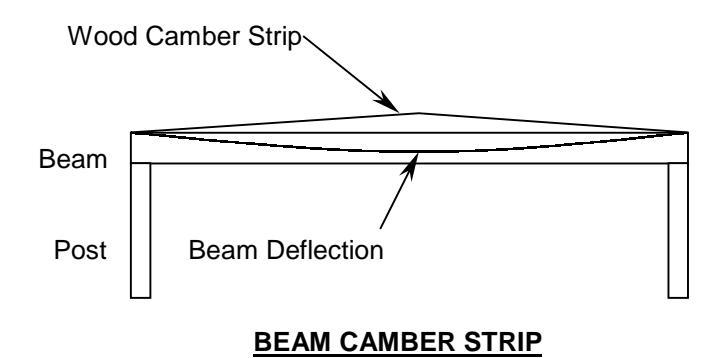
Between the joist and the beam is commonly placed a camber strip. This camber strip is usually a triangular wedge that will keep the bottom deck on grade as the beam deflects under the weight of the bottom deck and stems plus the form and beam weights. The width of the camber strip is determined to prevent rolling and perpendicular to the grain timber crushing pressures from developing.

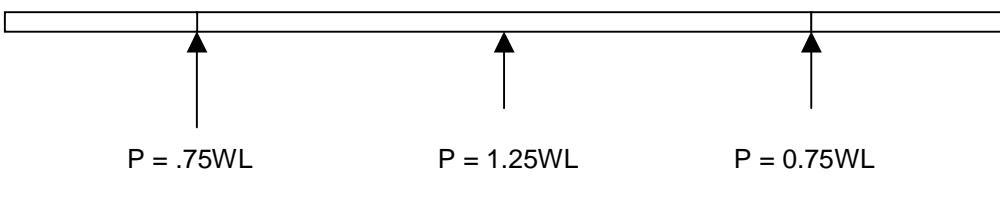
Generally simple span beams are preferred for several reasons. Multiple span beams will not evenly distribute the loads to the supporting posts.

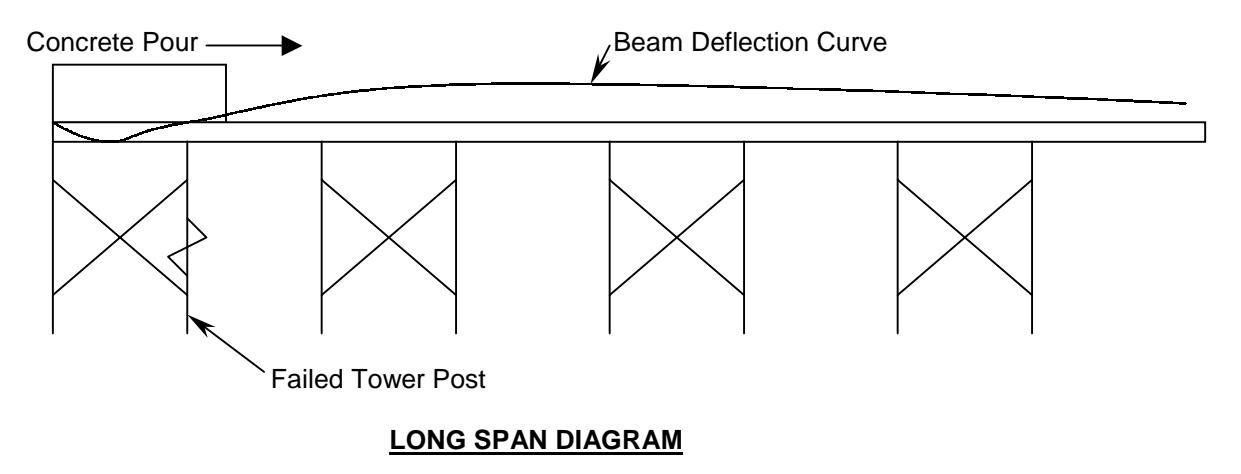
There have been instances where long beams have contributed to falsework failures due to the pour sequence. In one case a heavy slab supported by 10K "Tinker Toy" shoring towers was caused to fail because the beam deflection in a partially completed pour transferred too much load to a tower leg. The leading end of the long beam actually lifted off the towers and transferred all the form and rebar weight to the leg under the leading edge of the concrete pour.

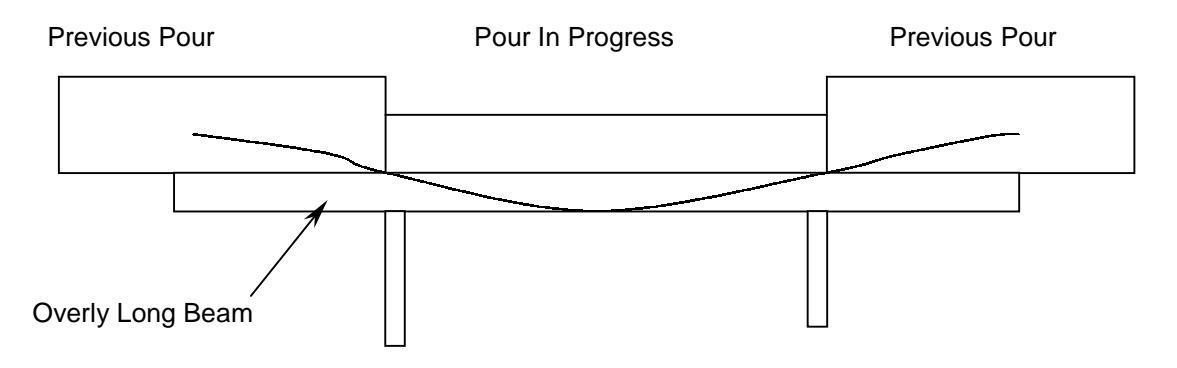
OVERLY LONG SIMPLE SPAN BEAM

In another case, overly long beams caused excessive settlement by transferring excessive load to the posts. Fortunately, this was discovered in time to prevent a collapse. The Posts were designed to support only the pour in progress. The pour in progress caused the tips of the beam to deflect upward and transferred the weight of the previous pours to the posts.

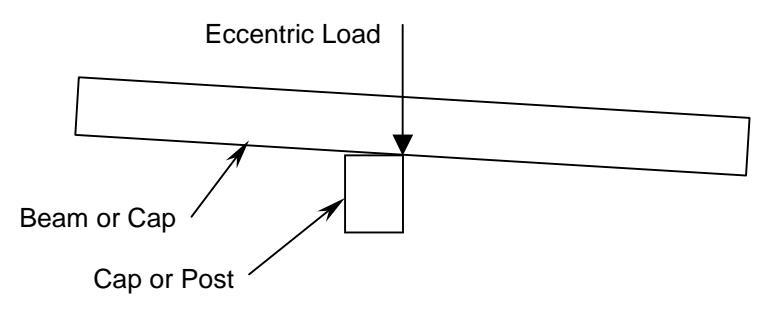
SUPERELEVATION & GRADE SLOPE DIAGRAM

The eccentric loading can cause lateral bending of the beams webs and induce bending moments into the posts. Wedging can be employed, but a two-way rocker bearing on the post is the preferred solution. Because the bridge bottom deck in commonly on a significant slope, squat and compact beams are preferred, such as a W14x90 shape. Because of the eccentric effects the bending stress of steel should be limited to 0.6 of the steel yield strength.

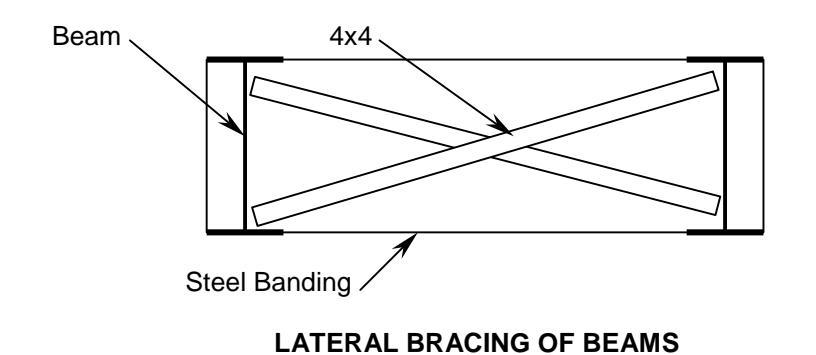
Lateral bracing should be used to keep the steel beams in a supported compact length. On severe transverse slopes the beams should be laterally supported at least near the supports and at mid-span. This can be easily accomplished with crossed 4x4 and steel banding.

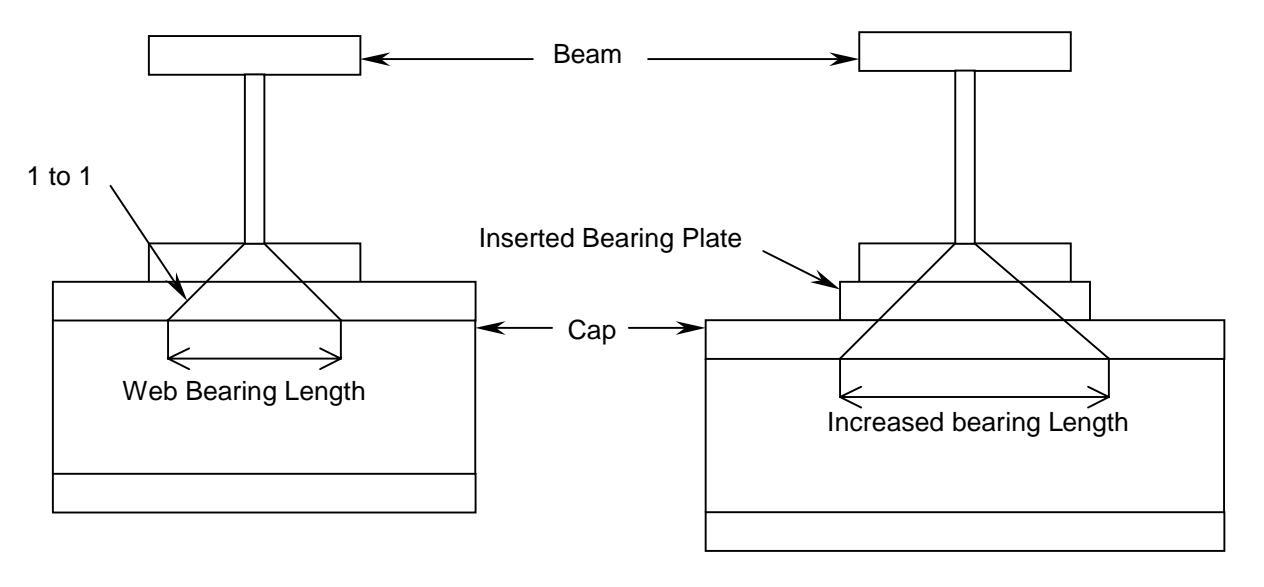
BEAM WEB CRIPPLING

A significant consideration is web crippling of steel and aluminum shapes. It is expensive to install stiffeners and they must be accurately located. This limits the flexibility of the placement of crossing member as well as the reuse to another location. It is common to insert bearing plates between crossing beams to distribute the point loads. The plates are easily placed and make for an inexpensive solution to the web crippling issue.

PLATE ADDED TO INCREASE BEARING LENGTH

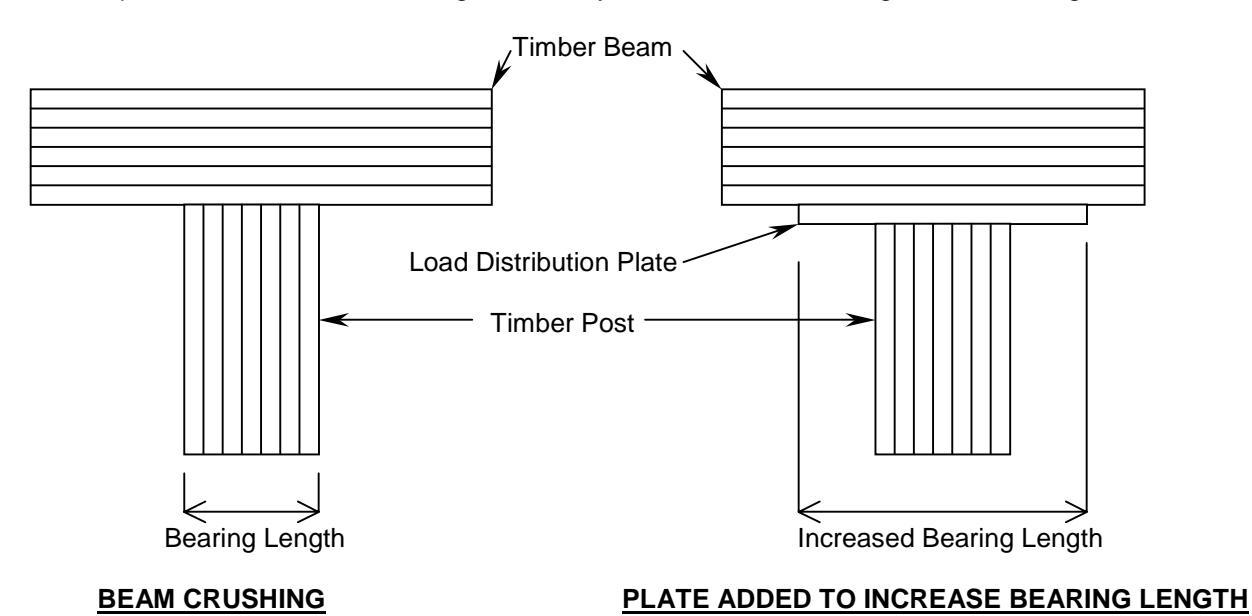
Just as steel plates can be used to distribute the web crippling loads in steel beams, plates can be easily inserted to distribute the crushing loads in timber beam to post connections. The added consideration is that the plate thickness must be designed to carry the distributed crushing load in bending.

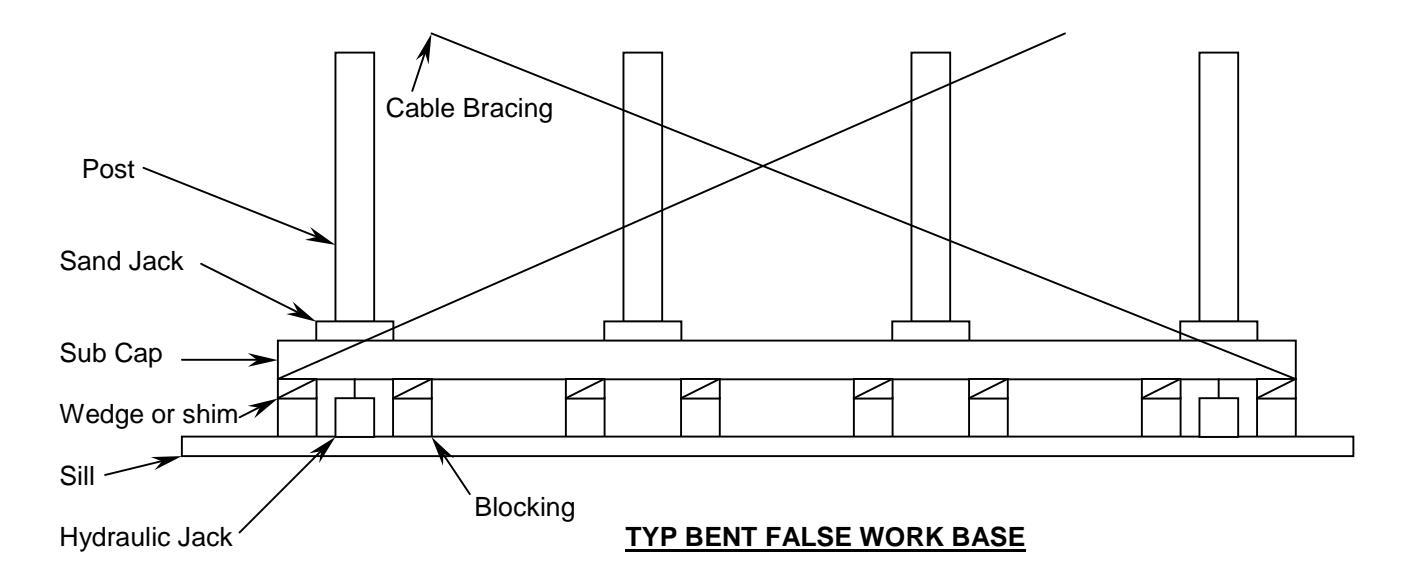
The sub cap serves several purposes. It anchors the cable cross bracing so that the entire falsework bent acts as a frame. If the cable is attached to a post, the lateral force can pull the post over causing a collapse of the falsework. The sub cap also aids in establishing the final soffit grade. Usually the falsework is erected an inch or two low and then jacked into final grade after the soffit plywood is installed. This also reduces the number of grade points. Trying to grade every beam end high in the air is a nearly hopeless task.

The sub cap allows the soffit to be raised to final grade with only two jack points per falsework bent. Once final grade is established, the gap between the blocking and sub cap is packed with shims or wedges. The gap between the blocking and sub cap during jacking or release should always be minimal. Falsework collapses have occurred when the hydraulic jack failed and allowed a sudden drop of the falsework. During the jacking and release the falsework should be adequately braced laterally in all directions.

Double blocking is shown in the above diagram. This serves to reduce crushing pressure and more evenly distributes the loads on to the sill. This reduces the sill timber or concrete thickness.
