Preservation Standards and Guidelines for Historic Buildings

Standards for Preservation & Guidelines for Preserving Historic Buildings

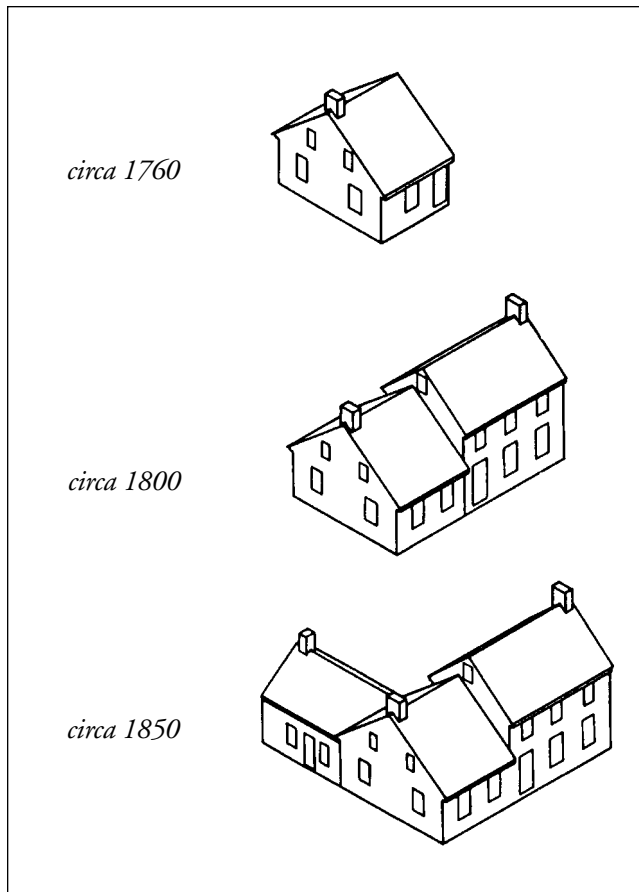
This three-part drawing shows the evolution of a farm house over time. Such change is part of the history of the place and is respected within the treatment, Preservation. Drawing: Center for Historic Architecture and Engineering, University of Delaware (adapted from Preservation Brief 35: Understanding Old Buildings).

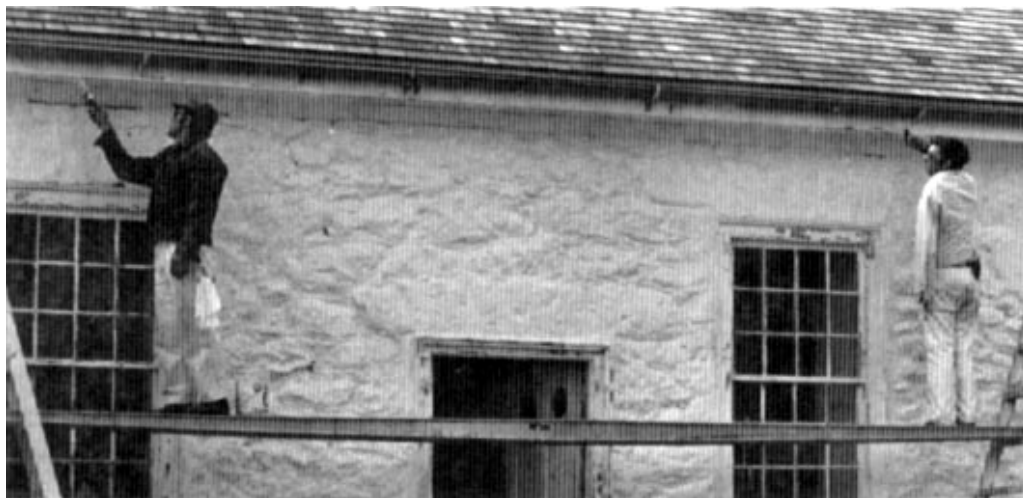
Adequate protection and maintenance of a historic building is an ongoing commitment. Here, two workers are priming and repainting exterior stone and wood trim. If surface treatments are neglected, more extensive repair and replacement will be required. Each loss further undermines a building's historic integrity.

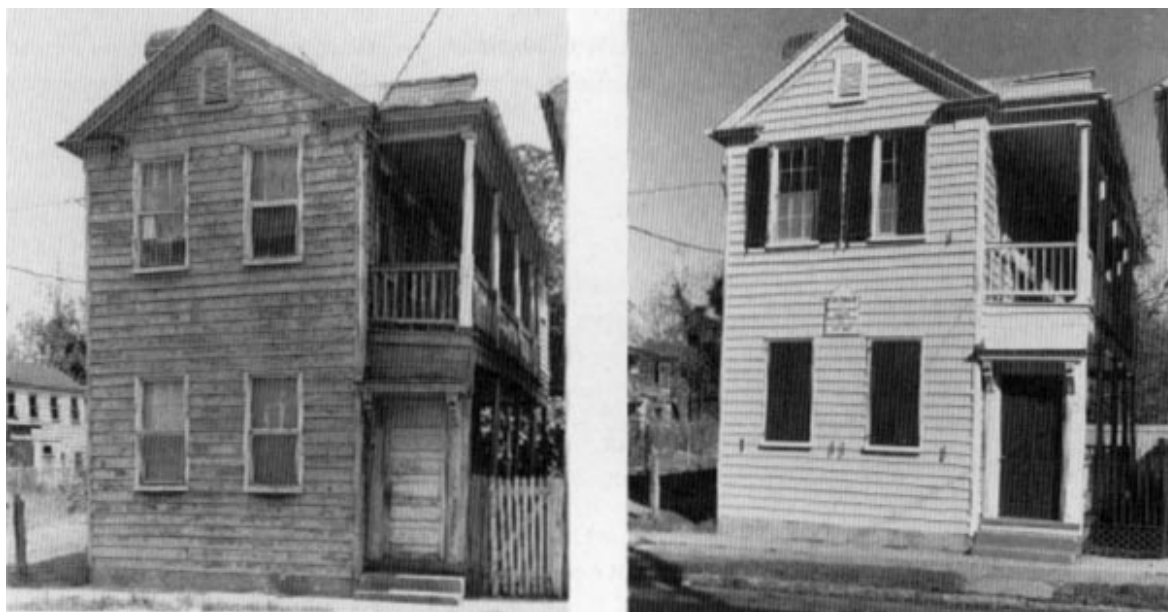
Maximizing retention of historic materials and features is the primary goal of Preservation as demonstrated here in these “before” and “after” photographs. Aside from some minor repairs and limited replacement of deteriorated material, work on this house consisted primarily of repainting the wood exterior. Photos: Historic Charleston Foundation.

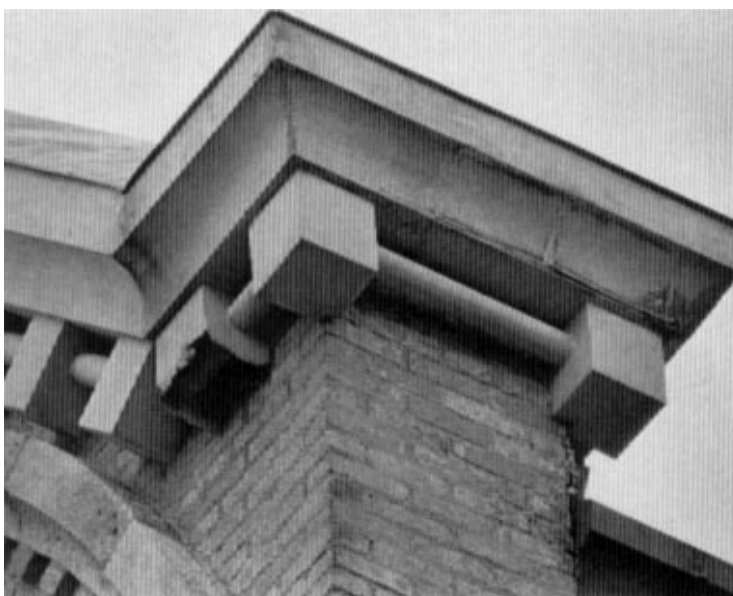
Two examples of “limited replacement in kind” point out an appropriate scope of work within the treatment, Preservation. (a) One metal modillion that has sustained damage from a faulty gutter will need to be replaced; and (b) targeted repairs to deteriorated wood cornice elements (fascia board and modillions) meant that most of the historic materials were retained in the work.

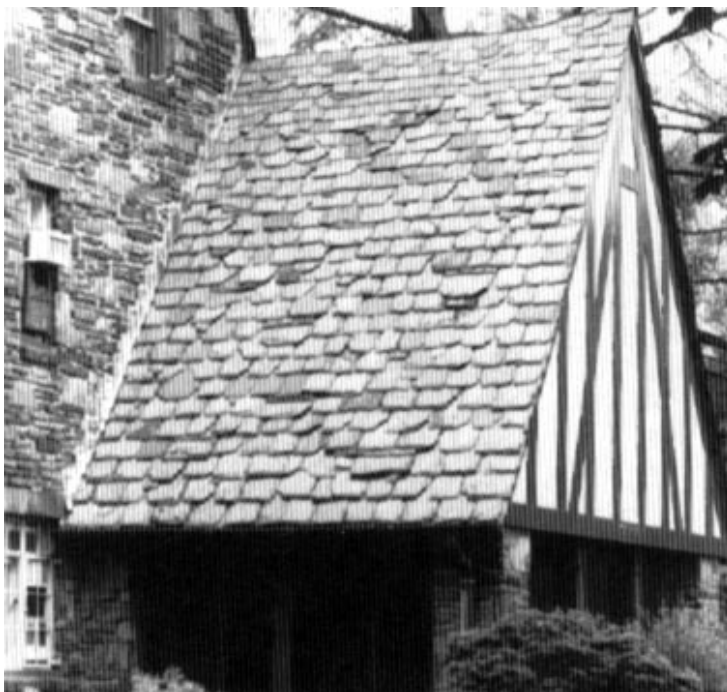
It is particularly important to preserve materials that contribute to a building's historic character, such as this highly visible slate roof. In the event that repair and limited replacement are necessary, all new slate would need to match the old exactly. Photo: Jeffrey S. Levine.

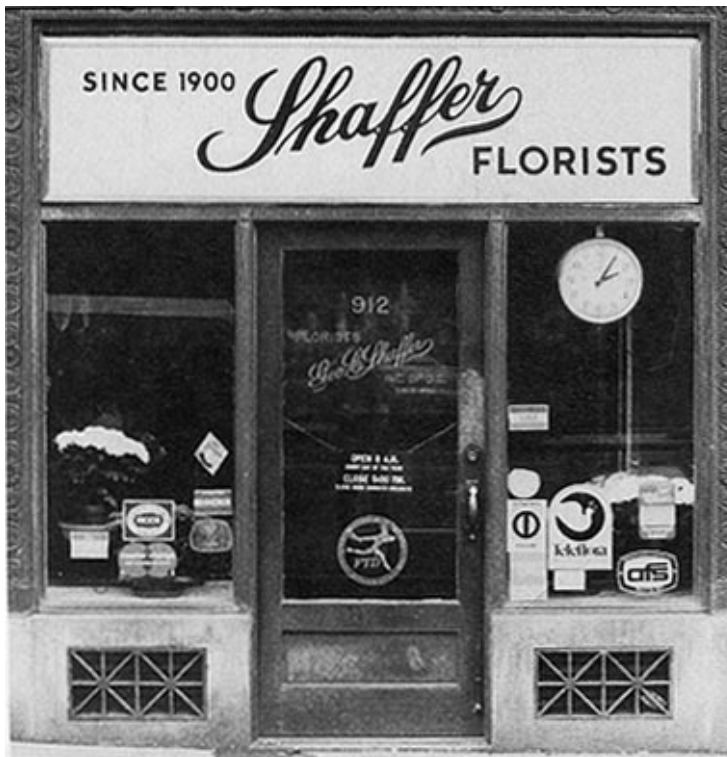
The original form and features of this 1920s storefront have been retained through Preservation. Photo: David W. Look, AIA.

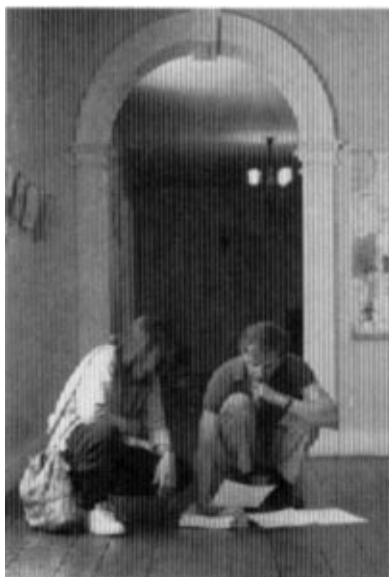
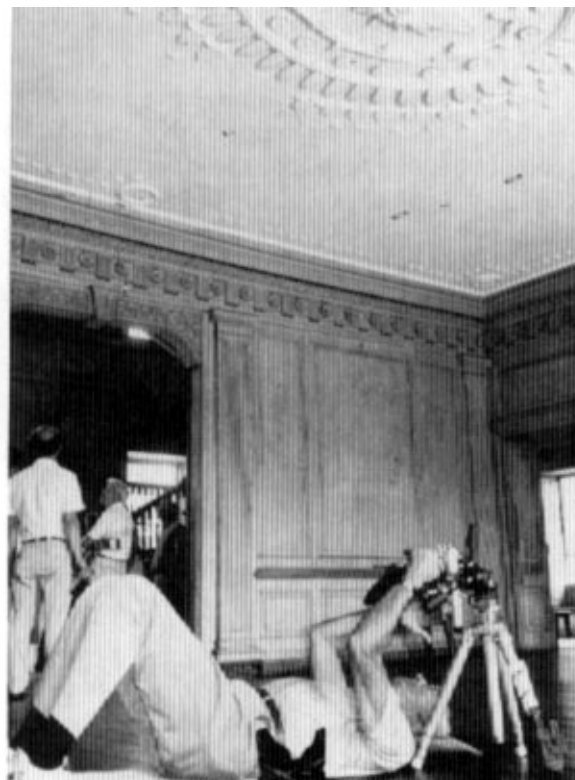
Careful documentation of a building's physical condition is the critical first step in determining an appropriate level of intervention. (a) This may include relating the historical research to existing materials and features; or (b) documenting a particular problem such as this cracked ceiling. Photo (a): Jean E. Travers; Photo (b): Lee H. Nelson, FAIA.

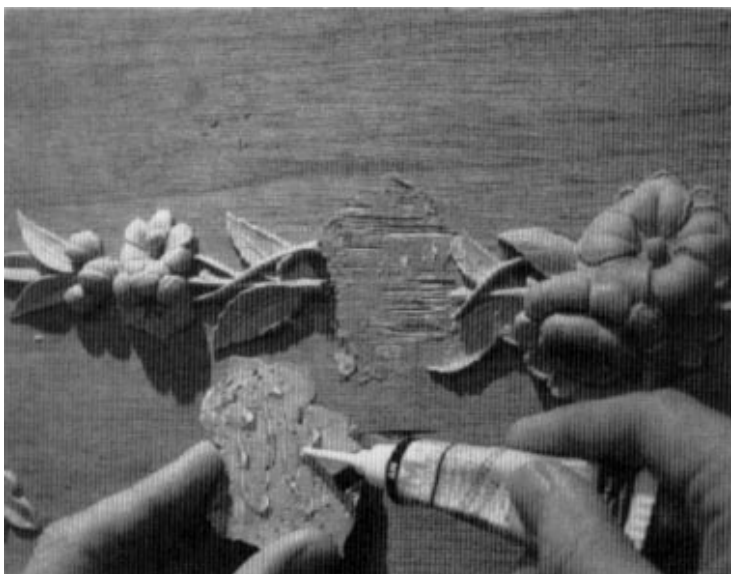
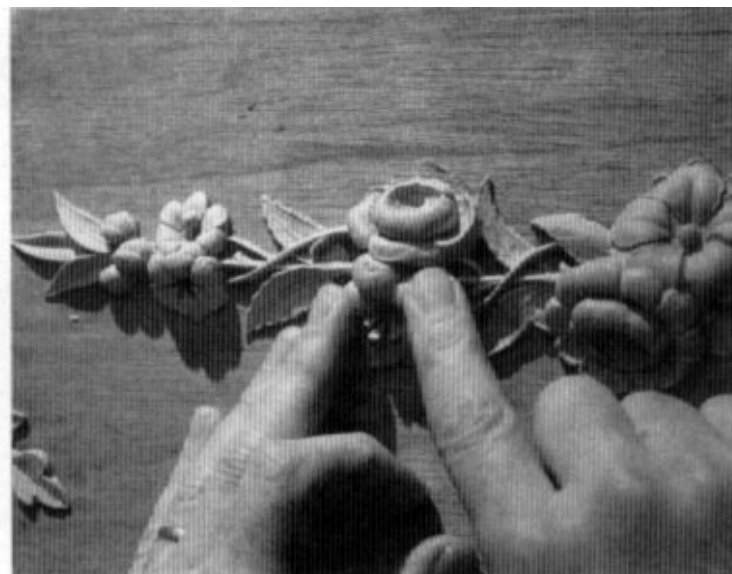
In Preservation, an appropriate level of intervention is established prior to work in order to maximize retention of historic materials.

(a) A conservator is applying adhesive to 19th century composition ornament that has delaminated from its wood substrate.

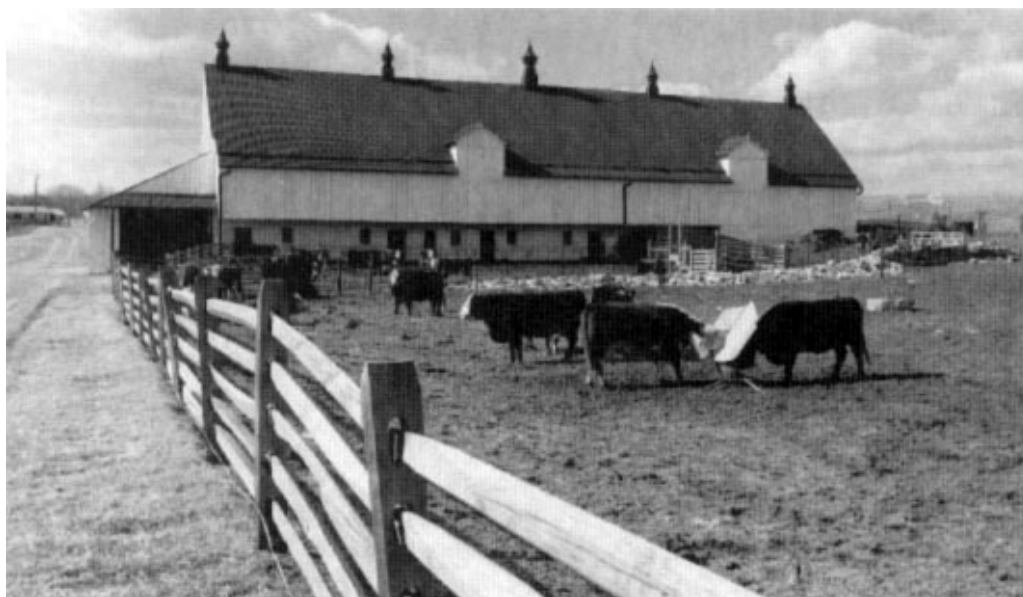
The goal of Preservation is to retain the historic form, materials, and features of the building and its site as they have changed—or evolved—over time. This bank barn was built in the 1820s, then enlarged in 1898 and again in 1914. Today, it continues its role as a working farm structure as a result of sensitive preservation work. This included foundation re-grading; a new gutter system; structural strengthening; and replacement of a severely deteriorated metal roof. Photo: Jack E. Boucher, HABS.
