PDHonline Course A107 (5 PDH)

Restoration Standards and Guidelines for Historic Buildings

Standards for Restoration & Guidelines for Restoring Historic Buildings

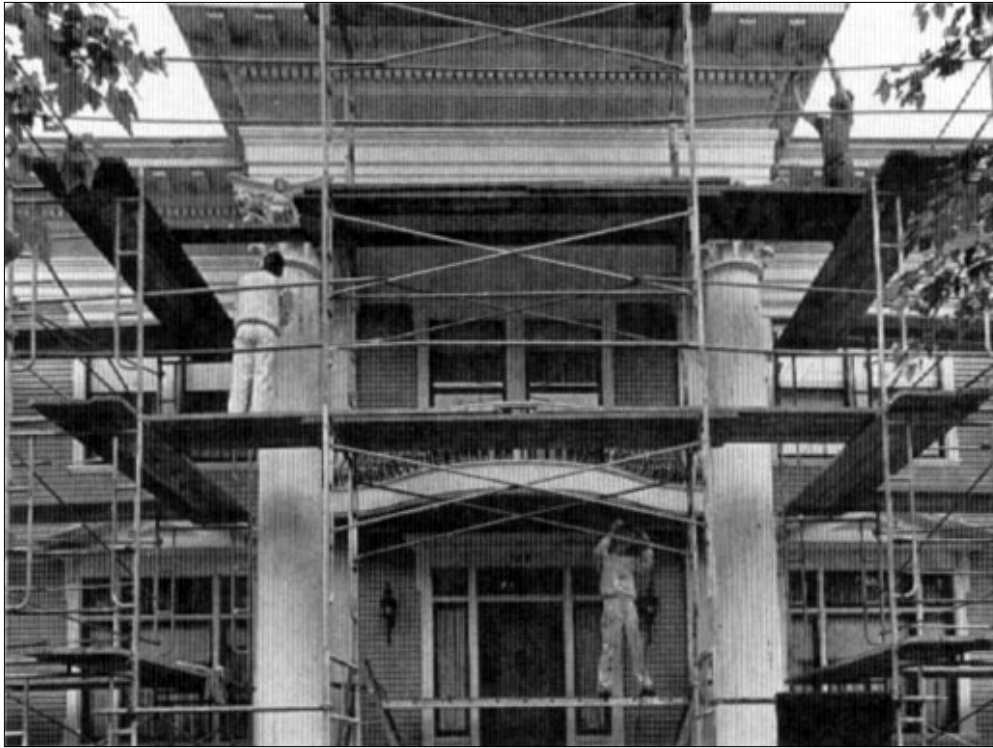
Ongoing work at this house focuses on the maintenance and repair of exterior wood features from the restoration period. After scraping and sanding, the wood was painted in colors documented to the Restoration period. Photo: ©Mary Randlett, 1992.

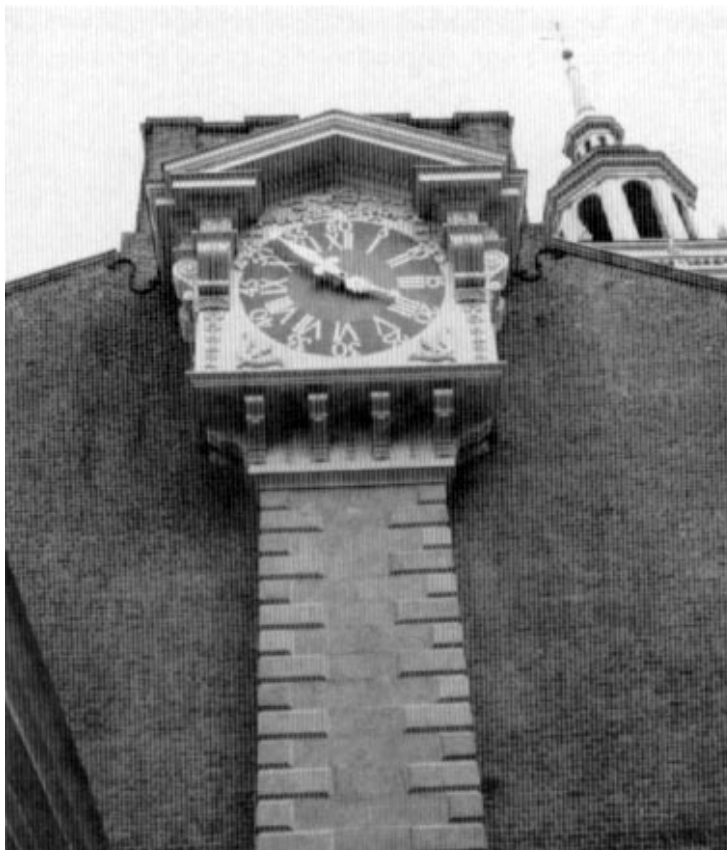
The Standards for Restoration call for the repair of existing features from the restoration period as well as the re-creation of missing features from the period. In some instances, when missing features are replaced, substitute materials may be considered if they convey the appearance of the historic materials. In this example at Philadelphia's Independence Hall, the clock was re-built in 1972-73 using cast stone and wood with fiberglass and polyester bronze ornamentation. Photo: Lee H. Nelson, FAIA.

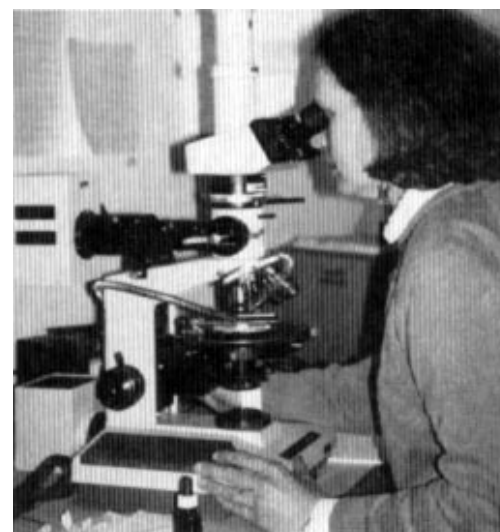
A complete paint investigation often needs to be conducted during Restoration. Paint samples are carefully collected onsite. In the laboratory, an ultra violet light is used to identify pigment and binding media. Paint samples are then photographed. Physical evidence documented through laboratory research provides a sound basis for an accurate restoration of painted finishes, such as the complex stencilling pictured here. Photo left: Courtesy, Alexis Elza; Photo right: Courtesy, Andrea Gilmore.

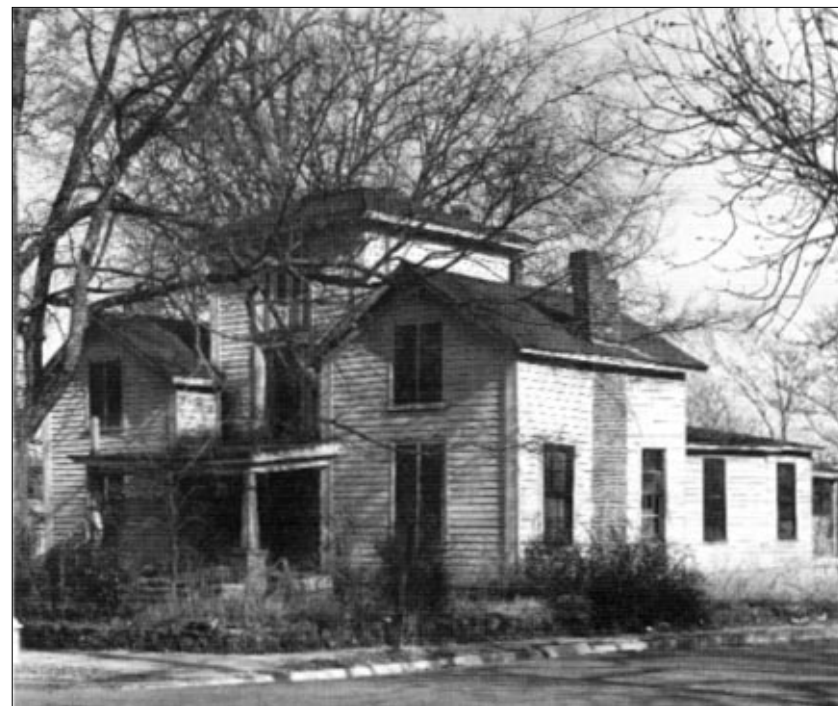
This ca. 1900 photograph (left) would be invaluable to guide restoration of the deteriorated house (right) to its documented earlier appearance, complete with decorative trim, shutters, polychromed exterior, and fencing. Photos: Courtesy, North Carolina Department of Archives and History.

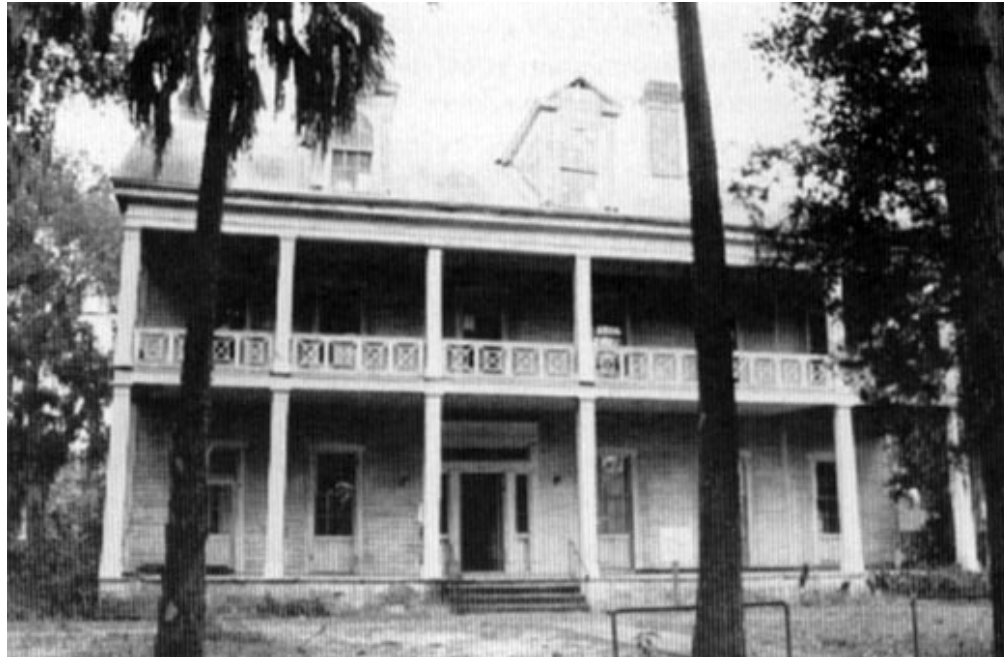
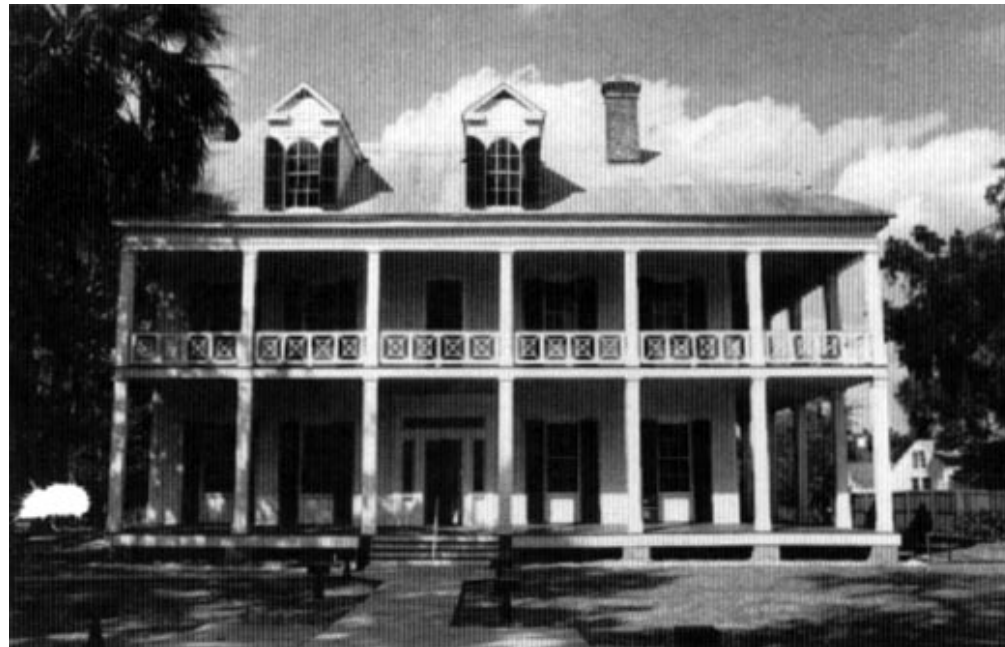
The Bronson-Mulholland House in Palatka, Florida, ca. 1845, is shown (a) before and (b) after the treatment, Restoration. Over the years the east (far right) side of the veranda had been filled in as a sixth bay. During the restoration, this later infill was removed and the east veranda, together with its flooring, stairs, and foundation, restored. Photo: City of Palatka, Community Development Department.
