## **PDHonline Course C220 (6 PDH)**

# **Assessing the Vulnerability at Coastal Sites**

# Chapter 7: Identifying Hazards

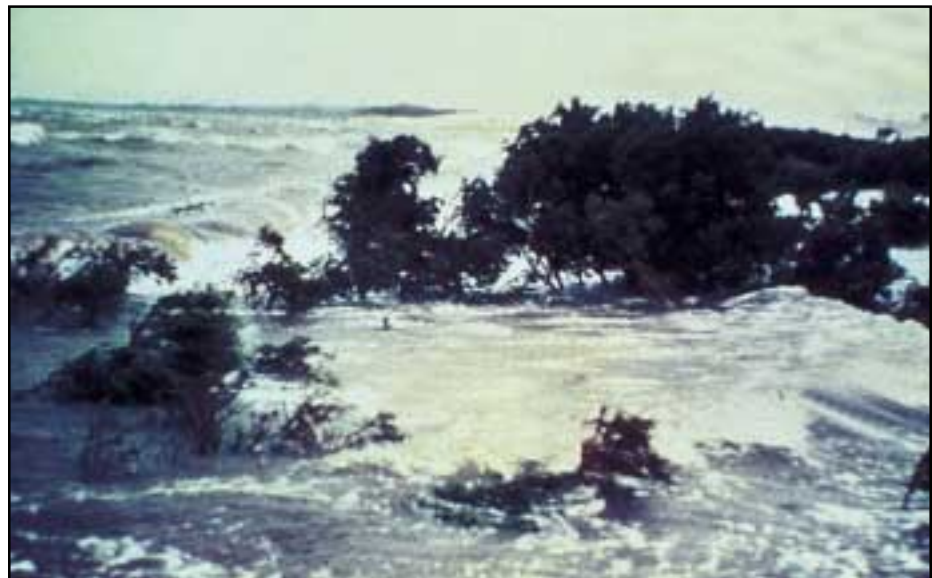
**Figure 7-1**  
Hurricane Frederic (1979).  
Storm surge and waves  
overtopping a coastal barrier  
island in Alabama.

Tropical cyclones and coastal storms are capable of generating high winds, coastal flooding, high-velocity flows, damaging waves, significant erosion, and intense rainfall (see Figure 7-1). Like all flood events, they are also capable of generating and moving large quantities of waterborne sediments and floating debris. Consequently, the risk to improperly sited, designed, or constructed coastal buildings can be great.

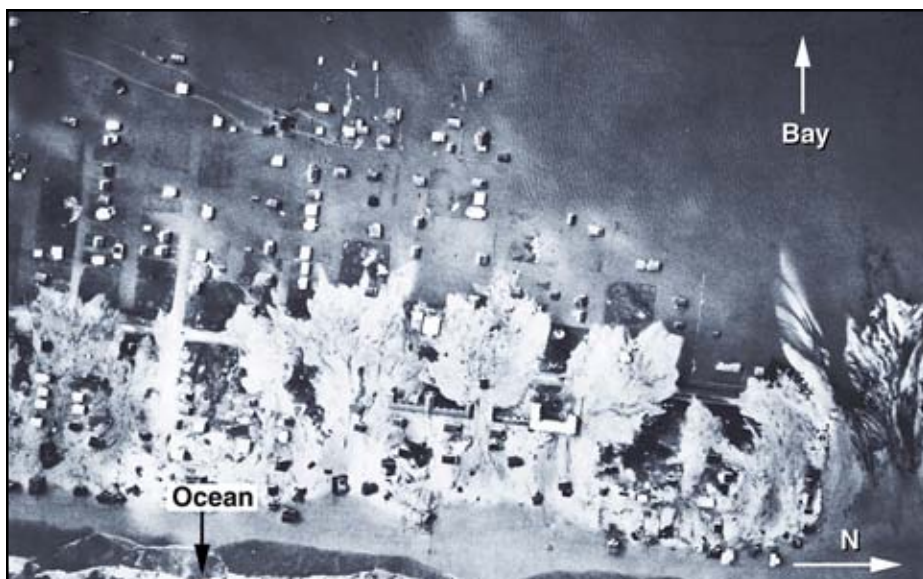
**Figure 7-5**

March 1962 northeaster. Flooding, erosion, and overwash at Fenwick Island, Delaware.

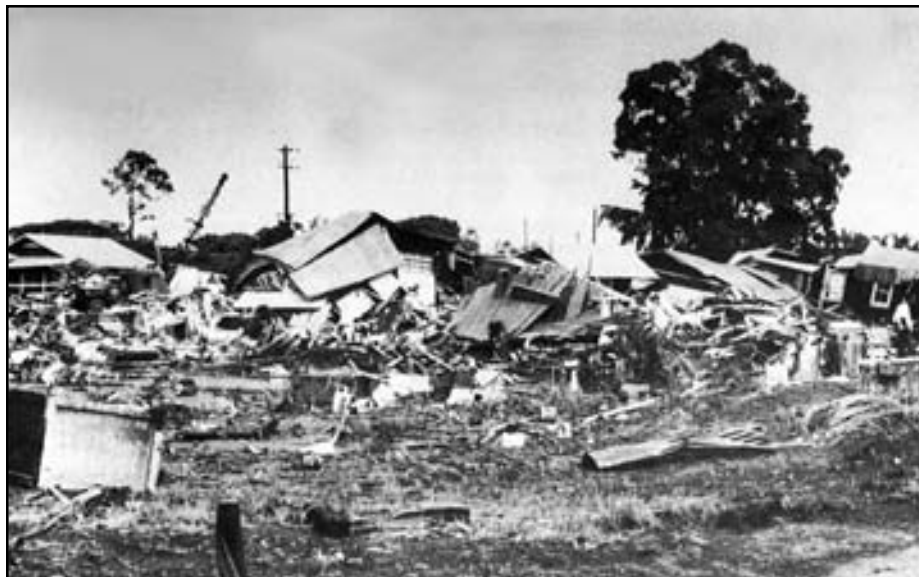
Hilo, Hawaii. Damage from the 1960 Tsunami (from Camfield 1994). Courtesy of *Journal of Coastal Research*.

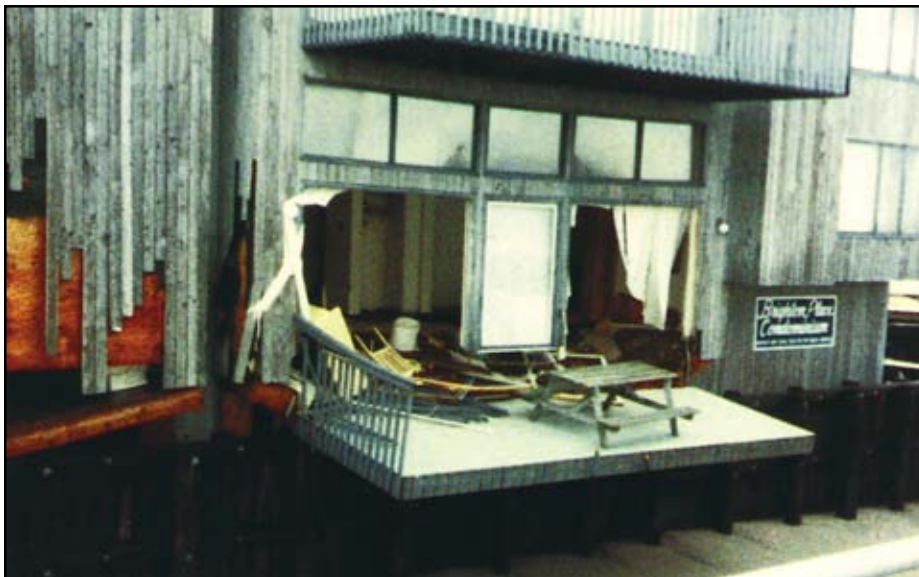
**Figure 7-14**

Wave runup beneath elevated buildings at Scituate, Massachusetts, during the December 1992 northeast storm. Nine homes in the area were purchased with public funds and demolished following the storm. Photograph by Jim O'Connell.

*Wave runup* occurs as waves break and run up beaches, sloping surfaces, and vertical surfaces. Wave runup (see Figure 7-14) can drive large volumes of water against or around coastal buildings, inducing fluid impact forces (albeit smaller than breaking wave forces), current drag forces, and localized erosion and scour. Wave runup against a vertical wall will generally extend to a higher elevation than runup on a sloping surface and will be capable of destroying overhanging decks and porches. Figure 7-15 shows the effects of wave runup and breaking against a vertical wall and adjacent building. *Wave reflection or deflection* from adjacent structures or objects can produce forces on a building similar to those caused by wave runup.

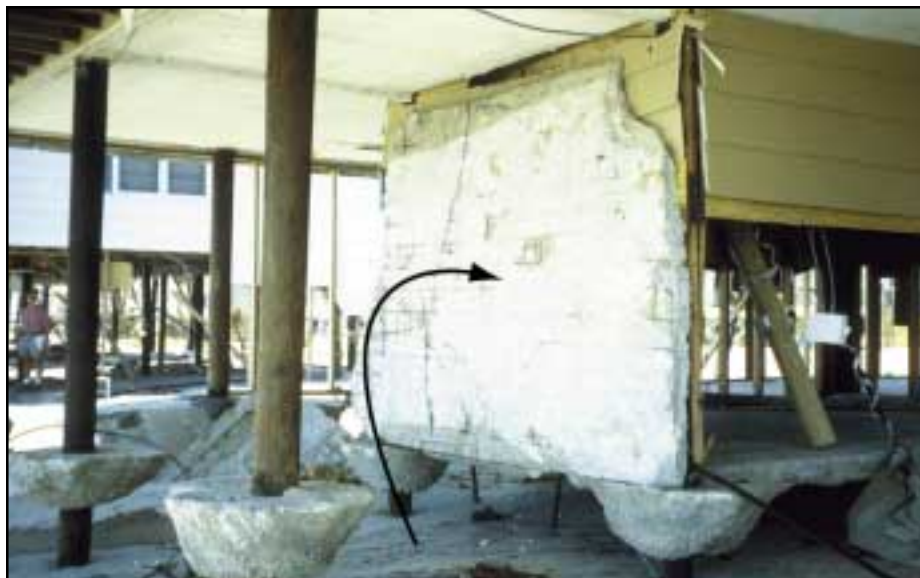
**Figure 7-16**  
Hurricane Fran (1996).  
Concrete slab-on-grade  
flipped up by wave action  
came to rest against two  
foundation members,  
generating large  
unanticipated loads on the  
foundation.

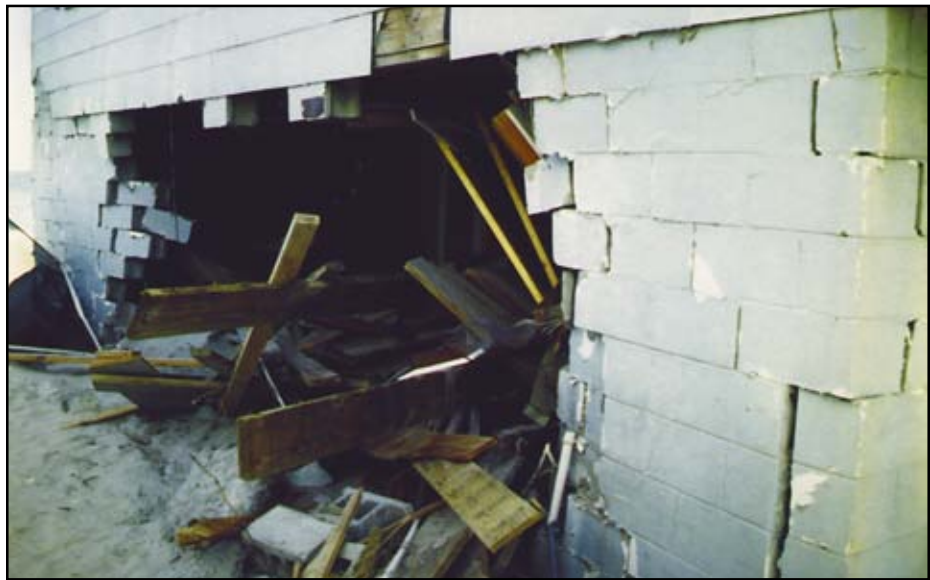
**Figure 7-19**

Hurricane Fran (1996). Debris lodged beneath a Topsail Island, North Carolina, house elevated on unreinforced masonry walls. The wall damage could have resulted from flood and wave forces, debris loads, or both.

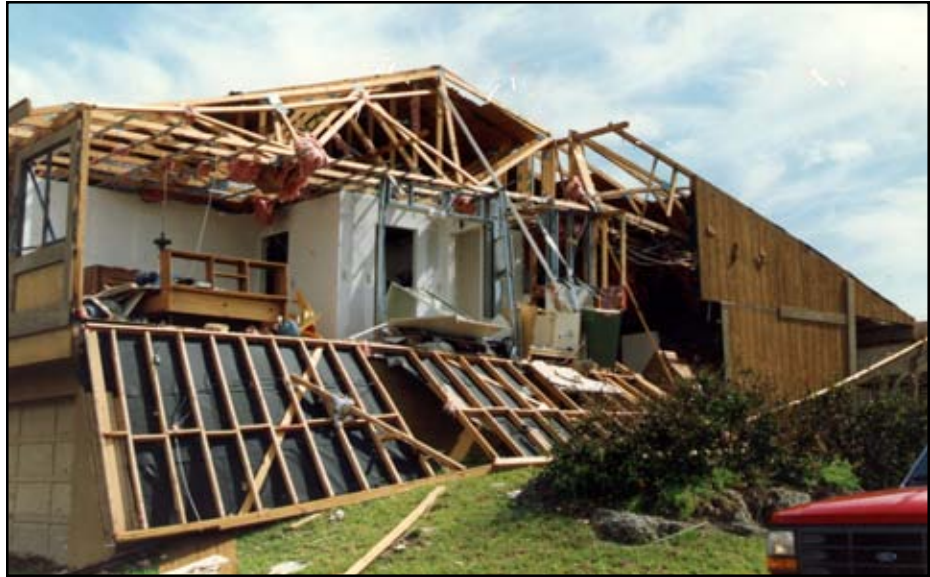
**Figure 7-24**

Hurricane Andrew (1992).  
End-wall failure of typical  
first-floor masonry/second-  
floor wood-frame building in  
Dade County, Florida.

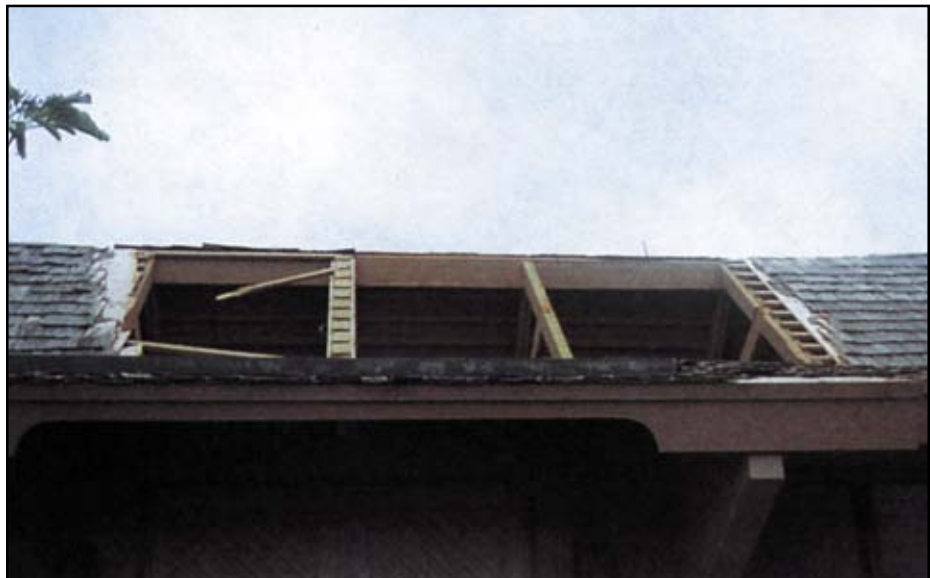
**Figure 7-25**

Hurricane Iniki (1992), Kauai  
County, Hawaii. Loss of roof  
sheathing due to improper  
nailing design and schedule.

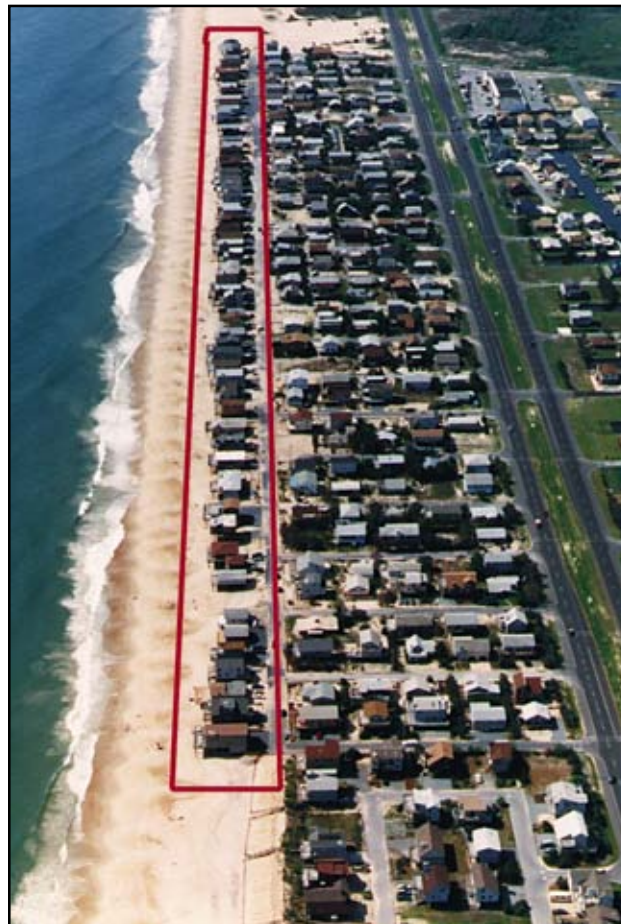
**Figure 7-29**

Long-term erosion at South Bethany Beach, Delaware, has lowered ground elevations beneath buildings and left them more vulnerable to storm damage. 1992 photograph.

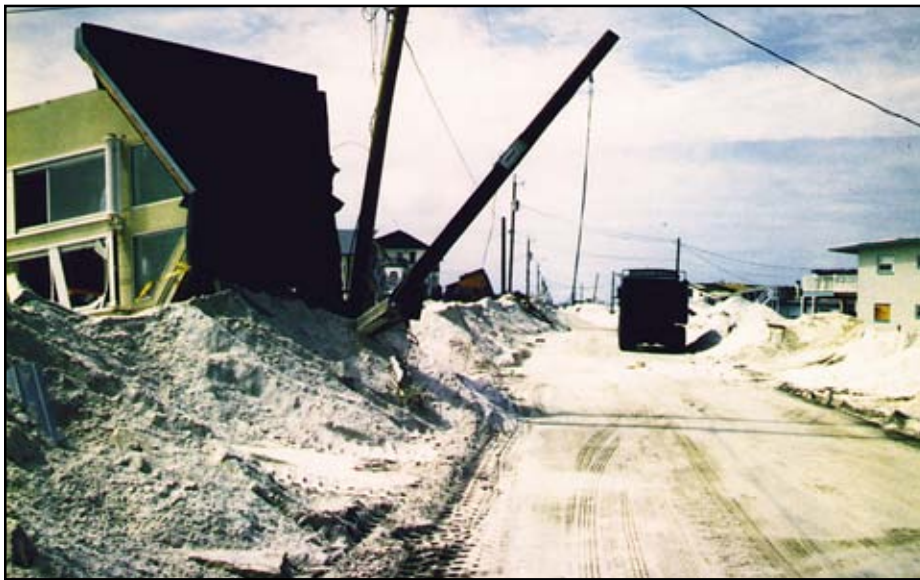
**Figure 7-30**

Erosion undermining a coastal residence at Cape Shoalwater, Washington. 1992 photograph by Washington Department of Ecology.

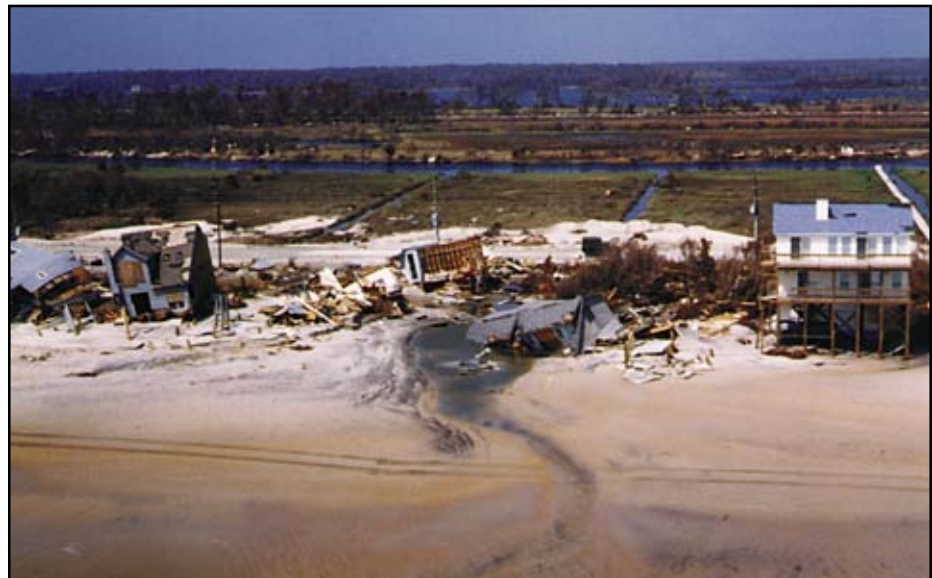
**Figure 7-33**

Hurricane Fran (1996).  
Breach and building damage  
at North Topsail Beach, North  
Carolina.

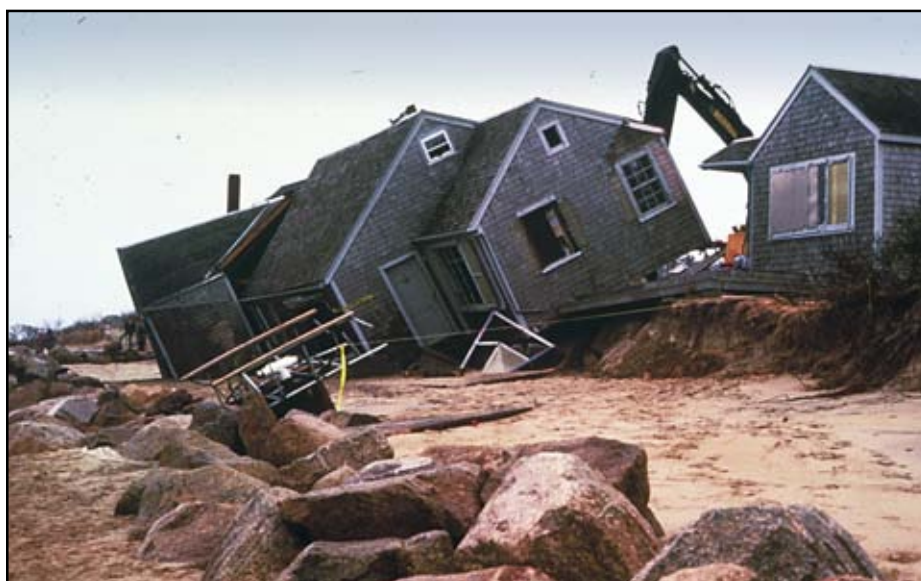
**Figure 7-34**

A breach was cut across Nauset Spit on Cape Cod, Massachusetts, by a January 1987 northeaster. The breach grew from an initial width of approximately 20 feet to over a mile within 2 years, exposing the previously sheltered shoreline of Chatham to ocean waves and erosion. Photograph by Jim O'Connell.

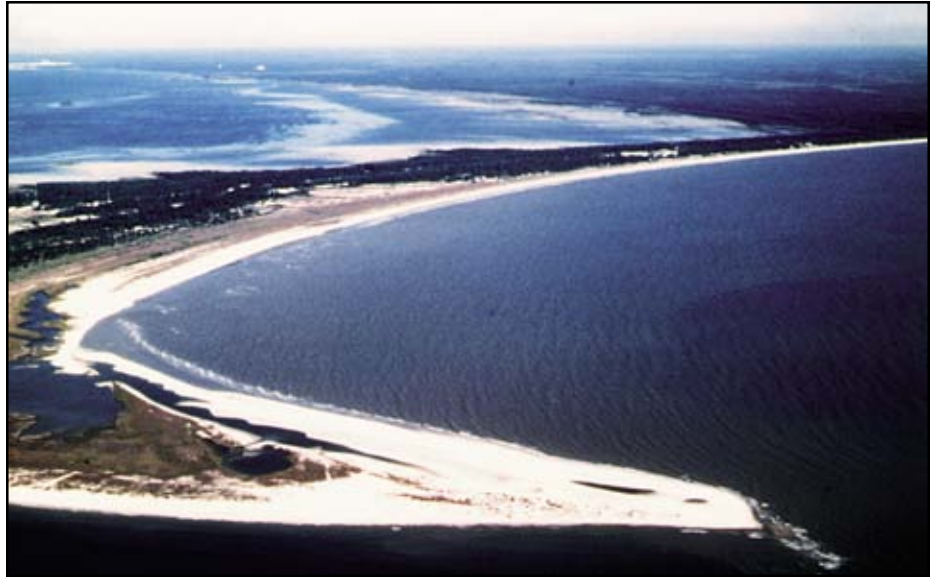
**Figure 7-36**  
Cape San Blas, Gulf County,  
Florida, in November 1984,  
before Hurricane Elena.

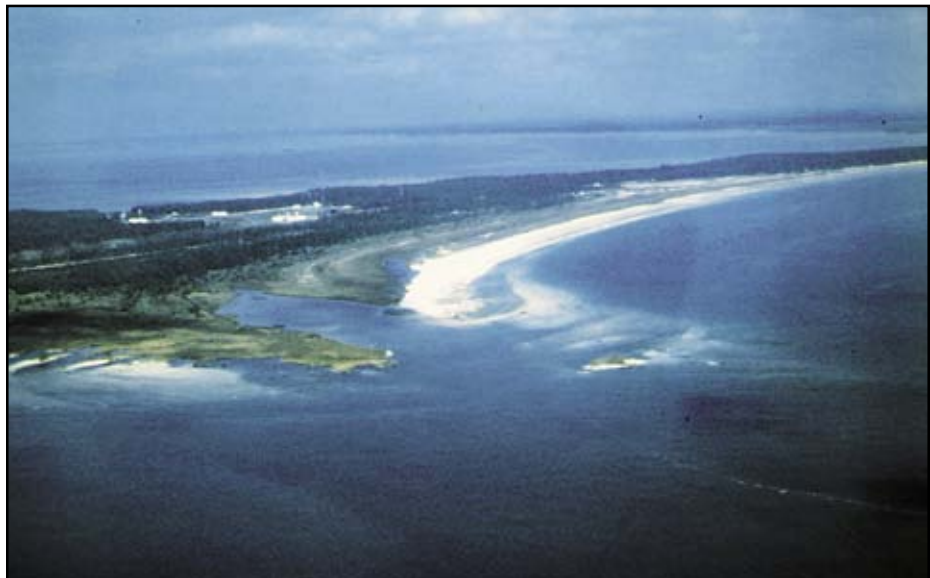
**Figure 7-37**  
Cape San Blas, Gulf County,  
Florida, in November 1985,  
after Hurricane Elena.

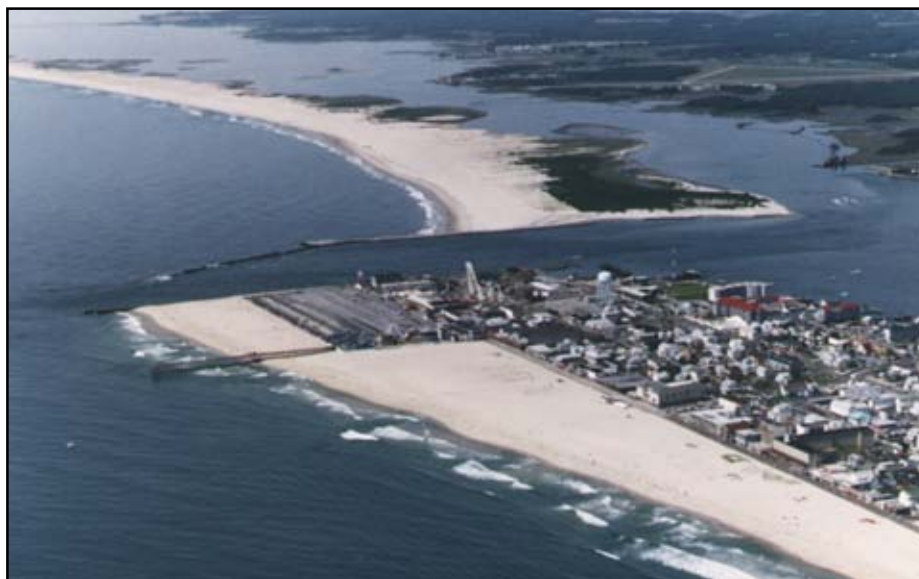
**Figure 7-45**  
Ocean City Inlet, Maryland, was opened by a hurricane in 1933 and stabilized by jetties in 1934–35. Note extreme shoreline offset and downdrift erosion resulting from inlet stabilization. 1992 photograph.

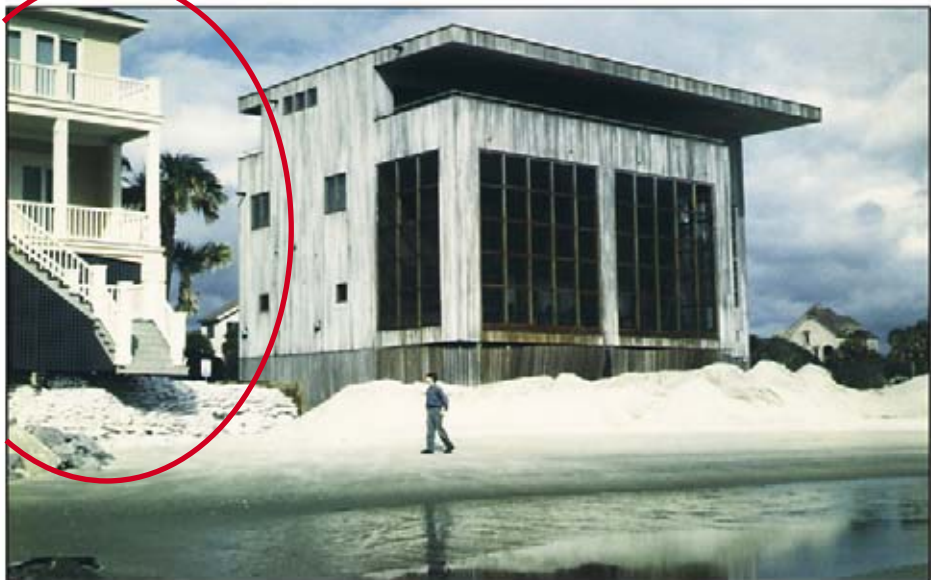
**Figure 7-48**

December 1997 photograph taken in the same area as Figure 7-47. Erosion and undermining of the houses is a result of shoreline changes associated with changes in inlet sand bars and wave patterns. Note that this area is approximately 0.5 mile from the houses shown in Figure 4-2.

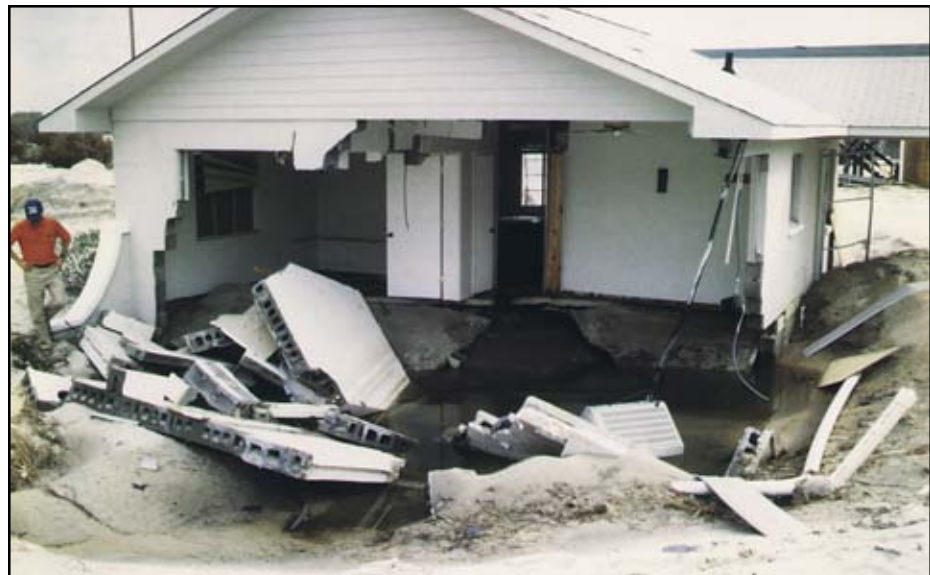
**Figure 7-52**  
Hurricane Fran (1996).  
Extreme case of localized  
scour undermining a slab-  
on-grade house on Topsail  
Island, North Carolina. The  
lot was several hundred feet  
from the shoreline and  
mapped as an A zone on the  
FIRM prior to the storm. This  
case provides one argument  
for the treatment of these  
areas as coastal A zones.

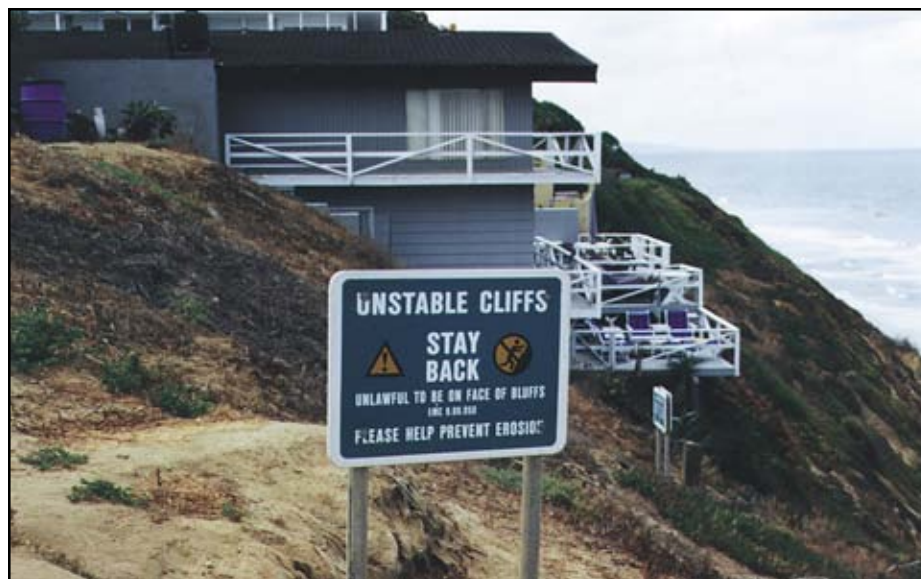
**Figure 7-56**  
Unstable coastal bluff at  
Beacon's Beach, San Diego,  
California. Photograph by  
Lesley Ewing.
